Town of Bethlehem

Road-Stream Crossing Assessment Inventory

Prepared by:
Pomperaug River Watershed Coalition
2025

August 2025

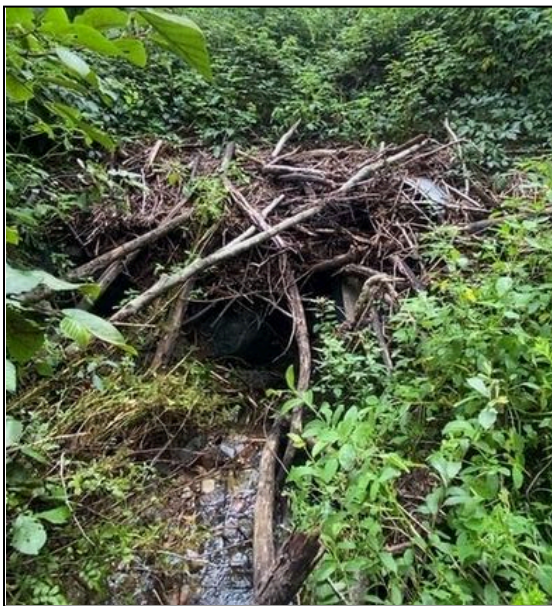
Inlet

- Moderate debris accumulation at inlet
- Outlet grade (cascade) has caused a 3ft-deep scour pool at outlet
- Culvert is made of thin grey plastic
- No substrate inside the structure
- No dry passage

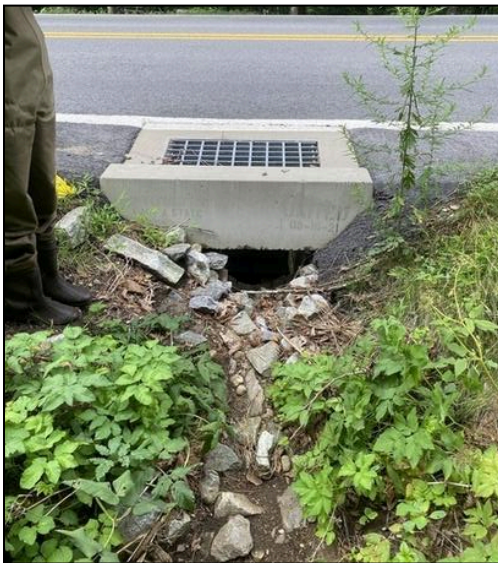
Inlet

- “Puzzle piece” shaped inlet is much smaller than outlet
- Large inlet drop into culvert
- Appears a new, smaller inlet may have been built in front of existing culvert inlet to accommodate catch basin system
- 5ft drop (cascade) from outlet to water surface
- Stream was dry at the time of assessment
- No dry passage if stream was flowing
- Extensive armoring needed because of cascade outlet grade to prevent scour

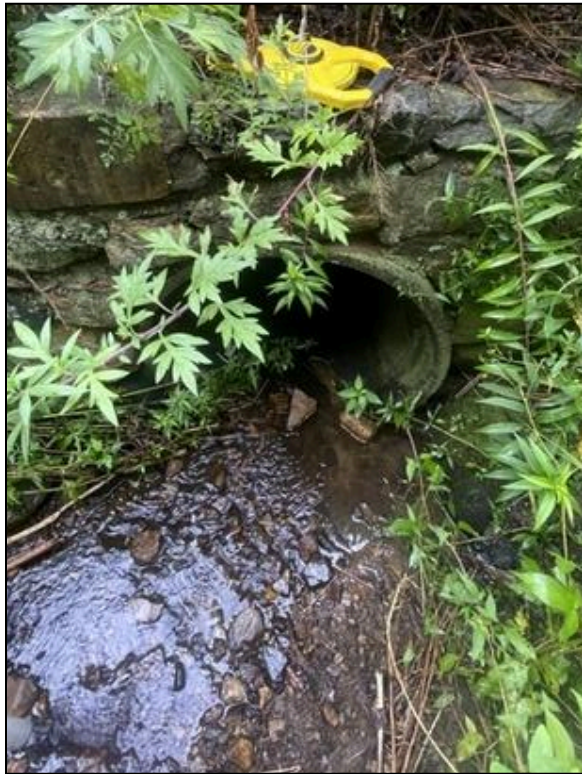
Inlet

- 3.8 ft drop from outlet to water surface
- Outlet grade (free fall onto cascade) has contributed to the formation of a small scour pool at outlet
- Extensive armoring placed at outlet to prevent scour
- No dry passage through structure

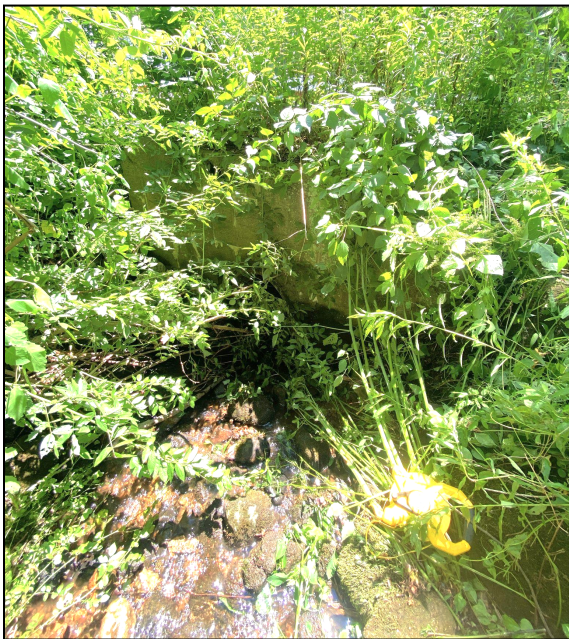
Inlet

- **Severe constriction**
- **3.1 ft drop from outlet to water surface**
- **Outlet grade (free fall onto cascade) has contributed to the formation of a large, 1.8ft-deep scour pool at outlet**
- **Inlet very overgrown**
- **Minor erosion of culvert bottom**
- **No dry passage**

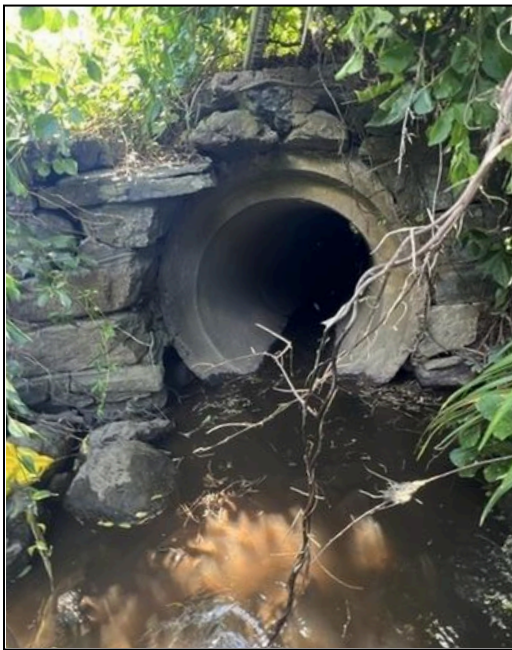
Inlet

- Erosion of culvert and headwall at inlet
- Dammed pond upstream of inlet
- Outlet grade (cascade) has resulted in a large, 1.8 ft-deep scour pool
- Storm water outflow to right of outlet
- Outlet is plastic while inlet is concrete
- Extensive armoring at outlet to mitigate scour from outlet grade
- Plastic wingwalls at outlet deformed by weight of rip rap
- No dry passage through structure

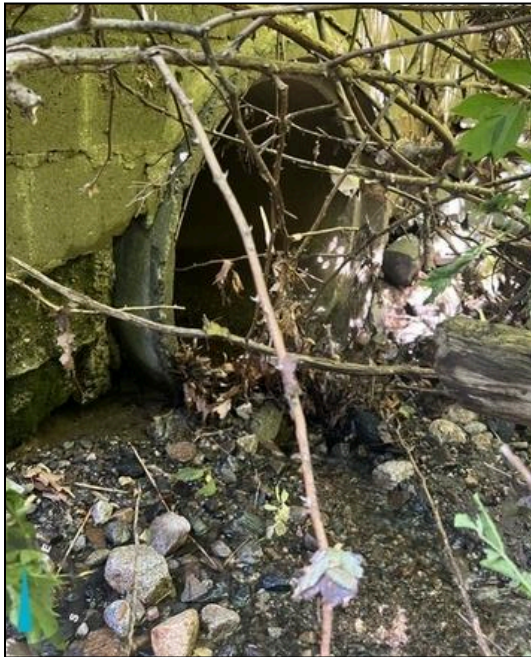
- Cracking of culvert segments inside structure
- 4.8ft drop from outlet to water surface
- Extensive armoring at outlet to mitigate scour
- Inlet is fed by 2 streams, both have skewed alignment relative to inlet
- Erosion of headwall around culvert at inlet
- Overgrown thorny vegetation and minor debris buildup at inlet
- No dry passage through structure

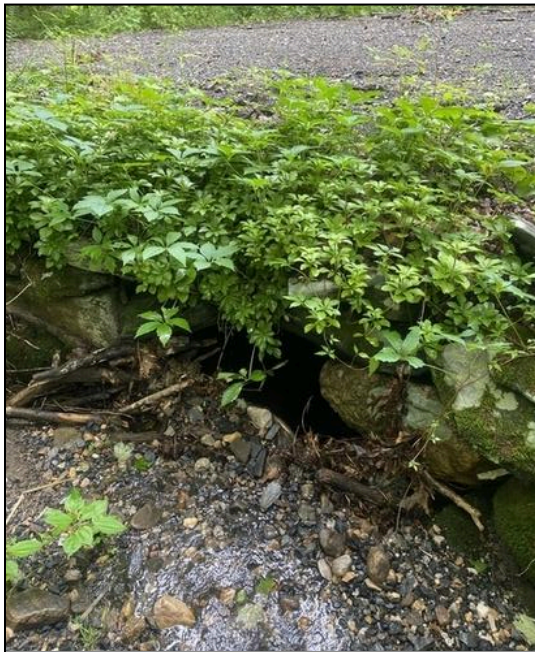
Inlet

- **Rocks piled around culvert inlet, no true headwall**
- **2.6 ft inlet drop as a result of sediment and debris buildup**
- **Severe constriction**
- **2 streams converge downstream of culvert outlet**
- **4.1 ft drop from outlet to water surface has contributed to the formation of a large 1.4 ft-deep scour pool despite extensive armoring**
- **No dry passage through the structure**

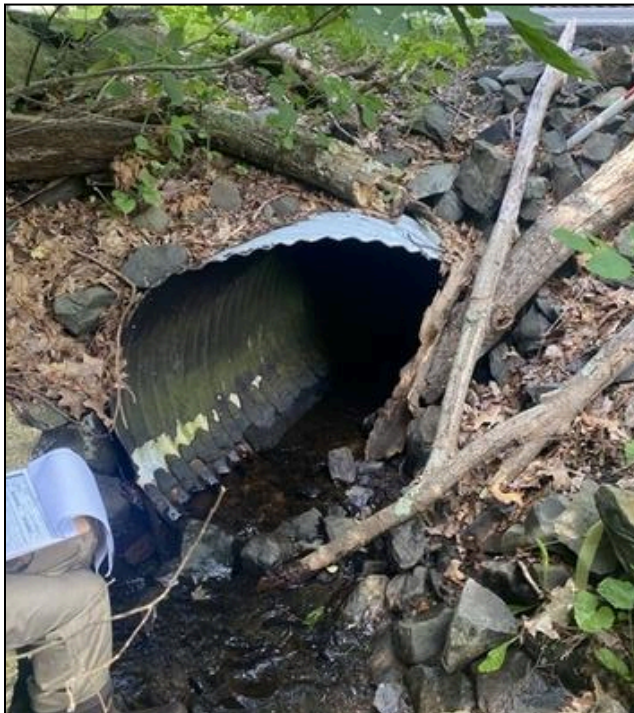
Inlet

- Severe constriction
- Outlet grade (free fall onto cascade) has contributed to the formation of a small scour pool at outlet
- No dry passage through structure
- Rubber-lined metal culvert is rusted and eroded
- Outlet is very overgrown
- Skewed alignment

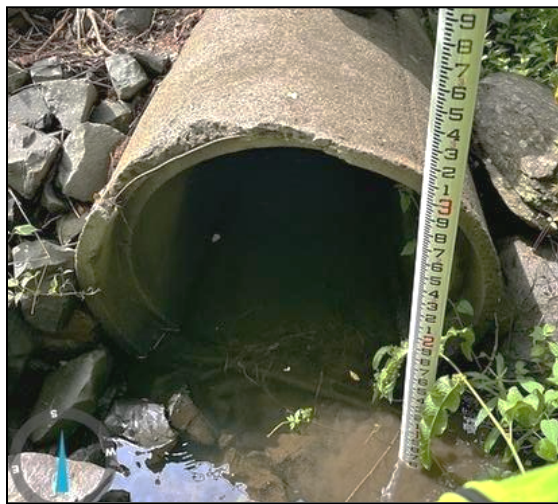
Inlet

- Moderate constriction
- 2.5 ft drop from outlet to water surface
- Large, 1.5ft-deep scour pool at outlet caused by outlet grade (free fall onto cascade)
- No dry passage through structure
- Extensive overgrowth and rip rap at outlet
- Headwall present at inlet but culvert projects
- Culvert segments separating at inlet
- Erosion of culvert inlet, rebar exposed

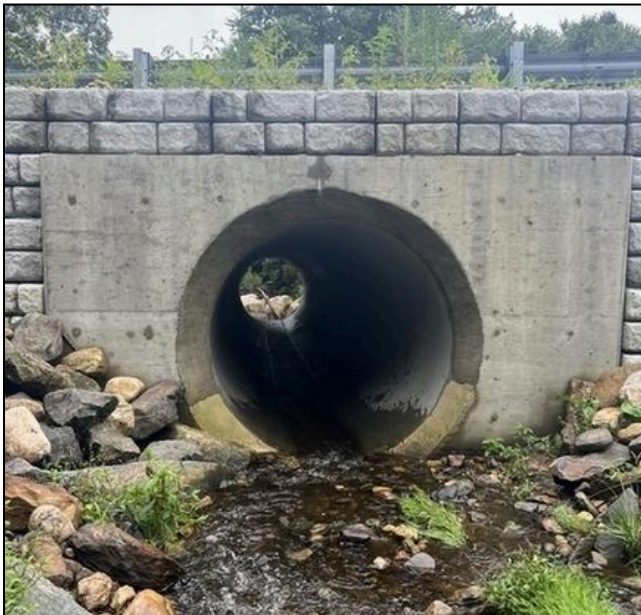
Inlet

- Moderate constriction
- 2.0 ft drop from outlet to water surface
- Large, 2.5 ft-deep scour pool at outlet caused by outlet grade (free fall onto cascade)
- No dry passage through structure
- Heavy rip rap at both the inlet and outlet and extensive armoring at outlet
