TECHNICAL MEMO

Weekeepeemee River Streamwalk Assessment Survey Woodbury and Bethlehem, CT

Field Assessments Completed July and August 2021
by Pomperaug River Watershed Coalition

Project Led and Memo Prepared by
Carol Haskins, PRWC Executive Director

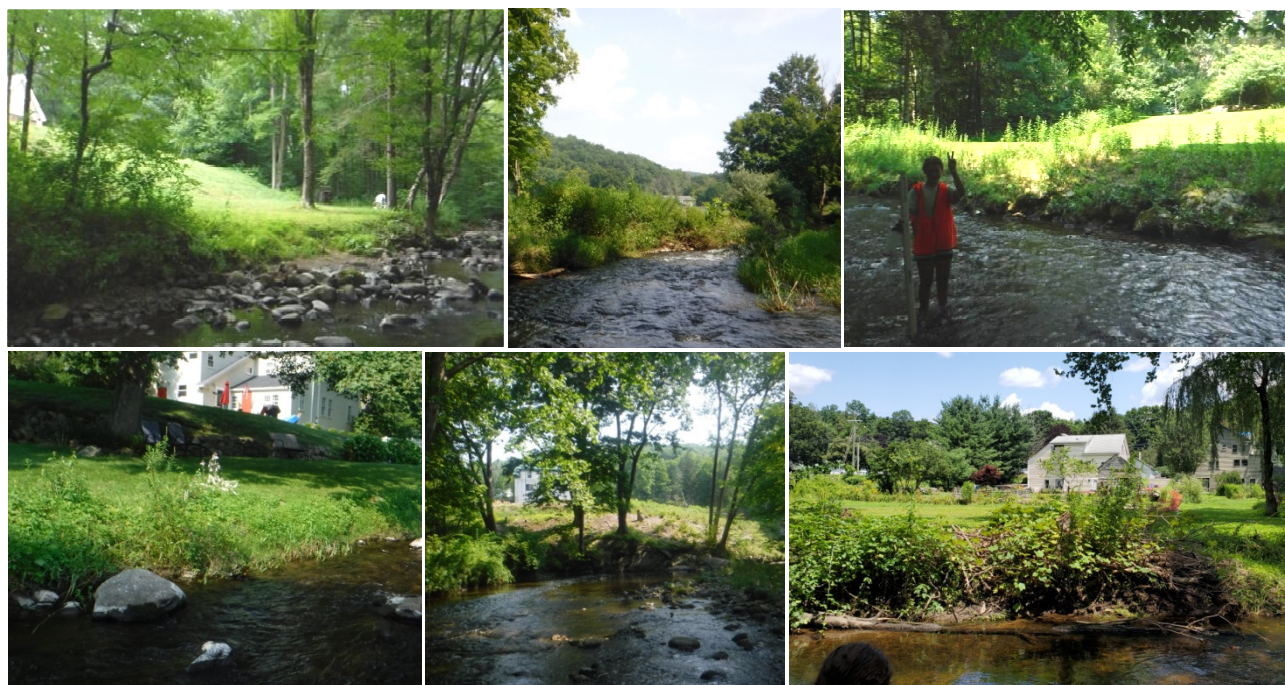
- **Lack of Stream Buffer** – Stream buffer encroachments were prevalent along the Weekepeemee River and are most often associated with residential and agricultural properties. Residential lawns and some agricultural practices extend down to the banks of the stream in many areas (**Figure 5**). The degree of stream buffer encroachment can have a significant impact on the overall stream and habitat conditions. In general, larger natural buffers are associated with better stream health, including channel substrate, flow regime, water quality, and shading as well as better upland and wetland habitat that provide larger areas available to native flora and fauna.

Figure 5. Examples of residential and agricultural sites where there are opportunities for riparian buffer restoration. A healthy riparian buffer should consist of vegetation that includes trees, shrubs, and perennial ground cover to provide stream shade, soil stability, stormwater infiltration, and habitat and food for a variety of organisms including dragonflies, frogs, turtles, birds, and mammals.

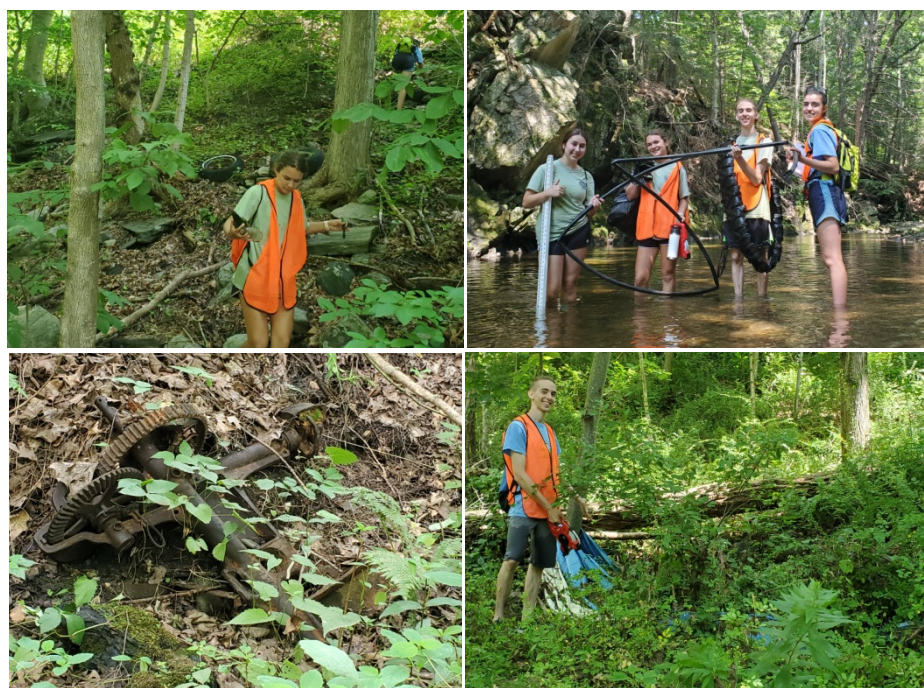
- **Trash and debris accumulation** – Evidence of littering and illegal dumping was observed in at least three locations along state and town roads. While this does not contribute to the bacteria impairment that makes for unsafe recreation, it does present other hazards like broken glass and rusty metal that make recreation undesirable (**Figure 6**). Trash and debris found at other sites consisted of items that appeared to be deposited by high streamflows in slower moving areas. Increased “No dumping” or “No littering” signs may be needed along certain road areas to help prevent further accumulation. These areas should also be included in municipal “adopt a road” programs where volunteers conduct regular litter clean-up efforts. More frequent in-stream trash clean-up efforts may also be warranted.

Figure 6. Examples of trash and debris observed in and along the Weekeepeemee River. Smaller items were collected during the survey and properly disposed of by the field team.

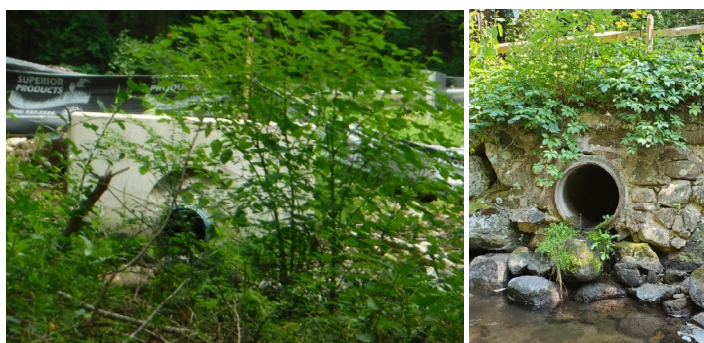
Figure 7. Examples of stormwater outfalls that discharge water in catch basins located on roadways and other impervious surfaces; their associated network of drainage pipes discharge stormwater away from the roadway and onto the ground or into a nearby river /stream.

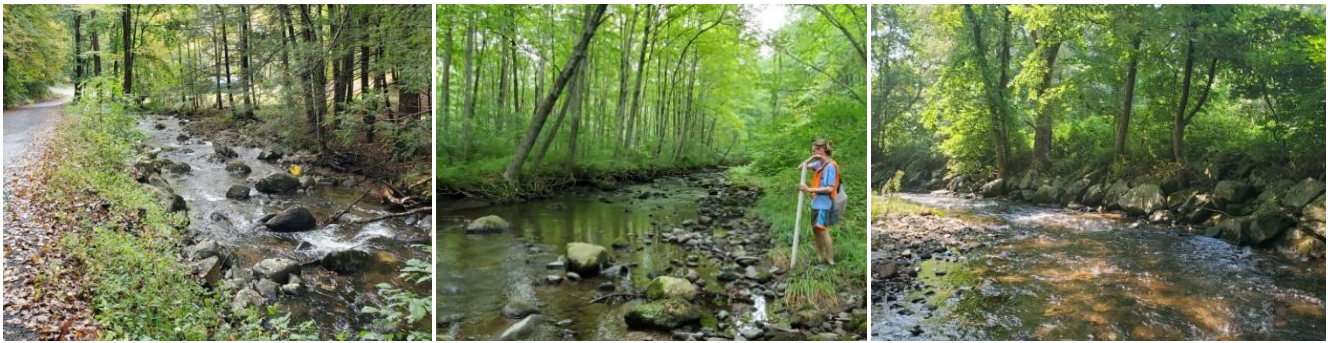
- **Channelization** – Historic realignment of stream channels was not uncommon throughout the Pomperaug Watershed (**Figure 9**). Many areas were straightened prior to the adoption of wetlands and watercourses regulations in order to develop transportation routes, commercial areas, neighborhoods, to make agricultural areas easier to cultivate, and to provide faster drainage of water downstream. Such channelization was observed in several areas along the length of the Weekepeemee River, many of which coincided with observations of streambank erosion. Restoring channelized section to more natural, meandering paths face many challenges including physical infrastructure and obtaining agreements among multiple property owners. While challenging and costly to restore some of these areas, there are opportunities that could support a healthier fishery and enhance recreational opportunities (example: Site Code R01-CM-01). These efforts are a low priority through the lens of addressing bacteria related impairments.

Figure 9. Examples of channel modification where portions of the Weekeepeemee River had been straightened at some point in its history; typically in areas adjacent to agricultural fields and transportation routes.

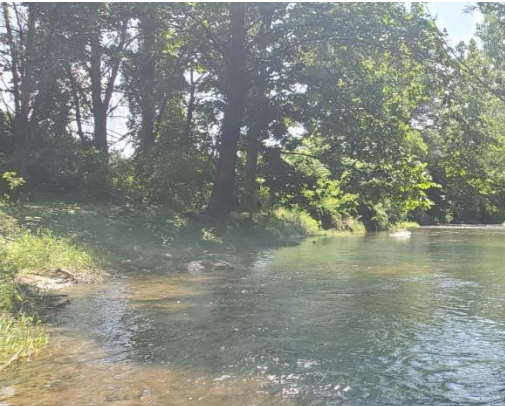
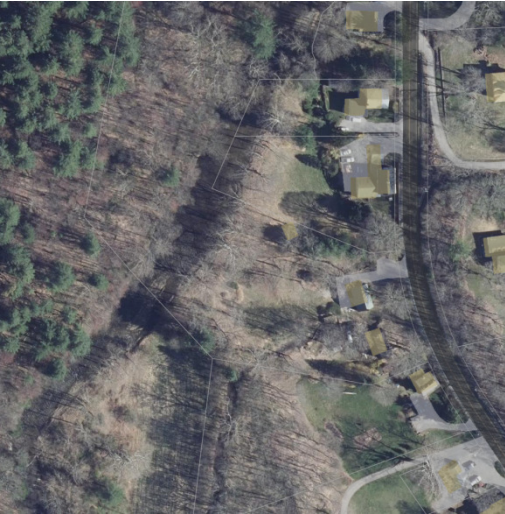
Site Code	Location Description	Observations	Potential Bacteria Sources	Potential BMPs	Other Recommendations and Notes	BMP Potential	BMP Priority	BMP Cost	Photos
R1-IB-01	Route 47 / Upstream Jacks Bridge Road	Impacted Buffer (IB-01) - Three houses on the left bank with lawns mowed to the edge of the river bank; some large shade trees (sycamores) interspersed; shrub layer or no mow zone recommended to cover approximately 100 feet x 15 feet along the river bank. Houses are set back from the river approximately 50 feet. Right bank is well vegetated.	None apparent	Plant shrub layer; shade tolerant perennials; and/or establish a no mow zone	Stream is partially shaded	Med	Low	Low	<div>

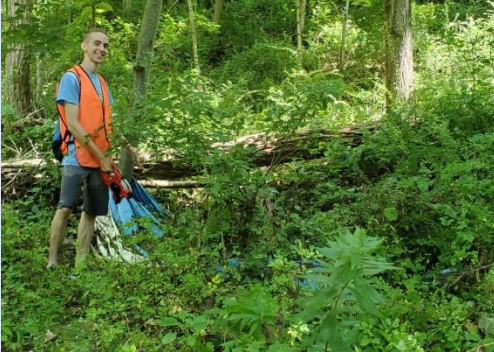
Site Code	Location Description	Observations	Potential Bacteria Sources	Potential BMPs	Other Recommendations and Notes	BMP Potential	BMP Priority	BMP Cost	Photos
R1-TR-01	Route 47 Right of Way near Easy St	Trash and Debris (TR-01) - Pool liner embedded in the sediment on the left bank within the right-of-way. Requires additional tools (shovels, scissors, blade, pry bar) and a canoe or kayak to float the trash to an easier removal point.	None apparent	Remove trash and debris		High	Low	Low

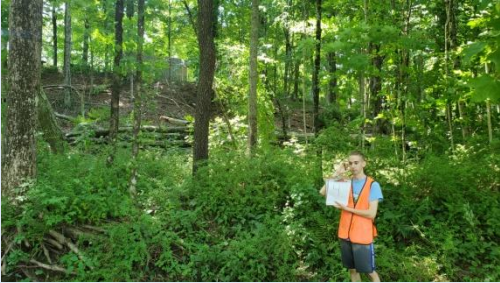
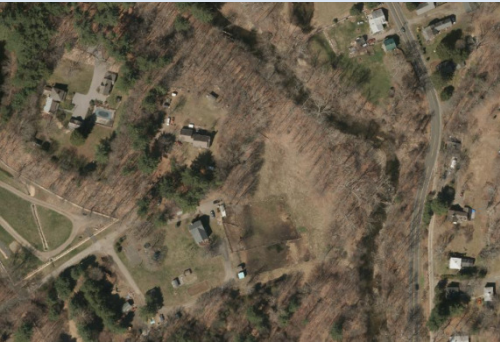
Site Code	Location Description	Observations	Potential Bacteria Sources	Potential BMPs	Other Recommendations and Notes	BMP Potential	BMP Priority	BMP Cost	Photos
R1-MI-01	Off Westwood Road	Miscellaneous (MI-01) – Half dozen goats are present at the top of a steep slope; within a fenced area approximately 100 feet from the right on the right bank. The steeply sloped bank between the goats and the hill could use some understory plantings (ferns, grasses, shrubs); established cover over young trees (less than 30 years old) provides stability and shading. The floodplain is terraced; the river bank is approximately 4.5 feet above the water's surface.	Goats and possibly other livestock. During leaf-off conditions in Fall 2021, cattle were observed on the Westwood Road side of the river when looking at Route 47 toward Westwood Road. Based on the aerial image, there may be other livestock in the area.	Understory planting on steep slope area for added filtration and bank stability.	There is a level, well-vegetated area that extends approximately 50 feet back from the river before rising steeply towards the goat area. Minor bank erosion was also noted where undercutting has exposed tree roots.	Low	Low	Med

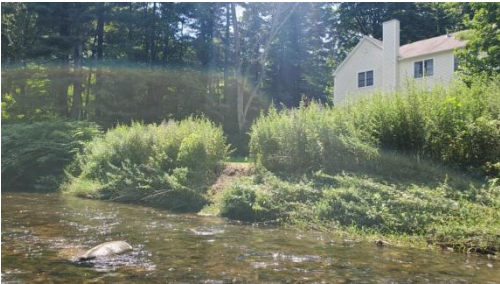
R1-IB-03	Ruffin Road	Impacted Buffer (IB-03) - Buffer area is less than 5 feet wide over a length of 150 feet that consists primarily of invasive species including Japanese knotweed and mugwort.	None observed; potential for septic or pet associated bacteria	Recommendation to remove invasive species and plant natives, establish a no mow zone along 150 feet of riverbank.	House is less than 50 feet from the river but it doesn't appear the lawn area is used, and could establish at least a 10 foot wide buffer.	Med	Med	Med

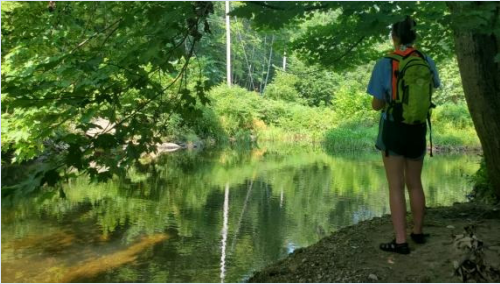
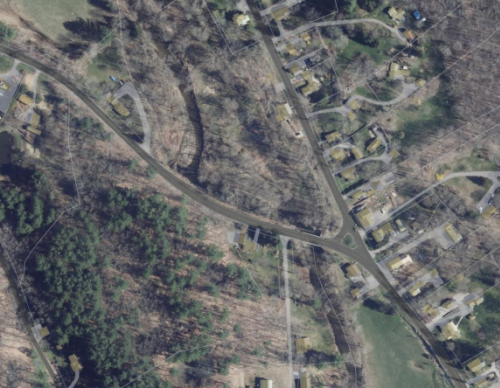
Site Code	Location Description	Observations	Potential Bacteria Sources	Potential BMPs	Other Recommendations and Notes	BMP Potential	BMP Priority	BMP Cost	Photos
R2-CM-01	Route 47 at Route 132	Channel Modification (CM-01) - River is straightened for approximately 1000 feet on the right bank where it flows along the edge of Route 47 upstream of the bridge. The area between the river and the road is only about 10 to 15 feet wide and is heavily armored. There is a large scour at the upstream end of the channelized area where the river is forced to make a sharp turn as it flows towards the armored bank. The river is also forced to make a sharp turn to flow under the bridge.	Wildlife	Update / replace / realign Hotchkissville Bridge at Route 47 so that it spans beyond the banks and is better aligned to the river channel. Root wads, woody debris, strategically placed boulders for in-stream habitat diversity, dissipating energy in the river channel, and better connecting the river to its floodplain.	Note restoration challenge presented by Route 47 as well as the power lines located along the river-side of the road. There is room on the left bank for the river to spill into the floodplain. In heavy storms, the river will also spill over Route 47.	Low	Med	High	<div>

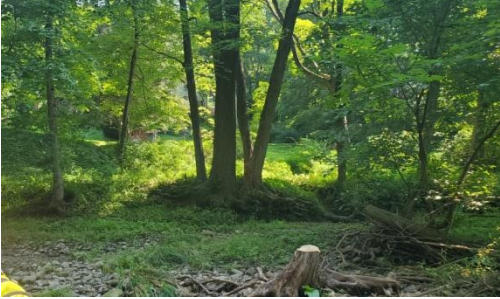
Site Code	Location Description	Observations	Potential Bacteria Sources	Potential BMPs	Other Recommendations and Notes	BMP Potential	BMP Priority	BMP Cost	Photos
R2-MI-01	Route 132	Miscellaneous (MI-01) - Chickens in a fenced area well set back from the river. Recently-cut tree on the river bank with only the stump remaining.	Chickens	Enhance understory vegetation	Distribute education materials on clearing vegetation in and along wetlands and watercourses (and the inverse re: planting riparian buffers)	Low	Low	Low

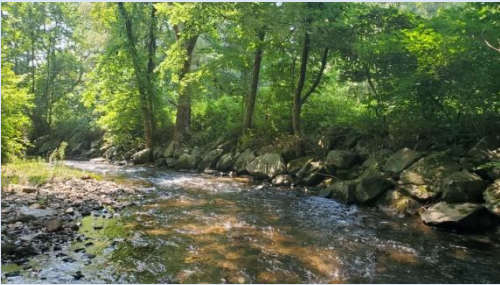
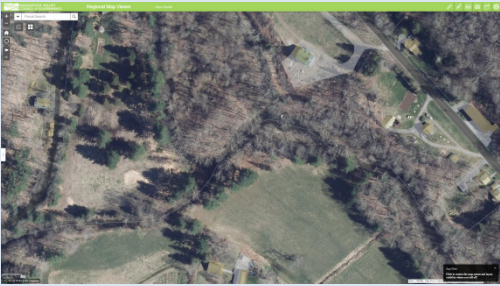
R2-CM-02	Confluence at Sprain Brook	Channel Modification (CM-02) - Right bank is armored with boulders for a length of about 150 feet where Sprain Brook flows into the Weekeepeemee; armoring continues along the right bank of the Weekeepeemee another 200 feet upstream of the confluence. Armoring is not extensive and there is plenty of room for restoration on both sides of the river (100 to 200 feet back from the river); the area along the river is mostly meadow. Bank height is approximately 5 feet.	Wildlife	Remove or breach armoring to help reconnect the river to the floodplain; beyond the vegetated buffer area are open fields with a few buildings set more than 100 feet from the river.	Verify if houses fall within the FEMA flood risk zones.	Low	Low	High

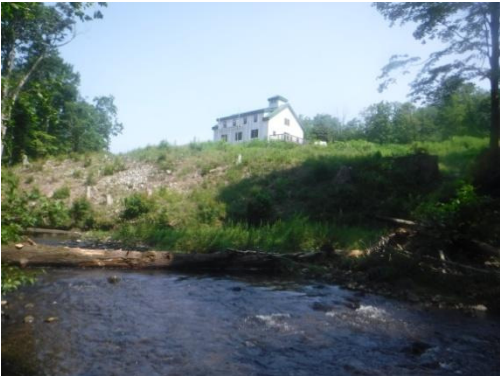
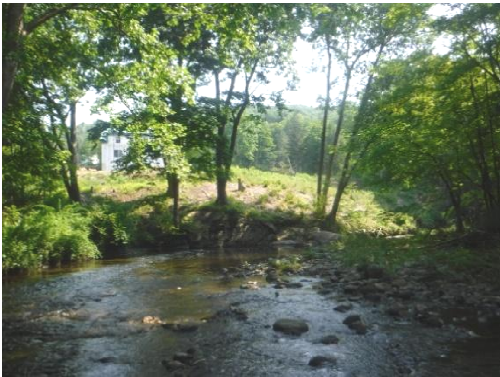
Site Code	Location Description	Observations	Potential Bacteria Sources	Potential BMPs	Other Recommendations and Notes	BMP Potential	BMP Priority	BMP Cost	Photos
R2-IB-01	Route 132 Vineyard	Impacted Buffer (IB-01) - Vegetation on the Left bank has been cleared, active earth excavation higher up on the slope. No silt fencing or erosion controls around the excavation zone. Area spanning 200 to 300 feet long and 100 to 150 feet wide has been cleared for agricultural purposes (vineyard). Stumps have been left in place; sparsely covered with some sapling and shrub volunteers. Cleared vegetation was mulched in place and covers the bank. Recommendation to establish at least 25 feet of buffer at the toe of the steep slope to filter runoff and stabilize the bank.	None apparent	Vegetate the toe of the slope at least 25 feet up the bank to provide stability and shading. Coir logs, hay bays, and/or silt fence would be appropriate erosion control measures to employ while the area is being cleared / excavated.		Med	Med/High	Med/High

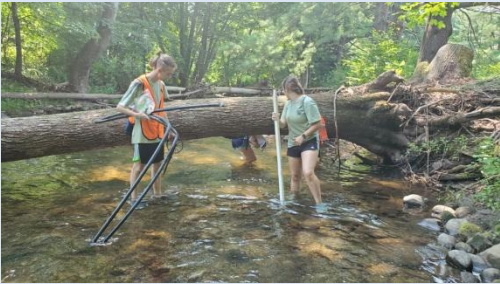
R2-TR-01	Papermill Road	Trash and Debris (TR-01) - Private property with a small amount of trash in a localized area; most of it was picked up during the streamwalk survey. Mostly plastic, metal, and styrofoam carried to this point by flooding.	None apparent	Periodic trash clean up, particularly after flooding events; flood deposition area		Low	Low	Low

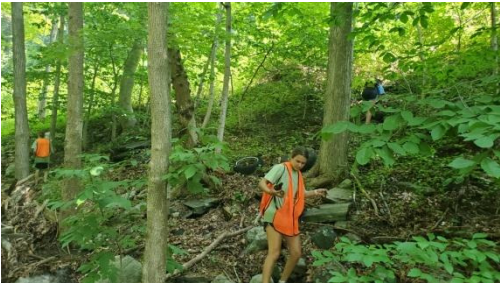
Site Code	Location Description	Observations	Potential Bacteria Sources	Potential BMPs	Other Recommendations and Notes	BMP Potential	BMP Priority	BMP Cost	Photos
R2-TR-02	Route 132 Right of Way near Hogpen Hill	Trash and Debris (TR-02) - On the left bank, there is lots of small trash items near the roadside / in the right of way; generally litter from passing vehicles (i.e. cans and bottles); most of it was picked up during the streamwalk survey, but tires remain between the road and the river. Will need a pick-up truck to remove; a pry bar or shovel might be helpful.	None apparent	Periodic trash clean up	Install “No Littering” or “No Illegal Dumping” signs along roadway.	Low	Low	Low

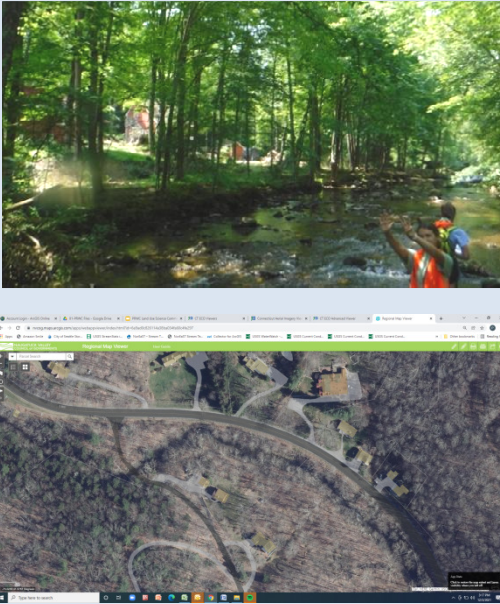
R2-IB-02	Papermill Road	Impacted Buffer (IB-02) - Understory clearing in the floodplain approximately 250 feet along the right bank of the river; house is set back from river approximately 150 feet. Yard area is flat and lacking a shrub layer but has scattered trees bordering the river.	None apparent	Enhance riparian buffers. May be an opportunity for rain garden installation or other downspout disconnection.	Recommendation to restore up to 30 feet with native shrubs or perennials to create an understory.	Med	Low	Low/ Med

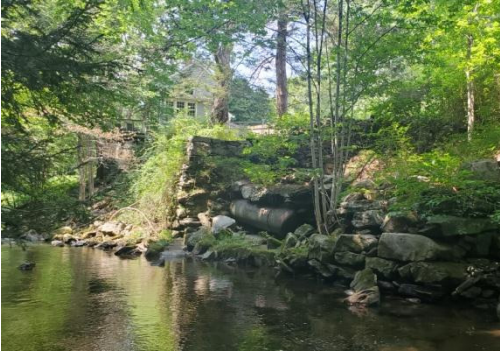
Site Code	Location Description	Observations	Potential Bacteria Sources	Potential BMPs	Other Recommendations and Notes	BMP Potential	BMP Priority	BMP Cost	Photos
R3-MI-01	Route 132	Miscellaneous (MI-01) - Exposed iron tank/pipe at the base of an old foundation on the left bank. Very rusty pipe/tank is approximately 2.5 foot diameter by 10 feet long and extends out of the stonewall / foundation; appears to be long since emptied and out of service.	None apparent	N/A	Inquire with the property owner about the nature of the stonewall / foundation feature around the tank.	Low	Low	Low

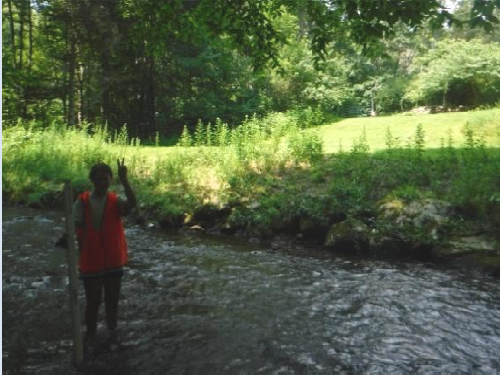
R3-IB-01	Route 132	Impacted Buffer (IB-01) - Historic house elevated from the river on the left bank; yard area north of the house is dominated by turf/grass; no trees or shrubs; some invasive species present; some bank armoring with steps down to the river.	None apparent	Recommend removing invasive species and planting natives to create a 10 foot wide buffer over a 75 foot length or establish a no mow zone for natural re-vegetation.		Med	Med	Low

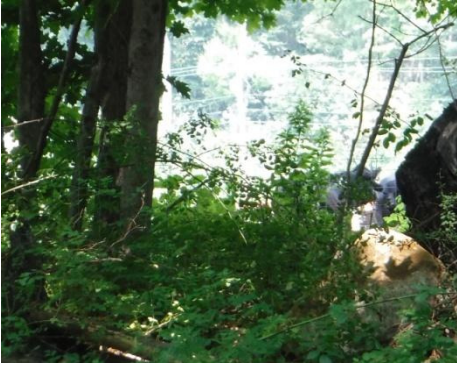
R3-MI-02	Route 132, Quickwater Farm	Miscellaneous (MI-02) - Cows (fewer than a dozen), chickens, and goats in pasture 25 feet away from the river on the left bank; livestock fencing in good repair and property is fairly level so low manure runoff potential; pastures do not appear to be overgrazed and appear to be using rotational pasturing practices.	Cows and other livestock	See notes for Site R3-IB-02

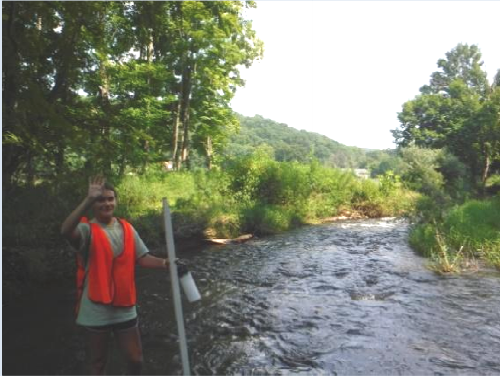
Site Code	Location Description	Observations	Potential Bacteria Sources	Potential BMPs	Other Recommendations and Notes	BMP Potential	BMP Priority	BMP Cost	Photos
R3-IB-02	Route 132, Quickwater Farm	Impacted Buffer (IB-02) - Left bank. Open pasture land where livestock fencing is in good shape and a good distance from the river; pasture land is level in the floodplain; area between the fence and the river is mowed and the tree / shrub / herbaceous layer is somewhat sparse.	Cows and other livestock	Area between the fence and the river is mowed and the tree / shrub / herbaceous layer is somewhat sparse. Enhance the buffer with more deep rooted plants to reinforce the bank and provide shade in an area 100 feet long by 5 to 10 feet wide.		Med	Med	Med

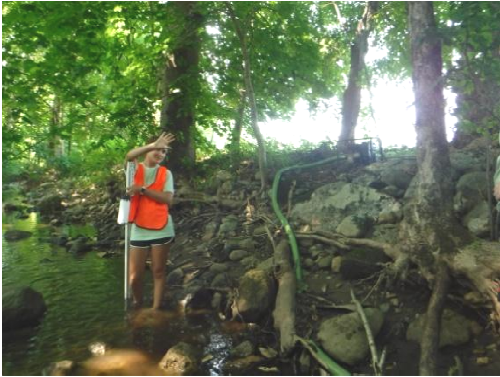
R3-MI-03	Route 132, The Farm	Miscellaneous (MI-03) - Two irrigation pumps located on the left bank with unsecured gas canisters sitting adjacent to them. Also a small amount of trash in the area.	None apparent	Recommend securing the gas canisters and/or having some kind of spill kit / spill containment associated with the irrigation pumps.		High	Med	Low

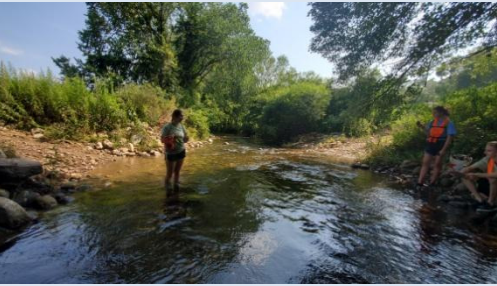
Site Code	Location Description	Observations	Potential Bacteria Sources	Potential BMPs	Other Recommendations and Notes	BMP Potential	BMP Priority	BMP Cost	Photos
R3-MI-04	Route 132, The Farm	Miscellaneous (MI-04) - Ford-style tractor crossing between crop fields on opposite sides of the river. Water downstream of the crossing was noticeably turbid.	None apparent	May be an opportunity to formalize the crossing as a ford wherein the riverbed is stabilized to prevent bed erosion or to establish a bridge crossing.	“Hog panel” or “GeoWeb” style crossing materials may be appropriate for this site. See NRCS bulletin: https://www.nrcs.usda.gov/Internet/FSE_DOCUMENTS/stelprdb1167481.pdf	Med	Med	Med /High

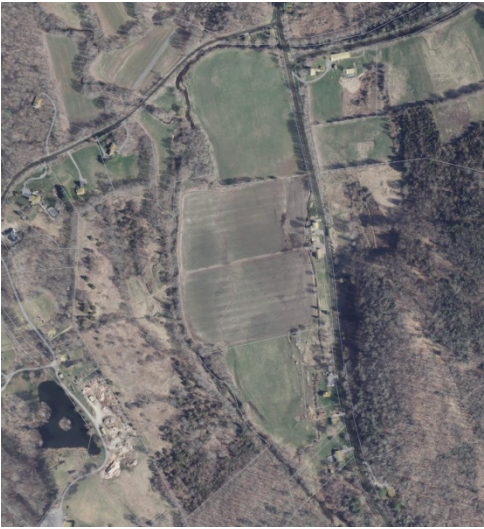
R3-IB-03	Route 132, The Farm	Impacted Buffer (IB-03) - On the left bank, farm/crop field has a narrow row of established trees along the river with minimal understory.	None apparent; possibly manure if spread as fertilizer on the crop fields.	Could use an additional row of shrubs, trees, and/or perennials between the river and the crop field. Area available for planting spans approximately 300 feet by 10 feet. Opposite bank also has room for similar planting or letting it naturally regenerate.	Aim to balance crop production area with river protections.	Med	High	High

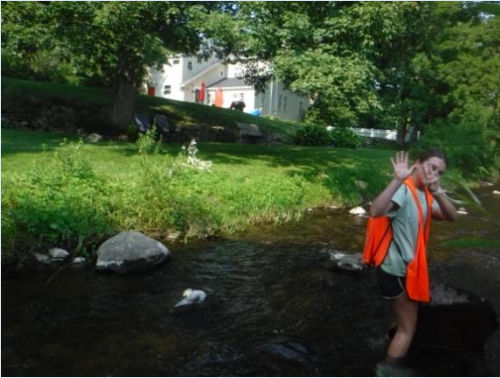
R3-IB-04	Peter Road	Impacted Buffer (IB-04) - House located very close to the river with minimal yard area which is dominated by lawn that is mowed and weed-whacked right up to the river's edge including vegetation growing between rocks that make up the streambank. No tree, shrub, or herbaceous layer; river has direct sun exposure.	None apparent	Recommend establishing at least 5 feet of a no-mow zone and/or strategically planting native perennials and shrubs along up to 100 feet of river bank. Small area could be kept clear (mowed) for view and or river access if desired.		Medium	Medium	Medium

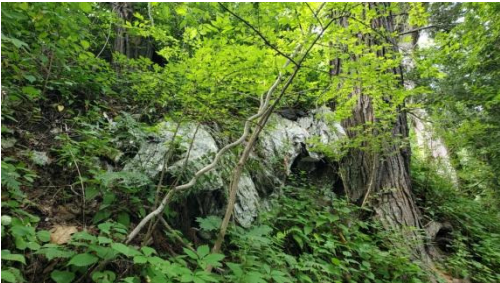
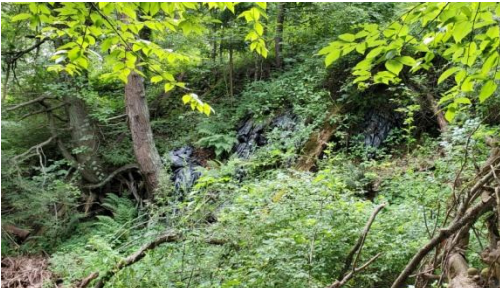
Site Code	Location Description	Observations	Potential Bacteria Sources	Potential BMPs	Other Recommendations and Notes	BMP Potential	BMP Priority	BMP Cost	Photos
R4-TR-01	Brushy Hill Road	Trash and Debris (TR-01) - Area along the left bank littered with a wide variety of trash and debris which appears to include items deposited by the river as well as roadside dumping. Items present included layers of plastic sheeting, plywood, chicken wire, and scrap metal. Layers of plastic sheeting are embedded in the riverbank about halfway up to the road. Smaller items including bottles, cans, bicycle, table, sink, plastic, glass, and metal items were collected.	None apparent	Remove trash and debris. Establish an “Adopt-a-Spot” as the site appears to be a chronic deposition area for flood swept debris. Install “No Dumping” signs on Brushy Hill Road to discourage illegal trash dumping.	Area requires further attention for clean-up; tools like shovels, pry bars, and sharp blades will be needed to remove the plastic sheeting so it can be bagged and walked up the bank or floated by boat down the river to an exit point. Note: some trash/debris could be associated with the farm across the road and/or farm operations upstream (greenhouse and/or weed barrier plastics). Use caution removing materials embedded in the streambank; disruption may cause erosion. Unclear if this is private property or a town right of way.	Medium	Medium	Medium

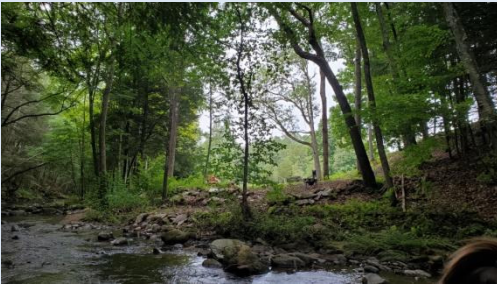
Site Code	Location Description	Observations	Potential Bacteria Sources	Potential BMPs	Other Recommendations and Notes	BMP Potential	BMP Priority	BMP Cost	Photos
R4-IB-01	Brushy Hill Road	Impacted Buffer (IB-01) - Private residence where there are a number of brush piles located in the floodplain which appear to be associated with active clearing along the right bank. A good number of large trees are present which provide 75% shading over the stream. Construction equipment is present.	Wildlife	Recommendation adding more understory vegetation along 200 feet of the bank to enhance the riparian buffer. Area approximately 25 feet wide is available for planting.	Stonewall and terracing down to the river. Stones somewhat piled in the river to enhance / deepen an existing pool. Disassemble this “dam” and redistribute rocks throughout the immediate area.	Medium	Low	Medium

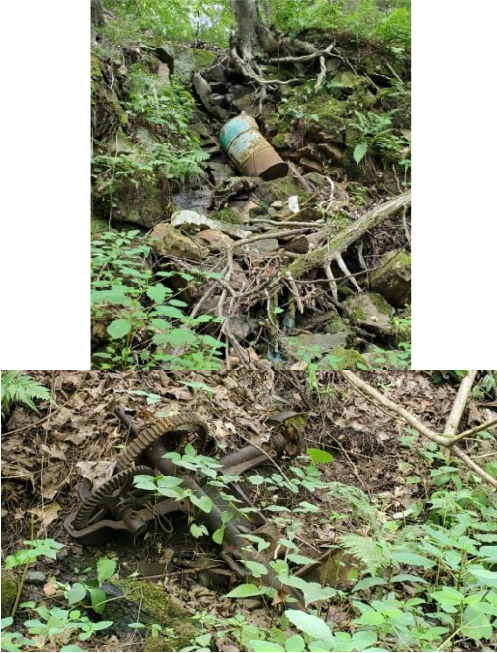
R4-TR-02	Brushy Hill Road	Trash and Debris (TR-02) - Items either associated with old farm operations or items that were illegally dumped including a 30 gallon barrel labeled "Agitene" which is a combustible solvent and a 1 gallon metal gas can and other metal items like tools; also cans, bottles, cups, styrofoam.	n/a	Area could be revisited along with TR-01 for additional clean-up by volunteers. Note - steep bank from road-side down to the river; best to float trash downstream to the bridge for removal. Establish an “Adopt-a-Spot” as the site appears to be a chronic deposition area for flood swept debris. Install “No Dumping” signs on Brushy Hill Road to curb illegal trash dumping.	Barrel reported to CT DEEP Spill Response Team and Town of Woodbury and removed at time of the Streamwalk Survey in August 2021.	High	High	Low

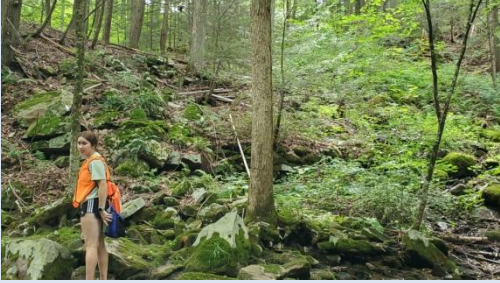
Site Code	Location Description	Observations	Potential Bacteria Sources	Potential BMPs	Other Recommendations and Notes	BMP Potential	BMP Priority	BMP Cost	Photos
R4-MI-01	Brushy Hill Road	Miscellaneous (MI-01) - Assorted metal and PVC pipes on the left streambank. Pipes range in size from 1 to 2 inch diameter; purpose is unknown. Might just be stockpiled material though some sticking out of the bank.	n/a	Secure pipes so they are not swept away in a flood.		Low	Low	Low

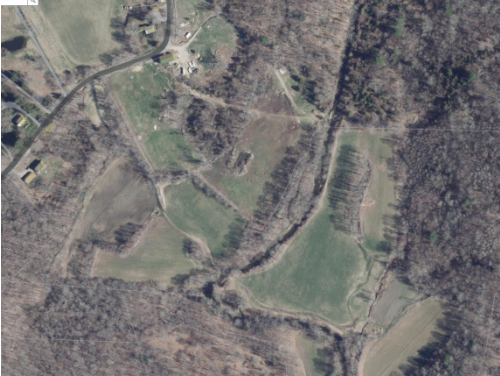
R4-MI-02	Weekeepeemee River Farm	Miscellaneous (MI-02) - Irrigation pump / water withdrawal on the right bank. Pipe connected to the pump has a 3" diameter; the pump is also connected to a filtration system and holding tanks. Irrigation pumps are located at the top of a steep, sandy bank on an outside bend in the river which may not be overly stable (nearly a 1:1 slope).	Livestock - goats, chickens, sheep, cattle	Move irrigation pumps and holding tanks further up the bank and extend the pipe length. Potential for a bank stabilization project / riparian planting along the sandy bank at an outside bend in the river which may not be overly stable (nearly a 1:1 slope). Unclear if livestock have access to the river. If so, livestock fencing and an alternate water source may be appropriate BMPs.	Aerial image shows evidence of a couple ford-style stream crossings; consider stream crossing structures to stabilize river bed / prevent erosion. May be an opportunity to formalize the crossing as a ford wherein the riverbed is stabilized to prevent bed erosion or to establish a bridge crossing. "Hog panel" or "GeoWeb" style crossing materials may be appropriate for this site. See NRCS bulletin: https://www.nrcs.usda.gov/Internet/FSE_DOCUMENTS/stelprdb1167481.pdf	Med	High	High

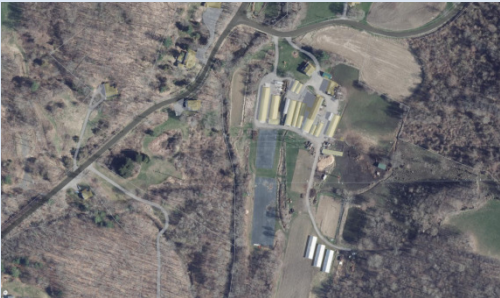
Site Code	Location Description	Observations	Potential Bacteria Sources	Potential BMPs	Other Recommendations and Notes	BMP Potential	BMP Priority	BMP Cost	Photos
R4-IB-02	Chohees Trail, The Farm	Impacted Buffer (IB-02) - Area under the power transmission lines has been cleared leaving the stream 95% unshaded for a length of 300 to 350 feet. There is ample understory vegetation providing stability, but the area is dominated by multiflora rose, Russian olive, mugwort, and other invasives.	None apparent	Recommend establishing shrub height vegetation so not to compete with maintenance of the power lines and in effort to provide some shading. More room on the right bank for natural revegetation or planting - 50 feet available. About 10 feet is available on the left bank where there is active crop production and where greenhouses are present.	Livestock presence was noted in the Pomperaug Watershed Based Plan (2018); they are no longer a component of the operations at this site. Adding vegetation under the power lines might not be feasible based on line maintenance practices and access needs of the power copy. Water conservation practices and other BMPs including drip irrigation; infiltration of stormwater runoff; rainfall capture (i.e. cistern); limited application of fertilizers and pesticides may be appropriate. Farm is already known to be using Integrated Pest Management strategies.	Low/ Med	Med	High

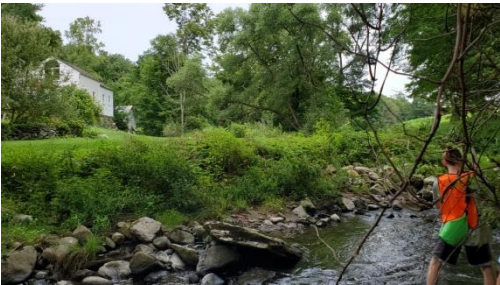
Site Code	Location Description	Observations	Potential Bacteria Sources	Potential BMPs	Other Recommendations and Notes	BMP Potential	BMP Priority	BMP Cost	Photos
R5-IB-01	Weekeepeemee Road	Impacted Buffer (IB-01) - Right bank upstream of the bridge is dominated by open, residential lawn area along 100 to 150 feet of the streambank. Lawn is mowed to the top of the rocky bank/gravel bar which is not touched. Stream is minimally shaded on the right bank.	None apparent; Septic / Pets	Recommend establishing a no mow zone at least 2 feet wide and/or plant a few trees or shrubs (only about 12 feet of space is available for planting).		Med	Med	Low

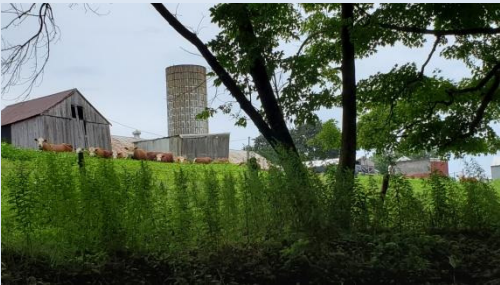
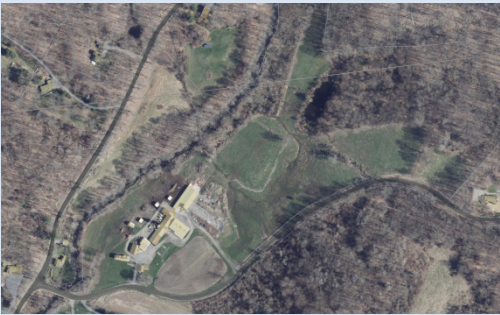
R5-IB-02	Chohees Trail Farm	Impacted Buffer (IB-02) - Length of 1000 feet on the left bank provides little canopy cover over the river. Area runs along the edge of pasture that shows some signs of overgrazing. Approximately 20 beef cattle are present in the pasture. Livestock fencing is placed approximately 8 feet from the river with pasture sloping down towards the river.	Beef Cattle	Recommend moving the livestock fencing further back from the river and/or repairing existing fencing; move up the bank to a 15 foot setback from the water and naturally revegetate or enhance with strategically planted trees or shrubs to replace invasive plants.	See conceptual design presented in Pomperaug Watershed Based Plan (2018). Based on walking the length of the Weekeepeemee River; this site has the highest potential for contributing bacteria pollution. Thus, it remains high on the priority list for installation of BMPs.	Med	High	Med

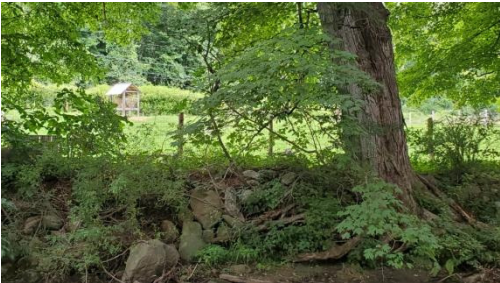
Site Code	Location Description	Observations	Potential Bacteria Sources	Potential BMPs	Other Recommendations and Notes	BMP Potential	BMP Priority	BMP Cost	Photos
R5-MI-01	Weekeepemee Road	Miscellaneous (MI-01) – Hobby farm with livestock in the floodplain. Half a dozen goats and two dozen chickens pastured 10 feet from the river; pasture extends approximately 150 along the right bank. There is an ample shrub layer and some tree cover providing bank stability. Livestock fencing present.	Goats; chickens; dog	Recommend moving the chickens back a bit and maintaining the existing buffer, potentially enhance the buffer with shrubs or perennials. Challenge will be to keep the goats from browsing through / beyond the fence line.	Small area available for pasturing the goats and chickens; suggest not expanding the herd size or flock size in order to balance protection of the river.	Med	Med	Low

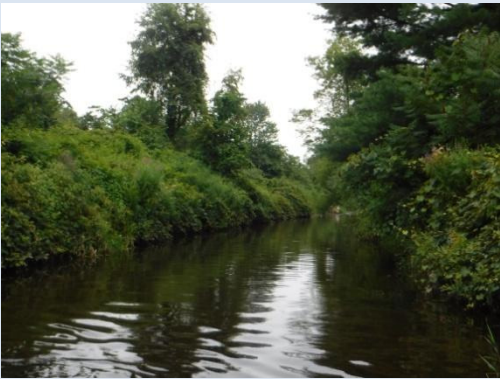
R5-IB-03	Downstream Crane Hollow Road	Impacted Buffer (IB-03) - Section along the left bank where old gravel ponds remain from former earth excavation operation is stabilized by an ample shrub layer with abundance of invasives including Russian Olive, Phragmites, and Japanese Knotweed. Stream is not well shaded due to lack of tree canopy along a 600 feet length.		Recommend adding trees to provide shade and try to remove invasive species.	The invasive plants provide an ample buffer for filtering runoff, preventing erosion, and absorbing flood waters but could provide better habitat and food for wildlife along with shade for the river if enhanced with native species including trees.	Low	Low	High

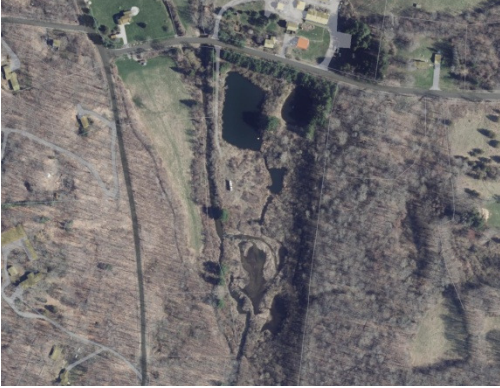
Site Code	Location Description	Observations	Potential Bacteria Sources	Potential BMPs	Other Recommendations and Notes	BMP Potential	BMP Priority	BMP Cost	Photos
R5-CM-01	Downstream Crane Hollow Road	Channel Modification (CM-01) - Approximately 500 feet length of the channel was historically straightened. Channel width is approximately 25 feet and the bank height is about 10 feet; the river is not connected to the floodplain and there isn't evidence of sediment deposition. There was a notable amount of algae covering the rocks and water weed (native <i>Elodea</i> sp.) growing in the river.	None apparent	Recommend strategically placing woody debris and or boulders to create channel diversity. May be a future opportunity to abandon earth excavation activities and re-introduce meanders within the river channel.	There is a decent buffer on both banks (though some areas open to sun – see R5-IB-03) and room for the river to spill into the floodplain without impacting infrastructure.	Low	Med	High

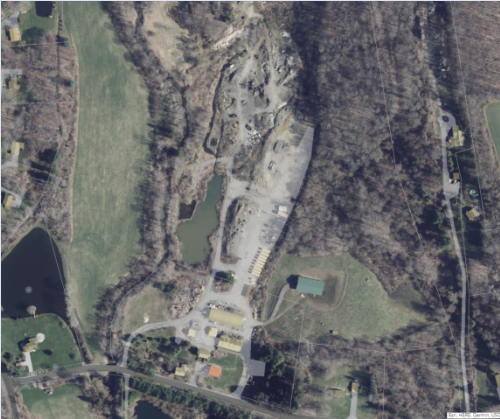
R6-OT-01	Upstream Crane Hollow Road	Stormwater Outfall (OT-01) - Natural, open stream channel on the left bank that is between 24 and 36 inches wide and is 4 inches deep with moderate flow. Unclear is if this is a tributary or a stormwater outfall; intense land use on the east side of the river suggests it is an outfall and there is no tributary shown on the map. Water is clear, not turbid, no benthic growth, no odor, no staining, and no floatables.	None apparent	Confirm source of flow; aerial image suggests it may be the outfall from a sediment or detention pond associated with earth excavation activities. These activities cannot be seen from the river channel; riparian buffers are adequate through this area.	Site with known waste water discharge permit issued by CT DEEP.	Low	Low	Low

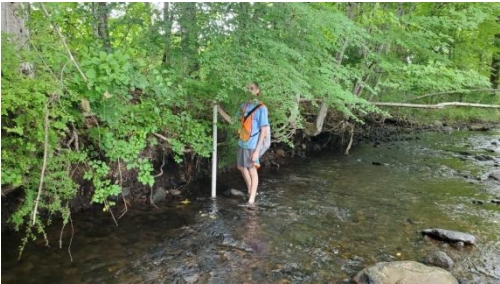
Site Code	Location Description	Observations	Potential Bacteria Sources	Potential BMPs	Other Recommendations and Notes	BMP Potential	BMP Priority	BMP Cost	Photos
R6-ER-01	Upstream Crane Hollow Road	Bank Erosion (ER-01) - Exposed roots along an area where down-cutting is occurring on the right bank; approximately 100 feet long with a bank height of 5 feet. Stream bottom/wetted width is about 15 feet wide; top width is approximately 35 feet wide.	None apparent	Could add features like root wads to help reconnect the river to the floodplain, but challenging in regards to access. More areas would be disrupted to achieve installation of BMPs.	There is no infrastructure at risk and there is 50 to 75 feet of well vegetated riparian land abutting. Stream channel is also noticeably straight.	Low	Low	High

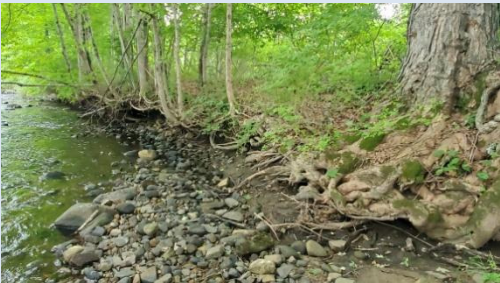
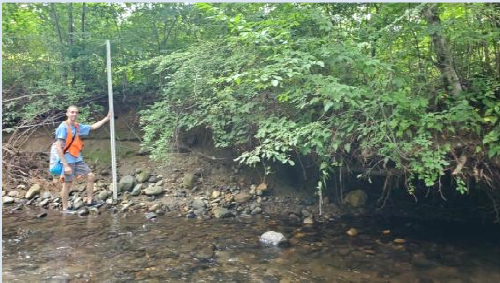
R6-ER-02	Upstream Crane Hollow Road	Bank Erosion (ER-02) - Long stretch (1000 feet) of bank erosion that alternates between the right and left bank. Bank height on the left is 6.5 feet and 4 feet on the right bank. There is very little plant growth along the bank; there are exposed roots with some overhang. There is scouring on the outside of the curve on the left bank and sand deposition along the right bank.	None apparent	Could add features like root wads and strategically placed boulders to help reconnect the river to the floodplain, but challenging in regards to access. More areas would be disrupted to achieve installation of BMPs.	No infrastructure is at risk with 50 to 75 feet of open riparian land abutting. Might be a candidate for bank stabilization through access would be difficult and would require vegetation clearing to get to. There is room to let the river naturally find equilibrium. Active processes appear to be down-cutting, widening, bank scour, and sediment deposition.	Low	Low	High

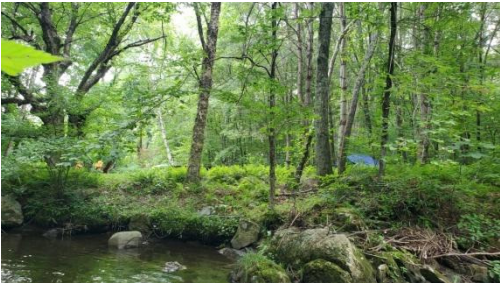
Site Code	Location Description	Observations	Potential Bacteria Sources	Potential BMPs	Other Recommendations and Notes	BMP Potential	BMP Priority	BMP Cost	Photos
R6-IB-01	Arrowhead Lane	Impaired Buffer (IB-01) - Area less than 100 feet long on the right bank that has been partially cleared to create a campsite near the river. House is more than 100 feet back from the river with a well vegetated area between the house and campsite. Campsite features a mowed spot for tenting, a fit pit, and seating. Established trees within the mowed area provide shade for the river.	None apparent	A few shrubs or perennials could be added along the water's edge for bank stability.	Low priority for restoration as the buffer impairment is VERY MINOR as there is no impervious cover in the area immediately adjacent to the river.	Low	Low	Low

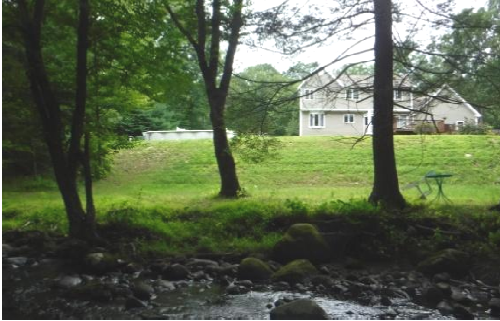
Site Code	Location Description	Observations	Potential Bacteria Sources	Potential BMPs	Other Recommendations and Notes	BMP Potential	BMP Priority	BMP Cost	Photos
R6-IB-02	Arrowhead Lane	Impacted Buffer (IB-02) - Approximately 125 feet of open lawn up to the water's edge on the right bank. No trees or shrubs and no shade cover. There is an above ground pool situated about 100 feet upslope of the stream, while the house is about 150 feet from the stream.	None apparent	Recommend planting native trees, shrubs, perennials to create at least a 15 foot wide riparian buffer along the 125 feet of streambank.		Med	Med	Med

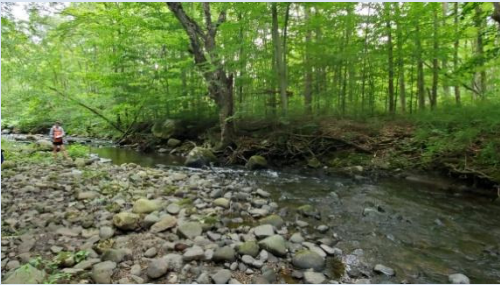
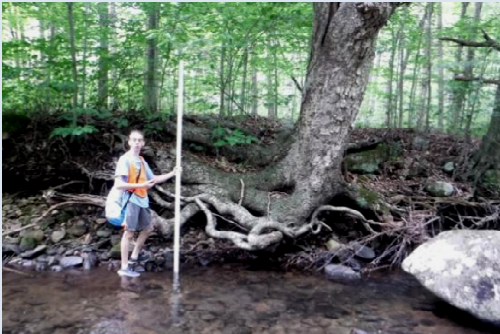
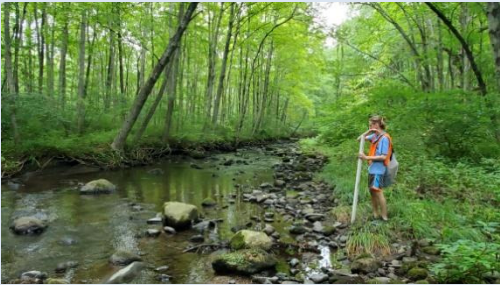
Site Code	Location Description	Observations	Potential Bacteria Sources	Potential BMPs	Other Recommendations and Notes	BMP Potential	BMP Priority	BMP Cost	Photos
R6-ER-03	Arrowhead Lane	Bank Erosion (ER-03) - Stretch of exposed tree roots on the right bank. Bank height ranges from 4 to 7 feet high. Down-cutting and bank scour is occurring on the inside of a meander on the right bank with deposition on the left bank. There is a gravel bar approximately 15 feet wide on the left bank. Some wetlands present in the adjoining riparian area; riparian area is dominated by forest cover; no infrastructure is at risk.	Wildlife	None	Low priority for restoration; let banks naturally find equilibrium given privately owned forest lands.	Low	Low	Low

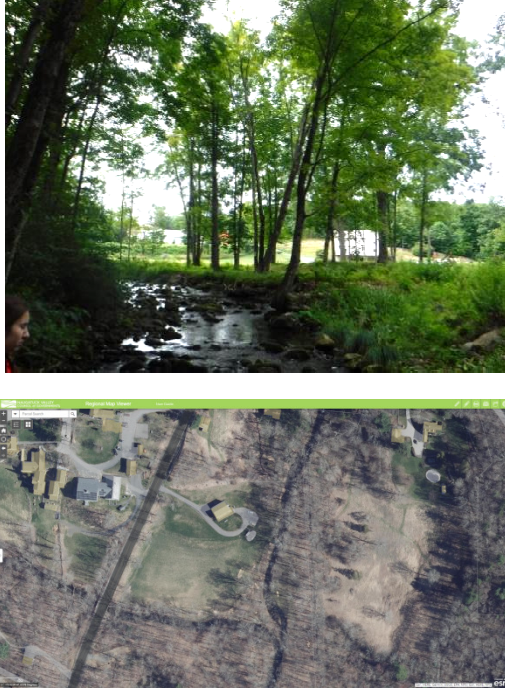
Site Code	Location Description	Observations	Potential Bacteria Sources	Potential BMPs	Other Recommendations and Notes	BMP Potential	BMP Priority	BMP Cost	Photos
R6-IB-03	Upstream Arrowhead Lane; Flanders Road interior	Impacted Buffer (IB-03) - Both right and left bank upstream of the confluence of Wood Creek is open lawn area with minimal trees and shrubs along 300 feet of each river (Left bank of Wood Creek; Right bank of Weekeepeemee - property upstream of confluence). Some bank erosion is evident; the stream is not shaded.	None apparent	Good potential for riparian buffer planting as house/driveway/pool are set away from the river; at least 25 feet available for planting. Could also add some plants along the left bank of the Weekeepeemee.	Consider bacteria sampling site on Wood Creek to consider inputs from land use activities in this sub-watershed	Med	Med	Low/Med

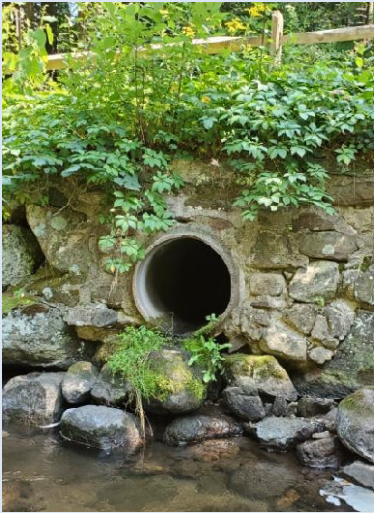
R7-OT-01	Mill Pond Road	Stormwater Outfall (OT-01) - 18 inch concrete, circular pipe flush with concrete retaining wall on the left bank just upstream of the covered bridge; outfall is 3 to 4 feet above stream grade. There is some benthic growth in the pipe that is brown and green in color, but there is no flow, no odor. Staining and algae growth is along the flow line. Note the road is within 10 feet from the river and the catch basin is visible.	None apparent.	Regular inspection and clean-out of the catch basin.	Proactively conduct outfall sampling to mirror MS4 permit requirements, which are not yet applicable in Bethlehem.	Med	Low	Low

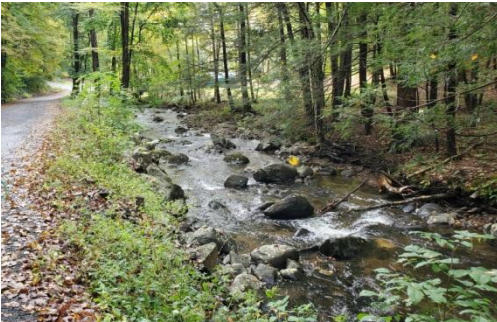
Site Code	Location Description	Observations	Potential Bacteria Sources	Potential BMPs	Other Recommendations and Notes	BMP Potential	BMP Priority	BMP Cost	Photos
R7-IB-01	Mill Pond Road	Impacted Buffer (IB-01) - Approximately 300 foot stretch along Mill Pond Road, downstream of Route 132 appears to have been straightened; both banks are armored with cobble to boulder sized riprap. The bank between the road and the river is slightly steeper than a 1:1 slope and the width to the road is only about 10 feet (this is on the left bank of the river). Sparse vegetation grows between the rocks and is dominated by poison ivy and jewelweed. The right bank is a little lower and opens into a narrow floodplain. There is some minor undercutting along the right bank.	None apparent		There is room for some plantings on the right bank, but not possible on the left given the intensive riprap. Stream is more than 50% shaded. Stability of the banks and potential for road washing out is the greater concern here.	Low	Med	High

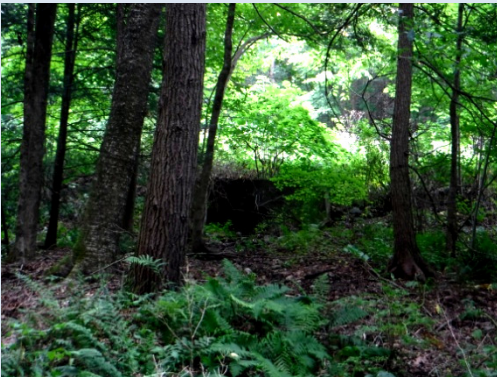
R7-OT-02	Upstream Route 132	Stormwater Outfall (OT-02) - 24 inch circular, singular, concrete outfall with concrete headwall/retaining wall located in the road right of way along Route 132; left bank of the river but discharges more than 20 feet from the river. No flow; no odor; no staining; minimal algae growth; no dry weather discharge.	None apparent	Regular inspection and clean-out of the catch basin.	Proactively conduct outfall sampling to mirror MS4 permit requirements, which are not yet applicable in Bethlehem.	Med	Med	Low

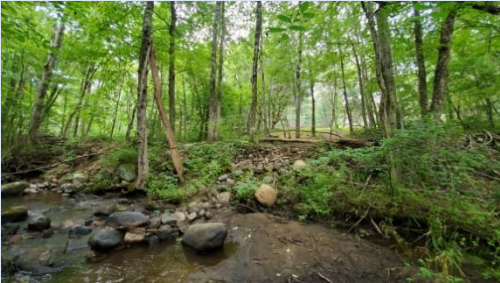
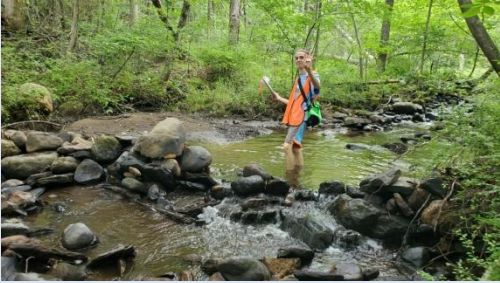
Site Code	Location Description	Observations	Potential Bacteria Sources	Potential BMPs	Other Recommendations and Notes	BMP Potential	BMP Priority	BMP Cost	Photos
R7-TR-01	Upstream Route 132	Trash and Debris (TR-01) - Lots of roadside litter including bottles, cans, plastic, cups, wrappers, etc.	None apparent	Establish "Adopt-a-Spot" for town clean up days.	Less than a pick-up truck load was picked up, but may need more attention for town clean-up days. Most litter seems to be tossed from cars on Route 132; add "No Littering" sign along roadway.	Med	Low	Low	N/A
R7-MI-01	Between Judge Lane and Route 132	Miscellaneous (MI-01) - Small rock dam/stonewall 2 to 3 feet high across the river; easily removed. Also noted is understory clearing on the right bank, mostly brush removal in an area out 100 feet wide in effort to provide a view towards the river; appears to be an invasive plant removal effort; the house is about 500 feet away from the river up a gently sloping hill.	None apparent	Recommend removing "dam" and strategically planting a couple trees in cleared swath to prevent long-term erosion.		Med	Low	Low

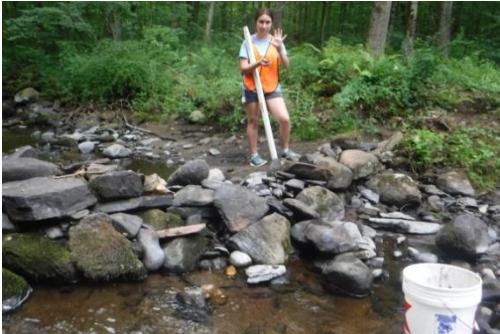
R7-MI-02	Between Judge Lane and Route 132	Miscellaneous (MI-02) - Small rock dam/stonewall 2 to 3 feet high across the river; easily removed.	None apparent	Remove dam / redistribute river rocks from pile to streambed.	May need to create / circulate educational materials to discourage building small dams like these (at least three observed during streamwalk survey).	Med	Low	Low

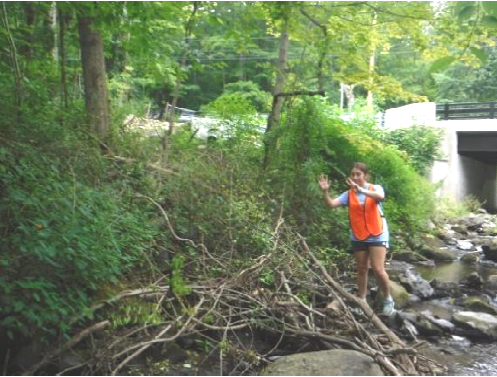
Site Code	Location Description	Observations	Potential Bacteria Sources	Potential BMPs	Other Recommendations and Notes	BMP Potential	BMP Priority	BMP Cost	Photos
R7-MI-03	Between Judge Lane and Route 132	Miscellaneous (MI-03) - Long green garden hose that extends up the right bank; approximately 100 ft long hose; purpose unknown - no pump to indicate water withdrawal; possible discharge hose associated with sump pump (not flowing).	None apparent	Recommend removing the hose if not associated with irrigation or sump drainage or otherwise necessary		Med	Low	Low	N/A
R7-OT-03	Wood Creek Road	Stormwater Outfall (OT-03) - Brand new 1 foot diameter corrugated metal pipe with concrete retaining wall/headwall support on the right bank. Relatively large, heavily rip-rapped sediment / plunge pool below outfall about 25 feet from the water's edge.	None apparent	Regular inspection and clean-out of the catch basin. Proactively conduct outfall sampling to mirror MS4 permit requirements, which are not yet applicable in Bethlehem.	Noted that new catch basins and curbing was installed along Wood Creek Road as part of the recent road and bridge rehabilitation projects. No dry weather flow, no odor, no staining, no benthic growth in the pipe.	Med	Low	Low
