TECHNICAL MEMO

Weekeepeemee River Streamwalk Assessment Survey Woodbury and Bethlehem, CT

Field Assessments Completed July and August 2021
by Pomperaug River Watershed Coalition

Project Led and Memo Prepared by
Carol Haskins, PRWC Executive Director

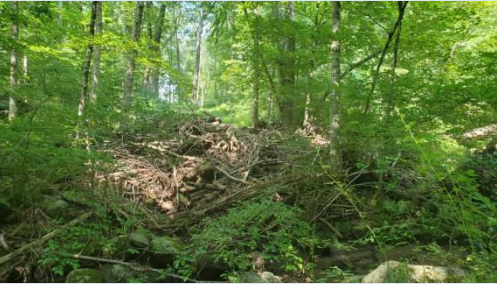
R8-MI-01	Upstream Wood Creek Road Bridge	Miscellaneous (MI-01) - Brush / log dump pile on the right bank immediately adjacent to the river that is about 25 wide by 25 long by 8 to 10 feet high. Majority of the logs are 6 to 12 inches in diameter; there is a timber road that runs perpendicular to the slope down to the river.	None apparent	Circulate educational materials on fill in and along wetlands and watercourses. Move the brush pile back away from the river.	Potential for erosion on the timber road. Brush pile could be considered as fill in a wetland; only visible from the river.	Med	Low	Low

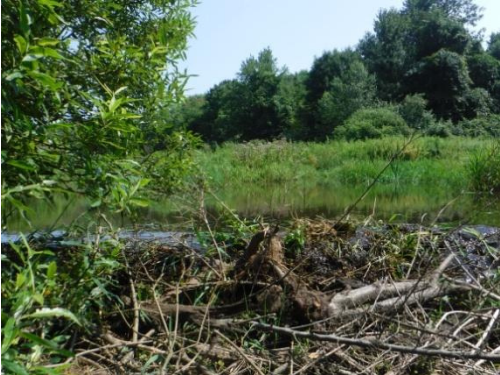
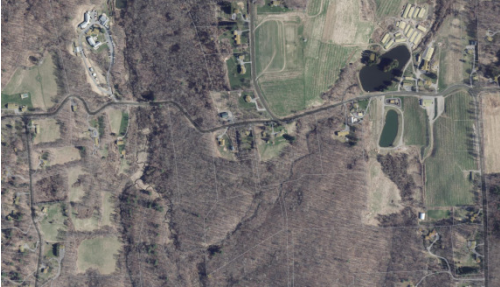
Site Code	Location Description	Observations	Potential Bacteria Sources	Potential BMPs	Other Recommendations and Notes	BMP Potential	BMP Priority	BMP Cost	Photos
R8-MI-02	Downstream Double Hill Road	Miscellaneous (MI-02) - Beaver dam across the river that is about 3 to 4 feet high and 12 feet wide; water is coming through the dam; adjacent riparian area consists of meadow and hayfield on the right bank; forested on the left bank. No infrastructure is at risk. Area upstream of the dam may be a bit more open to sun as aials indicate a series of beaver dams in a swampy area dominated by shrubs.	Wildlife – Beaver	Resume ambient water quality monitoring at Wood Creek Road bridge to track bacteria that might be associated with beaver activity (also note tributary from Long Meadow Lake that runs through March Farm on aerial image where livestock are present).	Let nature take its course; not infrastructure immediately at risk of damage or failure in relation to beaver activity	Low	Low	Low

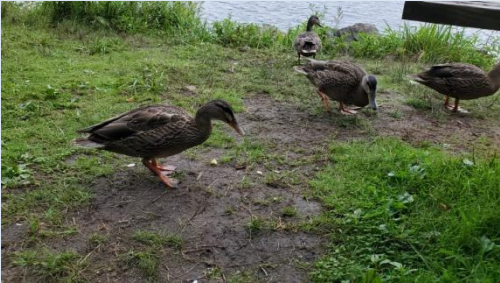
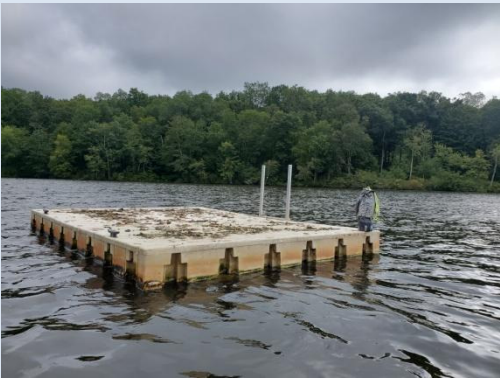
Site Code	Location Description	Observations	Potential Bacteria Sources	Potential BMPs	Other Recommendations and Notes	BMP Potential	BMP Priority	BMP Cost	Photos
HSI-02	Long Meadow Pond Town Beach	Hotspot Site Investigation (HSI-02) - Long Meadow Pond Beach. Lots of duck and goose poop scattered throughout the beach, playground, picnic and boat launch area. Port-o-potty located immediately adjacent to the water at the boat launch; potential bacteria source if leaking or if pushed over / backed into by a car.	Ducks / Geese / Port-o-let / Septic	Highly visible / high traffic area suitable for demonstration projects like native buffer plantings or a rain garden. A Rain garden could capture runoff from the pavilion or the building used for summer camp. Pervious gravel parking lots are already in place along with a stormwater detention pond.	Low risk for septic failure given seasonal use of bathrooms.	Med	Med	Med /High
