TECHNICAL MEMO

Weekeepeemee River Streamwalk Assessment Survey Woodbury and Bethlehem, CT

Field Assessments Completed July and August 2021
by Pomperaug River Watershed Coalition

Project Led and Memo Prepared by
Carol Haskins, PRWC Executive Director

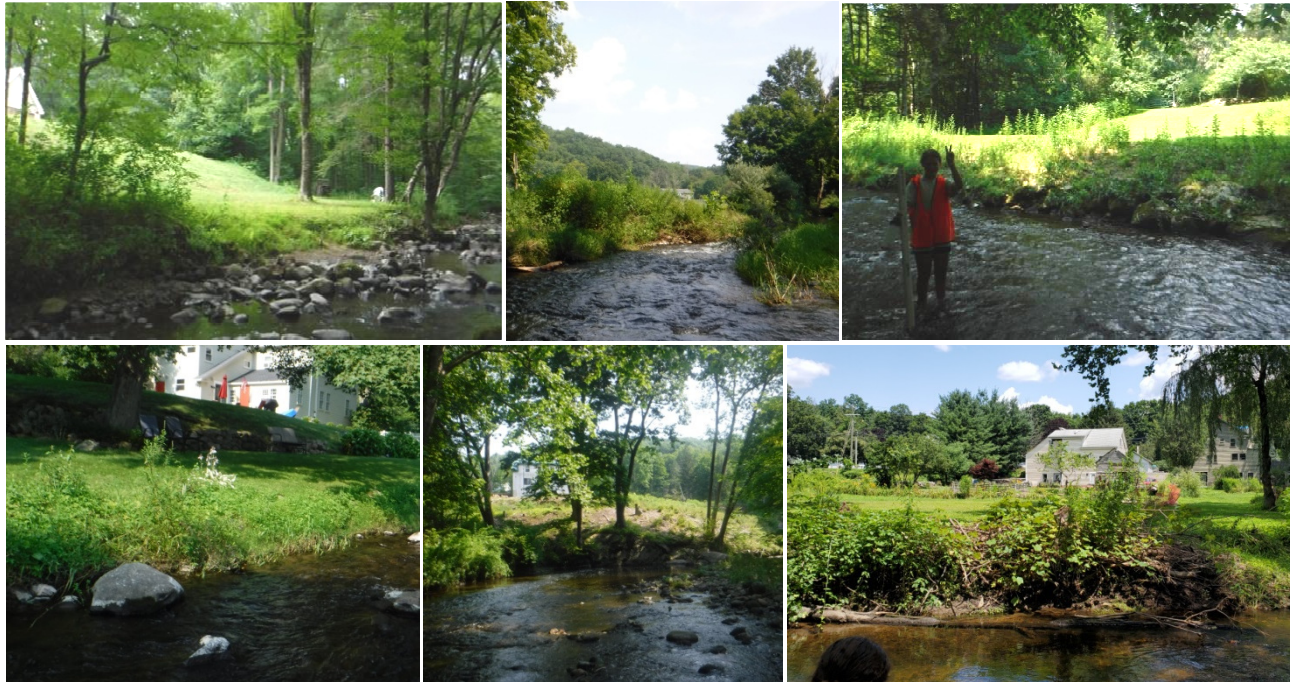
- **Lack of Stream Buffer** – Stream buffer encroachments were prevalent along the Weekepeemee River and are most often associated with residential and agricultural properties. Residential lawns and some agricultural practices extend down to the banks of the stream in many areas (**Figure 5**). The degree of stream buffer encroachment can have a significant impact on the overall stream and habitat conditions. In general, larger natural buffers are associated with better stream health, including channel substrate, flow regime, water quality, and shading as well as better upland and wetland habitat that provide larger areas available to native flora and fauna.

Figure 5. Examples of residential and agricultural sites where there are opportunities for riparian buffer restoration. A healthy riparian buffer should consist of vegetation that includes trees, shrubs, and perennial ground cover to provide stream shade, soil stability, stormwater infiltration, and habitat and food for a variety of organisms including dragonflies, frogs, turtles, birds, and mammals.

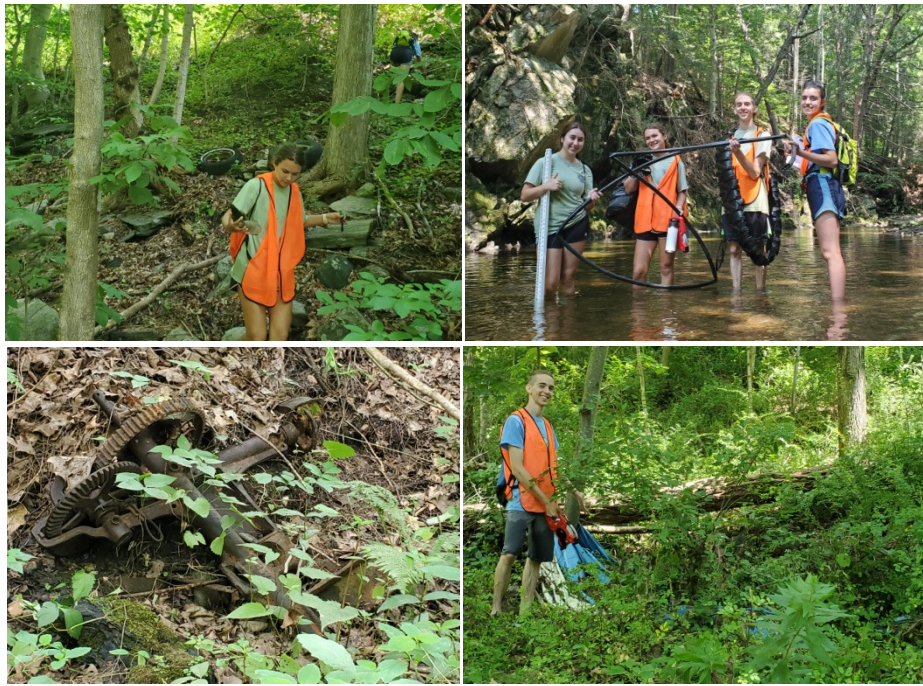
- **Trash and debris accumulation** – Evidence of littering and illegal dumping was observed in at least three locations along state and town roads. While this does not contribute to the bacteria impairment that makes for unsafe recreation, it does present other hazards like broken glass and rusty metal that make recreation undesirable (**Figure 6**). Trash and debris found at other sites consisted of items that appeared to be deposited by high streamflows in slower moving areas. Increased “No dumping” / “No littering” signs or surveillance cameras may be needed along certain road areas to help prevent further accumulation. These areas should also be included in municipal “adopt a road” programs where volunteers conduct regular litter clean-up efforts. More frequent in-stream trash clean-up efforts may also be warranted.

Figure 6. Examples of trash and debris observed in and along the Weekeepeemee River. Smaller items were collected during the survey and properly disposed of by the field team.

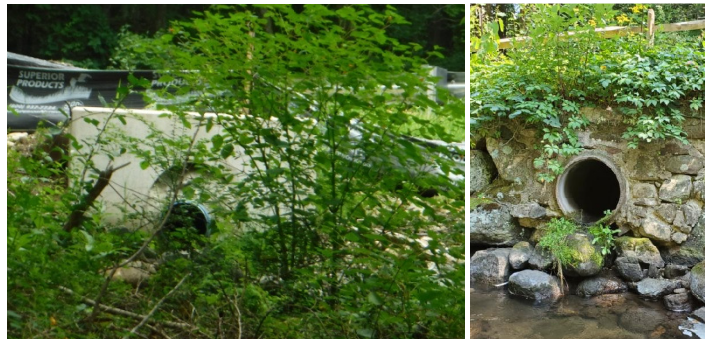
Figure 7. Examples of stormwater outfalls that discharge water in catch basins located on roadways and other impervious surfaces; their associated network of drainage pipes discharge stormwater away from the roadway and onto the ground or into a nearby river /stream.

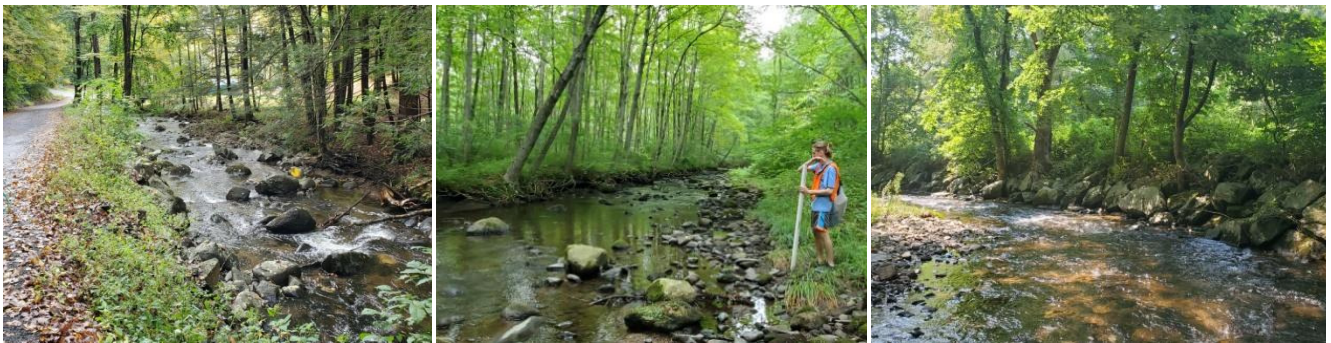
along the length of the Weekepeemee River, many of which coincided with observations of streambank erosion. Restoring channelized section to more natural, meandering paths face many challenges including physical infrastructure and obtaining agreements among multiple property owners. While challenging and costly to restore some of these areas, there are opportunities that could support a healthier fishery and enhance recreational opportunities (example: Site Code R01-CM-01). These efforts are a low priority through the lens of addressing bacteria related impairments.

Figure 9. Examples of channel modification where portions of the Weekeepemee River had been straightened at some point in its history; typically in areas adjacent to agricultural fields and transportation routes.

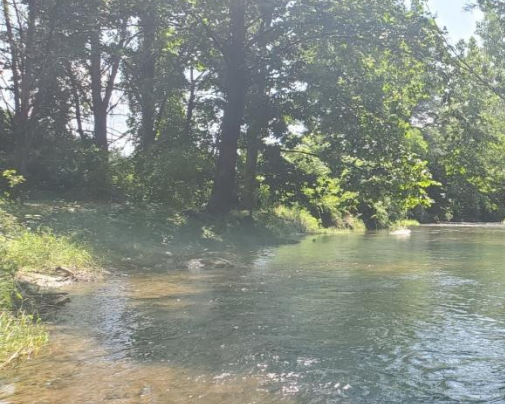
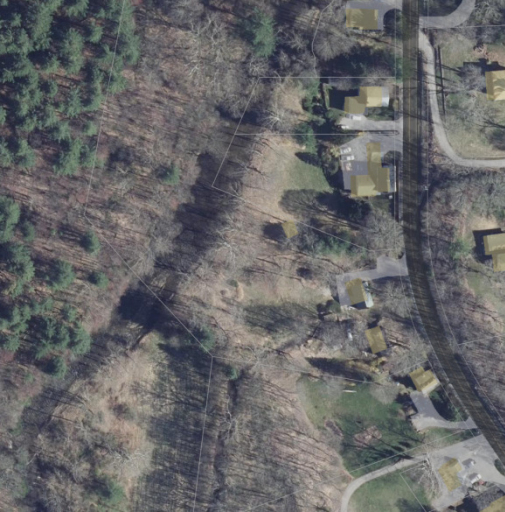
Site Code	Location Description	Observations	Potential Bacteria Sources	Potential BMPs	Other Recommendations and Notes	BMP Potential	BMP Priority	BMP Cost	Photos
R1-IB-01	Route 47 / Upstream Jacks Bridge Road	Impacted Buffer (IB-01) - Three houses on the left bank with lawns mowed to the edge of the river bank; some large shade trees (sycamores) interspersed; shrub layer or no mow zone recommended to cover approximately 100 feet x 15 feet along the river bank. Houses are set back from the river approximately 50 feet. Right bank is well vegetated.	None apparent	Plant shrub layer; shade tolerant perennials; and/or establish a no mow zone	Stream is partially shaded	Med	Low	Low

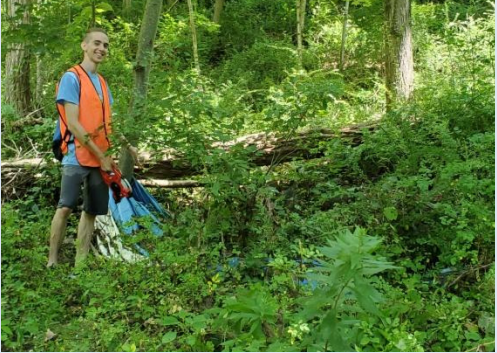
Site Code	Location Description	Observations	Potential Bacteria Sources	Potential BMPs	Other Recommendations and Notes	BMP Potential	BMP Priority	BMP Cost	Photos
R1-TR-01	Route 47 Right of Way near Easy St	Trash and Debris (TR-01) - Pool liner embedded in the sediment on the left bank within the right-of-way. Requires additional tools (shovels, scissors, blade, pry bar) and a canoe or kayak to float the trash to an easier removal point.	None apparent	Remove trash and debris		High	Low	Low

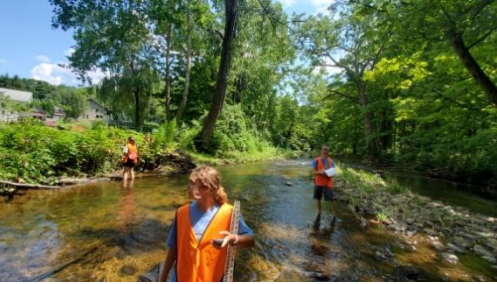
R1-IB-02	Washington Road near Quassuk Rd	Impacted Buffer (IB-02) - Three houses on the left bank with large, open, level lawns mowed to the edge of the river bank; some large shade trees (sycamores) interspersed;	None apparent	Recommend planting a shrub layer or establishing a no mow zone. Approximately 200 feet x 15 feet along the river bank available for planting.	Houses are set back from the river approximately 100 feet. Right bank is well vegetated.	Med	Med	Med

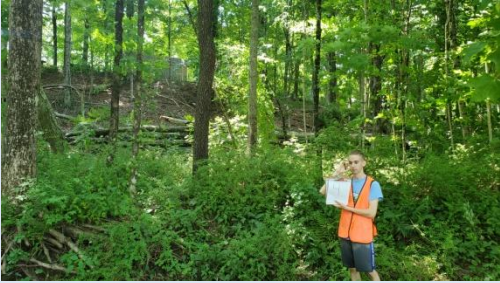
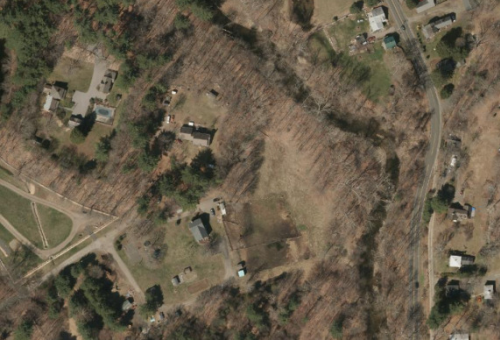
Site Code	Location Description	Observations	Potential Bacteria Sources	Potential BMPs	Other Recommendations and Notes	BMP Potential	BMP Priority	BMP Cost	Photos
R1-MI-01	Off Westwood Road	Miscellaneous (MI-01) – Half dozen goats are present at the top of a steep slope; within a fenced area approximately 100 feet from the right on the right bank. The steeply sloped bank between the goats and the hill could use some understory plantings (ferns, grasses, shrubs); established cover over young trees (less than 30 years old) provides stability and shading. The floodplain is terraced; the river bank is approximately 4.5 feet above the water's surface.	Goats and possibly other livestock. During leaf-off conditions in Fall 2021, cattle were observed on the Westwood Road side of the river when looking at Route 47 toward Westwood Road. Based on the aerial image, there may be other livestock in the area.	Understory planting on steep slope area for added filtration and bank stability.	There is a level, well-vegetated area that extends approximately 50 feet back from the river before rising steeply towards the goat area. Minor bank erosion was also noted where undercutting has exposed tree roots.	Low	Low	Med

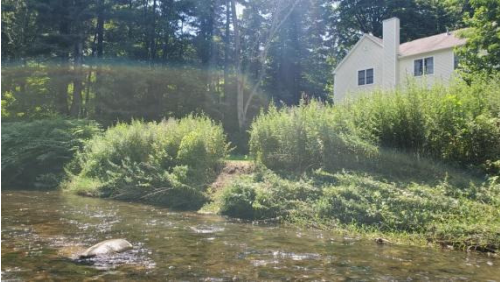
R1-IB-03	Ruffin Road	Impacted Buffer (IB-03) - Buffer area is less than 5 feet wide over a length of 150 feet that consists primarily of invasive species including Japanese knotweed and mugwort.	None observed; potential for septic or pet associated bacteria	Recommendation to remove invasive species and plant natives, establish a no mow zone along 150 feet of riverbank.	House is less than 50 feet from the river but it doesn't appear the lawn area is used, and could establish at least a 10 foot wide buffer.	Med	Med	Med

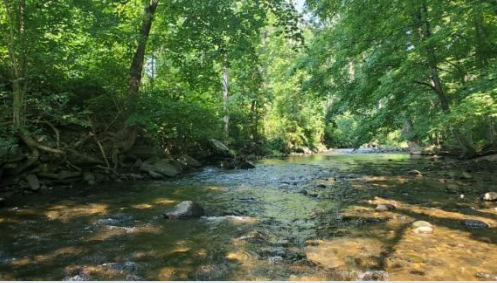
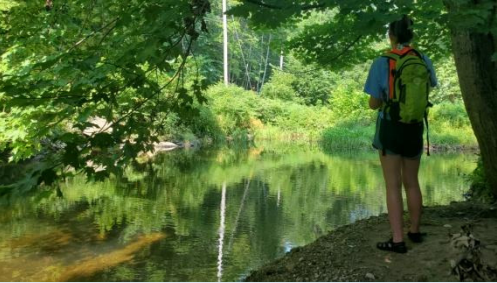
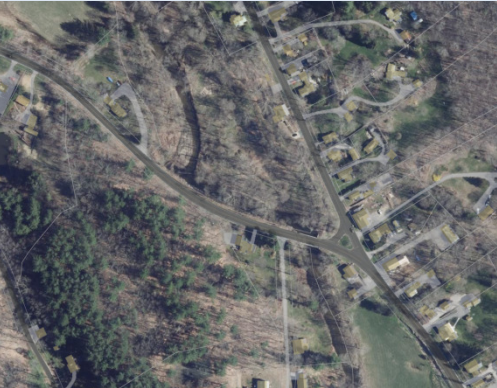
Site Code	Location Description	Observations	Potential Bacteria Sources	Potential BMPs	Other Recommendations and Notes	BMP Potential	BMP Priority	BMP Cost	Photos
R2-CM-01	Route 47 at Route 132	Channel Modification (CM-01) - River is straightened for approximately 1000 feet on the right bank where it flows along the edge of Route 47 upstream of the bridge. The area between the river and the road is only about 10 to 15 feet wide and is heavily armored. There is a large scour at the upstream end of the channelized area where the river is forced to make a sharp turn as it flows towards the armored bank. The river is also forced to make a sharp turn to flow under the bridge.	Wildlife	Update / replace / realign Hotchkissville Bridge at Route 47 so that it spans beyond the banks and is better aligned to the river channel. Root wads, woody debris, strategically placed boulders for in-stream habitat diversity, dissipating energy in the river channel, and better connecting the river to its floodplain.	Note restoration challenge presented by Route 47 as well as the power lines located along the river-side of the road. There is room on the left bank for the river to spill into the floodplain. In heavy storms, the river will also spill over Route 47.	Low	Med	High

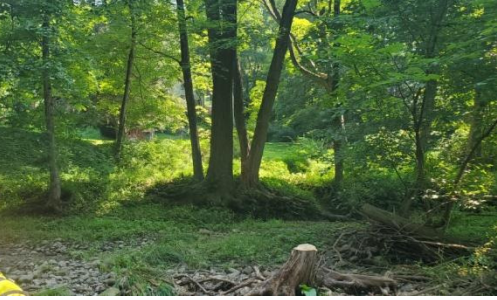
Site Code	Location Description	Observations	Potential Bacteria Sources	Potential BMPs	Other Recommendations and Notes	BMP Potential	BMP Priority	BMP Cost	Photos
R2-MI-01	Route 132	Miscellaneous (MI-01) - Chickens in a fenced area well set back from the river. Recently-cut tree on the river bank with only the stump remaining.	Chickens	Enhance understory vegetation	Distribute education materials on clearing vegetation in and along wetlands and watercourses (and the inverse re: planting riparian buffers)	Low	Low	Low

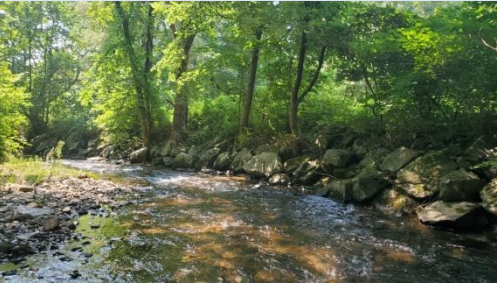
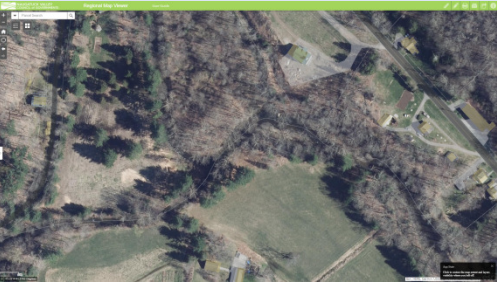
R2-CM-02	Confluence at Sprain Brook	Channel Modification (CM-02) - Right bank is armored with boulders for a length of about 150 feet where Sprain Brook flows into the Weekepeemee; armoring continues along the right bank of the Weekepeemee another 200 feet upstream of the confluence. Armoring is not extensive and there is plenty of room for restoration on both sides of the river (100 to 200 feet back from the river); the area along the river is mostly meadow. Bank height is approximately 5 feet.	Wildlife	Remove or breach armoring to help reconnect the river to the floodplain; beyond the vegetated buffer area are open fields with a few buildings set more than 100 feet from the river.	Verify if houses fall within the FEMA flood risk zones.	Low	Low	High

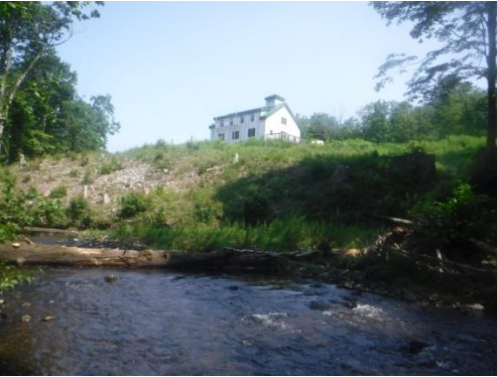
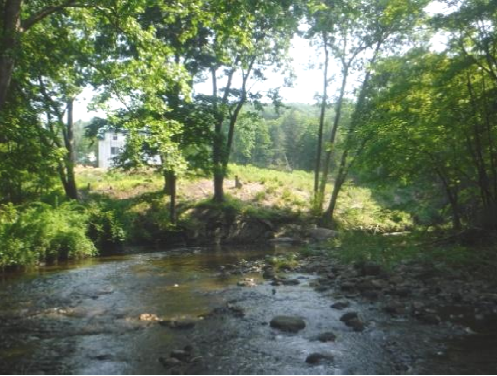
Site Code	Location Description	Observations	Potential Bacteria Sources	Potential BMPs	Other Recommendations and Notes	BMP Potential	BMP Priority	BMP Cost	Photos
R2-IB-01	Route 132 Vineyard	Impacted Buffer (IB-01) - Vegetation on the Left bank has been cleared, active earth excavation higher up on the slope. No silt fencing or erosion controls around the excavation zone. Area spanning 200 to 300 feet long and 100 to 150 feet wide has been cleared for agricultural purposes (vineyard). Stumps have been left in place; sparsely covered with some sapling and shrub volunteers. Cleared vegetation was mulched in place and covers the bank. Recommendation to establish at least 25 feet of buffer at the toe of the steep slope to filter runoff and stabilize the bank.	None apparent	Vegetate the toe of the slope at least 25 feet up the bank to provide stability and shading. Coir logs, hay bays, and/or silt fence would be appropriate erosion control measures to employ while the area is being cleared / excavated.		Med	Med/High	Med/High

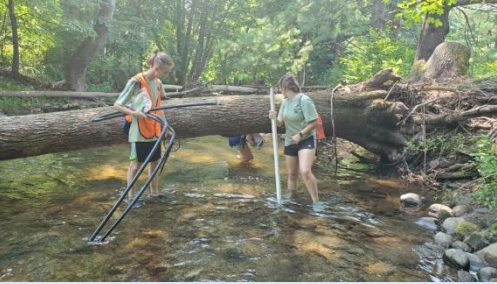
R2-TR-01	Papermill Road	Trash and Debris (TR-01) - Private property with a small amount of trash in a localized area; most of it was picked up during the streamwalk survey. Mostly plastic, metal, and styrofoam carried to this point by flooding.	None apparent	Periodic trash clean up, particularly after flooding events; flood deposition area		Low	Low	Low

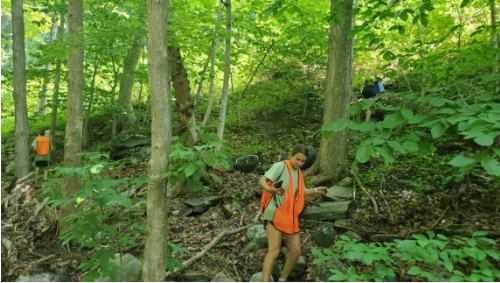
Site Code	Location Description	Observations	Potential Bacteria Sources	Potential BMPs	Other Recommendations and Notes	BMP Potential	BMP Priority	BMP Cost	Photos
R2-TR-02	Route 132 Right of Way near Hogpen Hill	Trash and Debris (TR-02) - On the left bank, there is lots of small trash items near the roadside / in the right of way; generally litter from passing vehicles (i.e. cans and bottles); most of it was picked up during the streamwalk survey, but tires remain between the road and the river. Will need a pick-up truck to remove; a pry bar or shovel might be helpful.	None apparent	Periodic trash clean up	Install "No Littering" or "No Illegal Dumping" signs along roadway.	Low	Low	Low

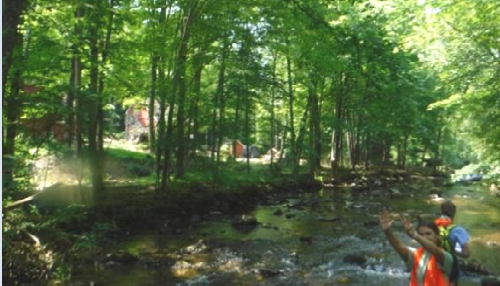
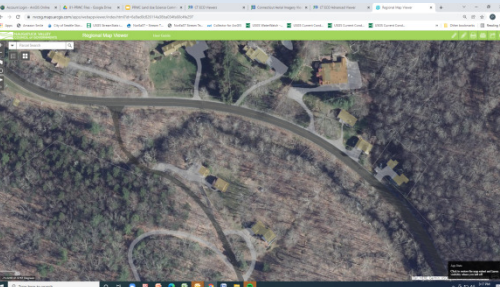
R2-IB-02	Papermill Road	Impacted Buffer (IB-02) - Understory clearing in the floodplain approximately 250 feet along the right bank of the river; house is set back from river approximately 150 feet. Yard area is flat and lacking a shrub layer but has scattered trees bordering the river.	None apparent	Enhance riparian buffers. May be an opportunity for rain garden installation or other downspout disconnection.	Recommendation to restore up to 30 feet with native shrubs or perennials to create an understory.	Med	Low	Low/Med

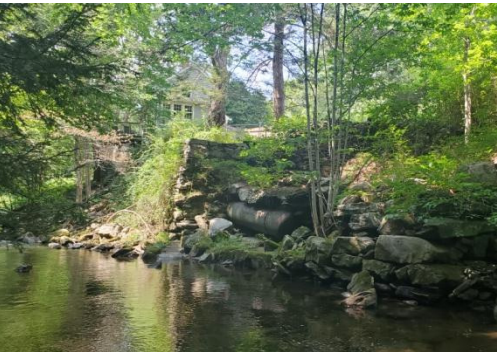
Site Code	Location Description	Observations	Potential Bacteria Sources	Potential BMPs	Other Recommendations and Notes	BMP Potential	BMP Priority	BMP Cost	Photos
R3-MI-01	Route 132	Miscellaneous (MI-01) - Exposed iron tank/pipe at the base of an old foundation on the left bank. Very rusty pipe/tank is approximately 2.5 foot diameter by 10 feet long and extends out of the stonewall / foundation; appears to be long since emptied and out of service.	None apparent	N/A	Inquire with the property owner about the nature of the stonewall / foundation feature around the tank.	Low	Low	Low

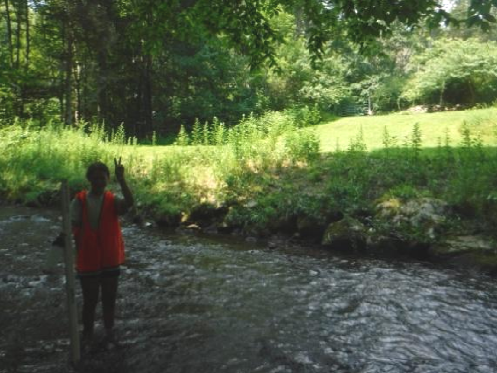
R3-IB-01	Route 132	Impacted Buffer (IB-01) - Historic house elevated from the river on the left bank; yard area north of the house is dominated by turf/grass; no trees or shrubs; some invasive species present; some bank armoring with steps down to the river.	None apparent	Recommend removing invasive species and planting natives to create a 10 foot wide buffer over a 75 foot length or establish a no mow zone for natural re-vegetation.		Med	Med	Low

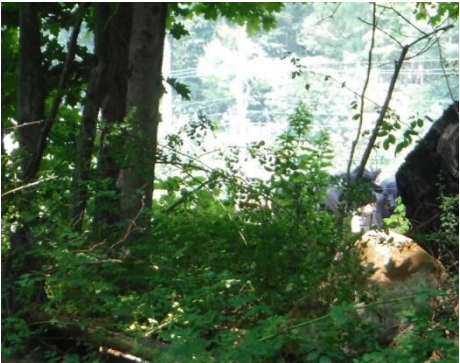
R3-MI-02	Route 132, Quickwater Farm	Miscellaneous (MI-02) - Cows (fewer than a dozen), chickens, and goats in pasture 25 feet away from the river on the left bank; livestock fencing in good repair and property is fairly level so low manure runoff potential; pastures do not appear to be overgrazed and appear to be using rotational pasturing practices.	Cows and other livestock	See notes for Site R3-IB-02

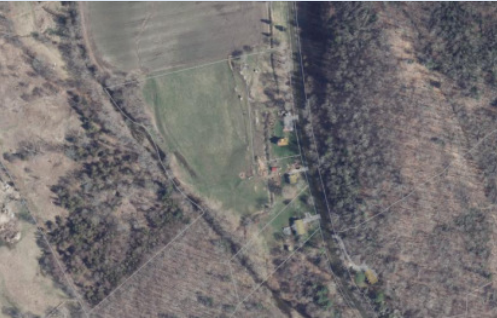
Site Code	Location Description	Observations	Potential Bacteria Sources	Potential BMPs	Other Recommendations and Notes	BMP Potential	BMP Priority	BMP Cost	Photos
R3-IB-02	Route 132, Quickwater Farm	Impacted Buffer (IB-02) - Left bank. Open pasture land where livestock fencing is in good shape and a good distance from the river; pasture land is level in the floodplain; area between the fence and the river is mowed and the tree / shrub / herbaceous layer is somewhat sparse.	Cows and other livestock	Area between the fence and the river is mowed and the tree / shrub / herbaceous layer is somewhat sparse. Enhance the buffer with more deep rooted plants to reinforce the bank and provide shade in an area 100 feet long by 5 to 10 feet wide.		Med	Med	Med

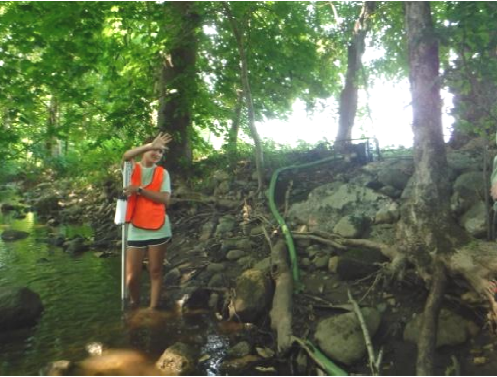
R3-MI-03	Route 132, The Farm	Miscellaneous (MI-03) - Two irrigation pumps located on the left bank with unsecured gas canisters sitting adjacent to them. Also a small amount of trash in the area.	None apparent	Recommend securing the gas canisters and/or having some kind of spill kit / spill containment associated with the irrigation pumps.		High	Med	Low

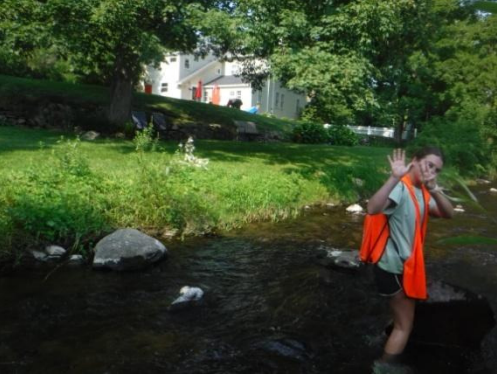
R3-IB-04	Peter Road	Impacted Buffer (IB-04) - House located very close to the river with minimal yard area which is dominated by lawn that is mowed and weed-whacked right up to the river's edge including vegetation growing between rocks that make up the streambank. No tree, shrub, or herbaceous layer; river has direct sun exposure.	None apparent	Recommend establishing at least 5 feet of a no-mow zone and/or strategically planting native perennials and shrubs along up to 100 feet of river bank. Small area could be kept clear (mowed) for view and or river access if desired.		Medium	Medium	Medium

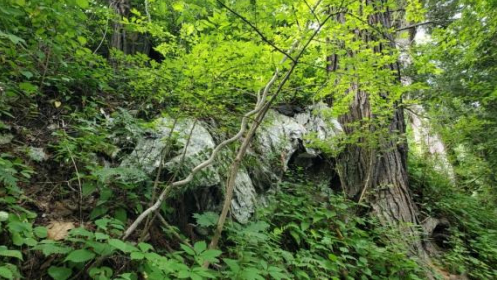
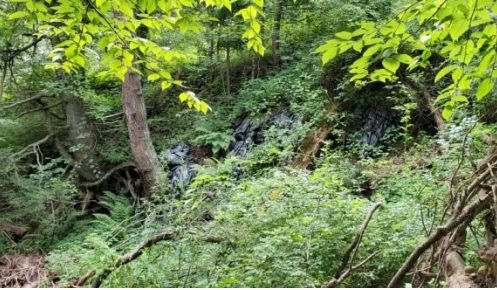
Site Code	Location Description	Observations	Potential Bacteria Sources	Potential BMPs	Other Recommendations and Notes	BMP Potential	BMP Priority	BMP Cost	Photos
R4-TR-01	Brushy Hill Road	Trash and Debris (TR-01) - Area along the left bank littered with a wide variety of trash and debris which appears to include items deposited by the river as well as roadside dumping. Items present included layers of plastic sheeting, plywood, chicken wire, and scrap metal. Layers of plastic sheeting are embedded in the riverbank about halfway up to the road. Smaller items including bottles, cans, bicycle, table, sink, plastic, glass, and metal items were collected.	None apparent	Remove trash and debris. Establish an "Adopt-a-Spot" as the site appears to be a chronic deposition area for flood swept debris. Install "No Dumping" signs on Brushy Hill Road to discourage illegal trash dumping.	Area requires further attention for clean-up; tools like shovels, pry bars, and sharp blades will be needed to remove the plastic sheeting so it can be bagged and walked up the bank or floated by boat down the river to an exit point. Note: some trash/debris could be associated with the farm across the road and/or farm operations upstream (greenhouse and/or weed barrier plastics). Use caution removing materials embedded in the streambank; disruption may cause erosion. Unclear if this is private property or a town right of way.	Medium	Medium	Medium

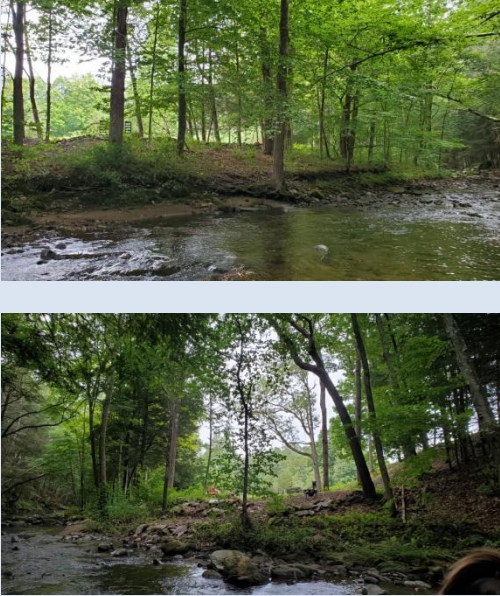
Site Code	Location Description	Observations	Potential Bacteria Sources	Potential BMPs	Other Recommendations and Notes	BMP Potential	BMP Priority	BMP Cost	Photos
R4-IB-01	Brushy Hill Road	Impacted Buffer (IB-01) - Private residence where there are a number of brush piles located in the floodplain which appear to be associated with active clearing along the right bank. A good number of large trees are present which provide 75% shading over the stream. Construction equipment is present.	Wildlife	Recommendation adding more understory vegetation along 200 feet of the bank to enhance the riparian buffer. Area approximately 25 feet wide is available for planting.	Stonewall and terracing down to the river. Stones somewhat piled in the river to enhance / deepen an existing pool. Disassemble this "dam" and redistribute rocks throughout the immediate area.	Medium	Low	Medium

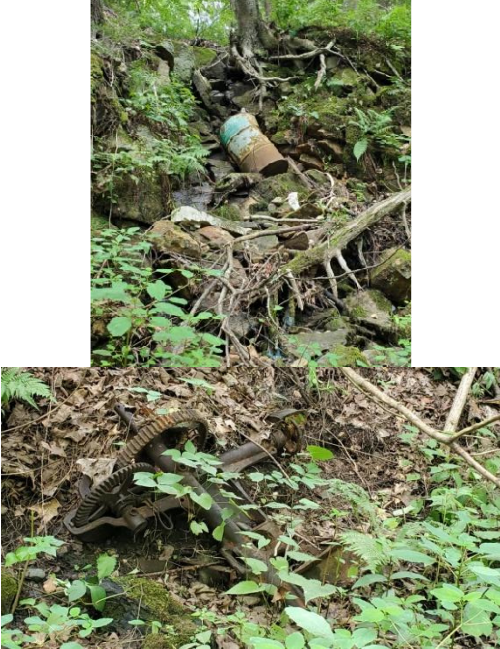
R4-TR-02	Brushy Hill Road	Trash and Debris (TR-02) - Items either associated with old farm operations or items that were illegally dumped including a 30 gallon barrel labeled "Agitene" which is a combustible solvent and a 1 gallon metal gas can and other metal items like tools; also cans, bottles, cups, styrofoam.	n/a	Area could be revisited along with TR-01 for additional clean-up by volunteers. Note - steep bank from road-side down to the river; best to float trash downstream to the bridge for removal. Establish an "Adopt-a-Spot" as the site appears to be a chronic deposition area for flood swept debris. Install "No Dumping" signs on Brushy Hill Road to curb illegal trash dumping.	Barrel reported to CT DEEP Spill Response Team and Town of Woodbury and removed at time of the Streamwalk Survey in August 2021.	High	High	Low

At the time of the visual assessment survey, PRWC also identified a high-priority, immediate-action item which was addressed at the time of the survey (see Site Code R4-TR-02 in Table 2). A 30 gallon barrel labeled “Agitene” (a combustible solvent) was observed on a steep streambank along with a 1 gallon gas canister. Without knowing if these containers actually held any hazardous fluids, they were immediately reported to the CT DEEP Spill Response Team and the Fire Marshall for Town of Woodbury. The response teams from these agencies coordinated to remove these items immediately; they no longer present an immediate hazard to the river. The presence of these items along with other trash and debris illustrate the need for “No Dumping” signage, broader promotion of hazardous waste disposal events in the region, and general education on waste reduction and disposal practices are important even though they do not directly relate to reducing bacteria loads to the river.

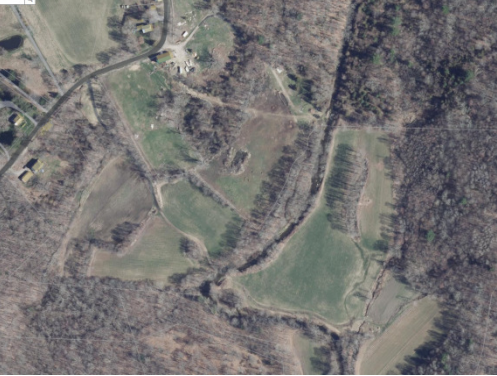
R4-MI-02	Weekeepemee River Farm	Miscellaneous (MI-02) - Irrigation pump / water withdrawal on the right bank. Pipe connected to the pump has a 3" diameter; the pump is also connected to a filtration system and holding tanks. Irrigation pumps are located at the top of a steep, sandy bank on an outside bend in the river which may not be overly stable (nearly a 1:1 slope).	Livestock - goats, chickens, sheep, cattle	Move irrigation pumps and holding tanks further up the bank and extend the pipe length. Potential for a bank stabilization project / riparian planting along the sandy bank at an outside bend in the river which may not be overly stable (nearly a 1:1 slope). Unclear if livestock have access to the river. If so, livestock fencing and an alternate water source may be appropriate BMPs.	Aerial image shows evidence of a couple ford-style stream crossings; consider stream crossing structures to stabilize river bed / prevent erosion. May be an opportunity to formalize the crossing as a ford wherein the riverbed is stabilized to prevent bed erosion or to establish a bridge crossing. "Hog panel" or "GeoWeb" style crossing materials may be appropriate for this site. See NRCS bulletin: https://www.nrcs.usda.gov/Internet/FSE_DOCUMENTS/stelprdb1167481.pdf	Med	High	High

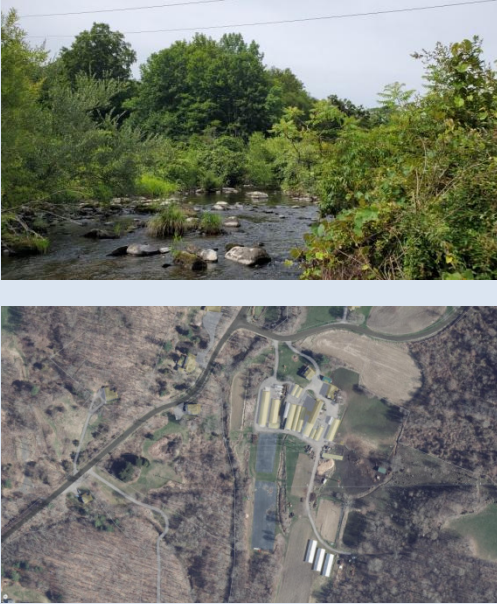
Site Code	Location Description	Observations	Potential Bacteria Sources	Potential BMPs	Other Recommendations and Notes	BMP Potential	BMP Priority	BMP Cost	Photos
R4-IB-02	Chohees Trail, The Farm	Impacted Buffer (IB-02) - Area under the power transmission lines has been cleared leaving the stream 95% unshaded for a length of 300 to 350 feet. There is ample understory vegetation providing stability, but the area is dominated by multiflora rose, Russian olive, mugwort, and other invasives.	None apparent	Recommend establishing shrub height vegetation so not to compete with maintenance of the power lines and in effort to provide some shading. More room on the right bank for natural revegetation or planting - 50 feet available. About 10 feet is available on the left bank where there is active crop production and where greenhouses are present.	Livestock presence was noted in the Pomperaug Watershed Based Plan (2018); they are no longer a component of the operations at this site. Adding vegetation under the power lines might not be feasible based on line maintenance practices and access needs of the power copy. Water conservation practices and other BMPs including drip irrigation; infiltration of stormwater runoff; rainfall capture (i.e. cistern); limited application of fertilizers and pesticides may be appropriate. Farm is already known to be using Integrated Pest Management strategies.	Low/ Med	Med	High

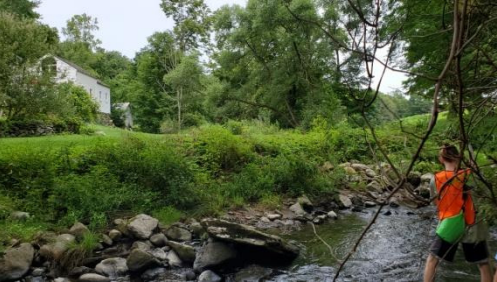
Site Code	Location Description	Observations	Potential Bacteria Sources	Potential BMPs	Other Recommendations and Notes	BMP Potential	BMP Priority	BMP Cost	Photos
R5-IB-01	Weekepeemee Road	Impacted Buffer (IB-01) - Right bank upstream of the bridge is dominated by open, residential lawn area along 100 to 150 feet of the streambank. Lawn is mowed to the top of the rocky bank/gravel bar which is not touched. Stream is minimally shaded on the right bank.	None apparent; Septic / Pets	Recommend establishing a no mow zone at least 2 feet wide and/or plant a few trees or shrubs (only about 12 feet of space is available for planting).		Med	Med	Low

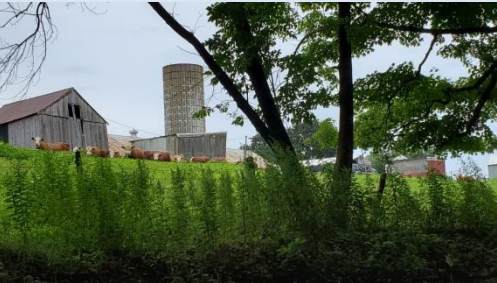
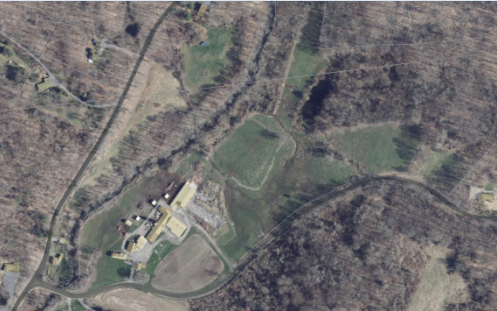
R5-IB-02	Chohees Trail Farm	Impacted Buffer (IB-02) - Length of 1000 feet on the left bank provides little canopy cover over the river. Area runs along the edge of pasture that shows some signs of overgrazing. Approximately 20 beef cattle are present in the pasture. Livestock fencing is placed approximately 8 feet from the river with pasture sloping down towards the river.	Beef Cattle	Recommend moving the livestock fencing further back from the river and/or repairing existing fencing; move up the bank to a 15 foot setback from the water and naturally revegetate or enhance with strategically planted trees or shrubs to replace invasive plants.	See conceptual design presented in Pomperaug Watershed Based Plan (2018). Based on walking the length of the Weekepeemee River; this site has the highest potential for contributing bacteria pollution. Thus, it remains high on the priority list for installation of BMPs.	Med	High	Med

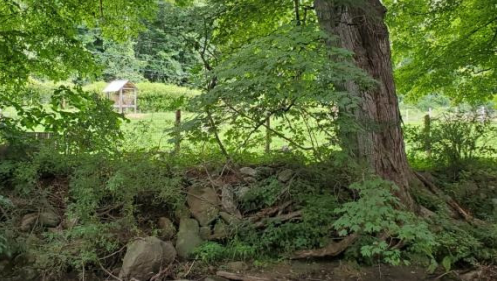
Site Code	Location Description	Observations	Potential Bacteria Sources	Potential BMPs	Other Recommendations and Notes	BMP Potential	BMP Priority	BMP Cost	Photos
R5-MI-01	Weekeepeemee Road	Miscellaneous (MI-01) – Hobby farm with livestock in the floodplain. Half a dozen goats and two dozen chickens pastured 10 feet from the river; pasture extends approximately 150 along the right bank. There is an ample shrub layer and some tree cover providing bank stability. Livestock fencing present.	Goats; chickens; dog	Recommend moving the chickens back a bit and maintaining the existing buffer, potentially enhance the buffer with shrubs or perennials. Challenge will be to keep the goats from browsing through / beyond the fence line.	Small area available for pasturing the goats and chickens; suggest not expanding the herd size or flock size in order to balance protection of the river.	Med	Med	Low

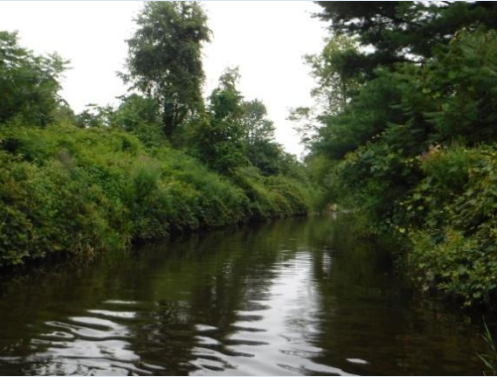
R5-IB-03	Downstream Crane Hollow Road	Impacted Buffer (IB-03) - Section along the left bank where old gravel ponds remain from former earth excavation operation is stabilized by an ample shrub layer with abundance of invasives including Russian Olive, Phragmites, and Japanese Knotweed. Stream is not well shaded due to lack of tree canopy along a 600 feet length.		Recommend adding trees to provide shade and try to remove invasive species.	The invasive plants provide an ample buffer for filtering runoff, preventing erosion, and absorbing flood waters but could provide better habitat and food for wildlife along with shade for the river if enhanced with native species including trees.	Low	Low	High

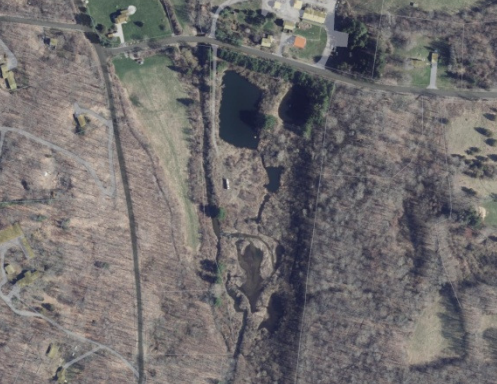
Site Code	Location Description	Observations	Potential Bacteria Sources	Potential BMPs	Other Recommendations and Notes	BMP Potential	BMP Priority	BMP Cost	Photos
R5-CM-01	Downstream Crane Hollow Road	Channel Modification (CM-01) - Approximately 500 feet length of the channel was historically straightened. Channel width is approximately 25 feet and the bank height is about 10 feet; the river is not connected to the floodplain and there isn't evidence of sediment deposition. There was a notable amount of algae covering the rocks and water weed (native <i>Elodea</i> sp.) growing in the river.	None apparent	Recommend strategically placing woody debris and or boulders to create channel diversity. May be a future opportunity to abandon earth excavation activities and re-introduce meanders within the river channel.	There is a decent buffer on both banks (though some areas open to sun – see R5-IB-03) and room for the river to spill into the floodplain without impacting infrastructure.	Low	Med	High

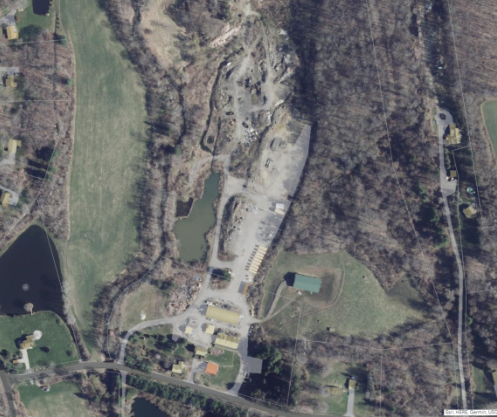
R6-OT-01	Upstream Crane Hollow Road	Stormwater Outfall (OT-01) - Natural, open stream channel on the left bank that is between 24 and 36 inches wide and is 4 inches deep with moderate flow. Unclear is if this is a tributary or a stormwater outfall; intense land use on the east side of the river suggests it is an outfall and there is no tributary shown on the map. Water is clear, not turbid, no benthic growth, no odor, no staining, and no floatables.	None apparent	Confirm source of flow; aerial image suggests it may be the outfall from a sediment or detention pond associated with earth excavation activities. These activities cannot be seen from the river channel; riparian buffers are adequate through this area.	Site with known waste water discharge permit issued by CT DEEP.	Low	Low	Low

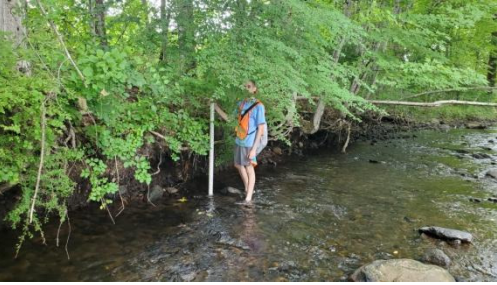
Site Code	Location Description	Observations	Potential Bacteria Sources	Potential BMPs	Other Recommendations and Notes	BMP Potential	BMP Priority	BMP Cost	Photos
R6-ER-01	Upstream Crane Hollow Road	Bank Erosion (ER-01) - Exposed roots along an area where down-cutting is occurring on the right bank; approximately 100 feet long with a bank height of 5 feet. Stream bottom/wetted width is about 15 feet wide; top width is approximately 35 feet wide.	None apparent	Could add features like root wads to help reconnect the river to the floodplain, but challenging in regards to access. More areas would be disrupted to achieve installation of BMPs.	There is no infrastructure at risk and there is 50 to 75 feet of well vegetated riparian land abutting. Stream channel is also noticeably straight.	Low	Low	High

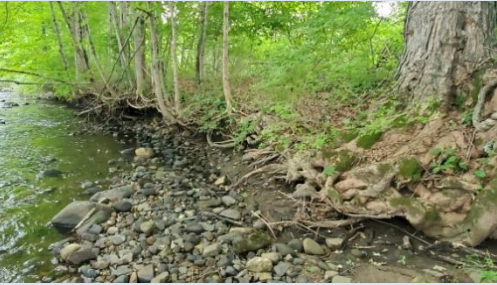
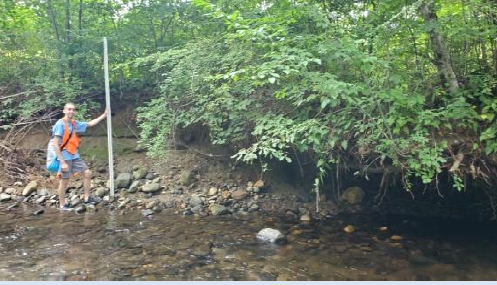
R6-ER-02	Upstream Crane Hollow Road	Bank Erosion (ER-02) - Long stretch (1000 feet) of bank erosion that alternates between the right and left bank. Bank height on the left is 6.5 feet and 4 feet on the right bank. There is very little plant growth along the bank; there are exposed roots with some overhang. There is scouring on the outside of the curve on the left bank and sand deposition along the right bank.	None apparent	Could add features like root wads and strategically placed boulders to help reconnect the river to the floodplain, but challenging in regards to access. More areas would be disrupted to achieve installation of BMPs.	No infrastructure is at risk with 50 to 75 feet of open riparian land abutting. Might be a candidate for bank stabilization through access would be difficult and would require vegetation clearing to get to. There is room to let the river naturally find equilibrium. Active processes appear to be down-cutting, widening, bank scour, and sediment deposition.	Low	Low	High

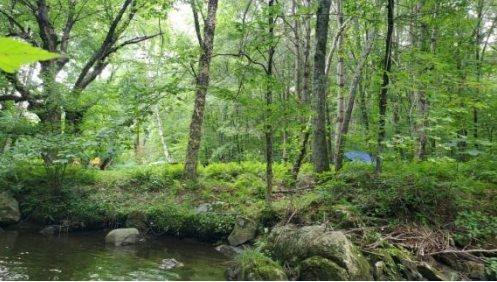
Site Code	Location Description	Observations	Potential Bacteria Sources	Potential BMPs	Other Recommendations and Notes	BMP Potential	BMP Priority	BMP Cost	Photos
R6-IB-01	Arrowhead Lane	Impaired Buffer (IB-01) - Area less than 100 feet long on the right bank that has been partially cleared to create a campsite near the river. House is more than 100 feet back from the river with a well vegetated area between the house and campsite. Campsite features a mowed spot for tenting, a fire pit, and seating. Established trees within the mowed area provide shade for the river.	None apparent	A few shrubs or perennials could be added along the water's edge for bank stability.	Low priority for restoration as the buffer impairment is VERY MINOR as there is no impervious cover in the area immediately adjacent to the river.	Low	Low	Low

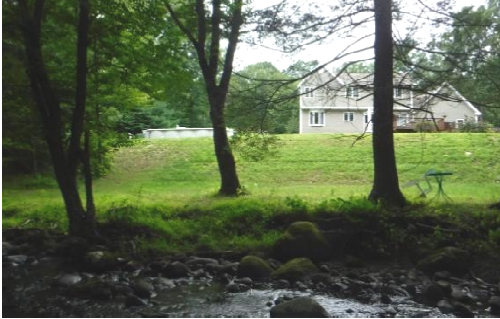
Site Code	Location Description	Observations	Potential Bacteria Sources	Potential BMPs	Other Recommendations and Notes	BMP Potential	BMP Priority	BMP Cost	Photos
R6-IB-02	Arrowhead Lane	Impacted Buffer (IB-02) - Approximately 125 feet of open lawn up to the water's edge on the right bank. No trees or shrubs and no shade cover. There is an above ground pool situated about 100 feet upslope of the stream, while the house is about 150 feet from the stream.	None apparent	Recommend planting native trees, shrubs, perennials to create at least a 15 foot wide riparian buffer along the 125 feet of streambank.		Med	Med	Med

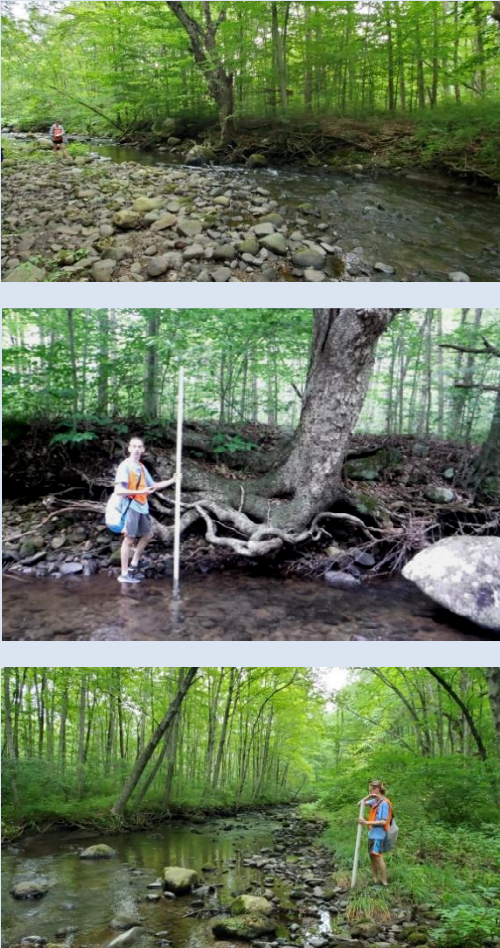
Site Code	Location Description	Observations	Potential Bacteria Sources	Potential BMPs	Other Recommendations and Notes	BMP Potential	BMP Priority	BMP Cost	Photos
R6-ER-03	Arrowhead Lane	Bank Erosion (ER-03) - Stretch of exposed tree roots on the right bank. Bank height ranges from 4 to 7 feet high. Down-cutting and bank scour is occurring on the inside of a meander on the right bank with deposition on the left bank. There is a gravel bar approximately 15 feet wide on the left bank. Some wetlands present in the adjoining riparian area; riparian area is dominated by forest cover; no infrastructure is at risk.	Wildlife	None	Low priority for restoration; let banks naturally find equilibrium given privately owned forest lands.	Low	Low	Low

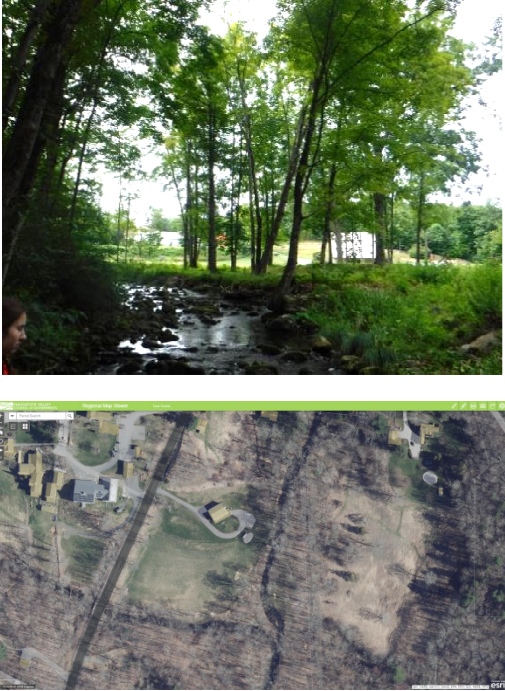
Site Code	Location Description	Observations	Potential Bacteria Sources	Potential BMPs	Other Recommendations and Notes	BMP Potential	BMP Priority	BMP Cost	Photos
R6-IB-03	Upstream Arrowhead Lane; Flanders Road interior	Impacted Buffer (IB-03) - Both right and left bank upstream of the confluence of Wood Creek is open lawn area with minimal trees and shrubs along 300 feet of each river (Left bank of Wood Creek; Right bank of Weekepeemee - property upstream of confluence). Some bank erosion is evident; the stream is not shaded.	None apparent	Good potential for riparian buffer planting as house/driveway/pool are set away from the river; at least 25 feet available for planting. Could also add some plants along the left bank of the Weekepeemee.	Consider bacteria sampling site on Wood Creek to consider inputs from land use activities in this sub-watershed	Med	Med	Low/Med

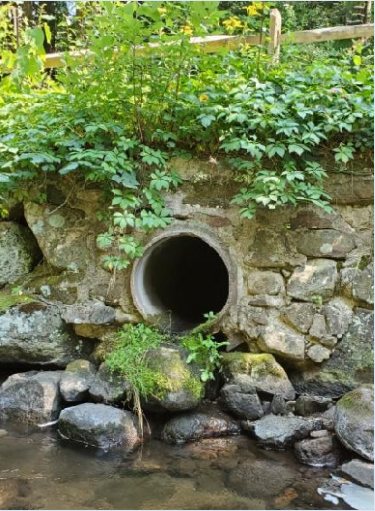
R7-OT-01	Mill Pond Road	Stormwater Outfall (OT-01) - 18 inch concrete, circular pipe flush with concrete retaining wall on the left bank just upstream of the covered bridge; outfall is 3 to 4 feet above stream grade. There is some benthic growth in the pipe that is brown and green in color, but there is no flow, no odor. Staining and algae growth is along the flow line. Note the road is within 10 feet from the river and the catch basin is visible.	None apparent.	Regular inspection and clean-out of the catch basin.	Proactively conduct outfall sampling to mirror MS4 permit requirements, which are not yet applicable in Bethlehem.	Med	Low	Low

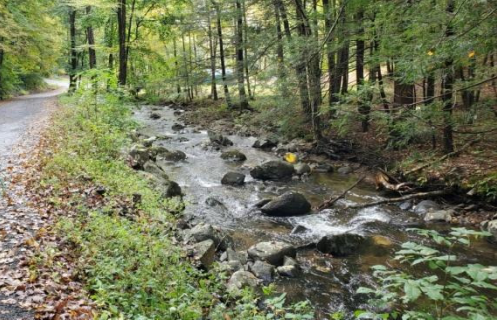
Site Code	Location Description	Observations	Potential Bacteria Sources	Potential BMPs	Other Recommendations and Notes	BMP Potential	BMP Priority	BMP Cost	Photos
R7-IB-01	Mill Pond Road	Impacted Buffer (IB-01) - Approximately 300 foot stretch along Mill Pond Road, downstream of Route 132 appears to have been straightened; both banks are armored with cobble to boulder sized riprap. The bank between the road and the river is slightly steeper than a 1:1 slope and the width to the road is only about 10 feet (this is on the left bank of the river). Sparse vegetation grows between the rocks and is dominated by poison ivy and jewelweed. The right bank is a little lower and opens into a narrow floodplain. There is some minor undercutting along the right bank.	None apparent		There is room for some plantings on the right bank, but not possible on the left given the intensive riprap. Stream is more than 50% shaded. Stability of the banks and potential for road washing out is the greater concern here.	Low	Med	High

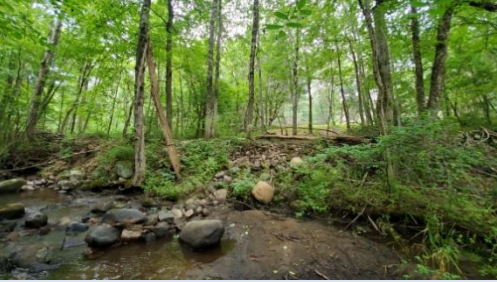
Site Code	Location Description	Observations	Potential Bacteria Sources	Potential BMPs	Other Recommendations and Notes	BMP Potential	BMP Priority	BMP Cost	Photos
R7-TR-01	Upstream Route 132	Trash and Debris (TR-01) - Lots of roadside litter including bottles, cans, plastic, cups, wrappers, etc.	None apparent	Establish "Adopt-a-Spot" for town clean up days.	Less than a pick-up truck load was picked up, but may need more attention for town clean-up days. Most litter seems to be tossed from cars on Route 132; add "No Littering" sign along roadway.	Med	Low	Low	N/A
R7-MI-01	Between Judge Lane and Route 132	Miscellaneous (MI-01) - Small rock dam/stonewall 2 to 3 feet high across the river; easily removed. Also noted is understory clearing on the right bank, mostly brush removal in an area out 100 feet wide in effort to provide a view towards the river; appears to be an invasive plant removal effort; the house is about 500 feet away from the river up a gently sloping hill.	None apparent	Recommend removing "dam" and strategically planting a couple trees in cleared swath to prevent long-term erosion.		Med	Low	Low

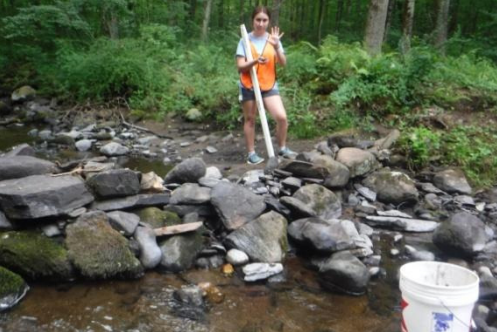
R7-MI-02	Between Judge Lane and Route 132	Miscellaneous (MI-02) - Small rock dam/stonewall 2 to 3 feet high across the river; easily removed.	None apparent	Remove dam / redistribute river rocks from pile to streambed.	May need to create / circulate educational materials to discourage building small dams like these (at least three observed during streamwalk survey).	Med	Low	Low

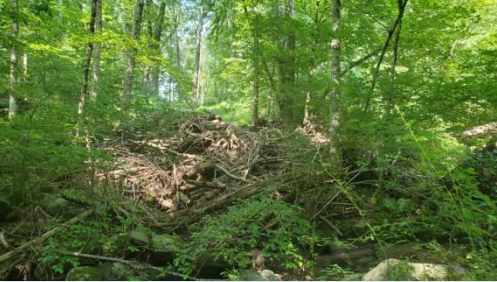
R8-MI-01	Upstream Wood Creek Road Bridge	Miscellaneous (MI-01) - Brush / log dump pile on the right bank immediately adjacent to the river that is about 25 wide by 25 long by 8 to 10 feet high. Majority of the logs are 6 to 12 inches in diameter; there is a timber road that runs perpendicular to the slope down to the river.	None apparent	Circulate educational materials on fill in and along wetlands and watercourses. Move the brush pile back away from the river.	Potential for erosion on the timber road. Brush pile could be considered as fill in a wetland; only visible from the river.	Med	Low	Low

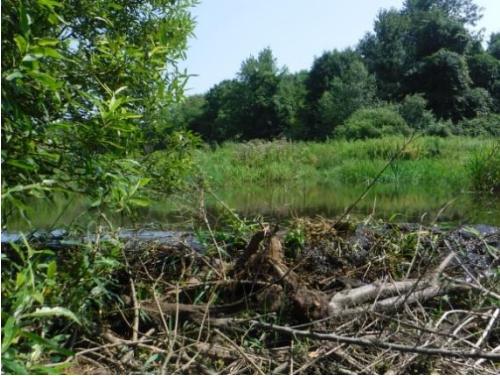
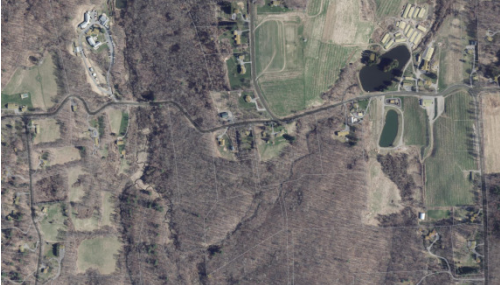
Site Code	Location Description	Observations	Potential Bacteria Sources	Potential BMPs	Other Recommendations and Notes	BMP Potential	BMP Priority	BMP Cost	Photos
R8-MI-02	Downstream Double Hill Road	Miscellaneous (MI-02) - Beaver dam across the river that is about 3 to 4 feet high and 12 feet wide; water is coming through the dam; adjacent riparian area consists of meadow and hayfield on the right bank; forested on the left bank. No infrastructure is at risk. Area upstream of the dam may be a bit more open to sun as arials indicate a series of beaver dams in a swampy area dominated by shrubs.	Wildlife – Beaver	Resume ambient water quality monitoring at Wood Creek Road bridge to track bacteria that might be associated with beaver activity (also note tributary from Long Meadow Lake that runs through March Farm on aerial image where livestock are present).	Let nature take its course; not infrastructure immediately at risk of damage or failure in relation to beaver activity	Low	Low	Low
