TECHNICAL MEMO

Weekeepeemee River Streamwalk Assessment Survey Woodbury and Bethlehem, CT

Field Assessments Completed July and August 2021
by Pomperaug River Watershed Coalition

Project Led and Memo Prepared by
Carol Haskins, PRWC Executive Director

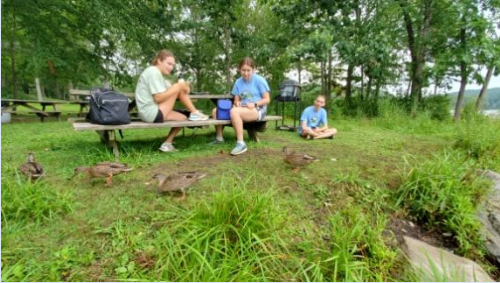
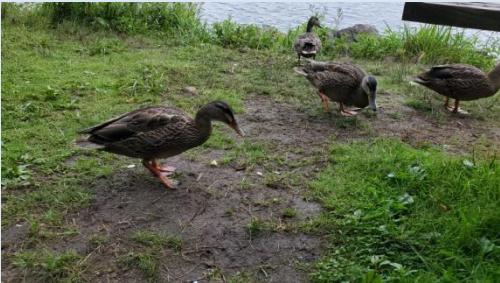
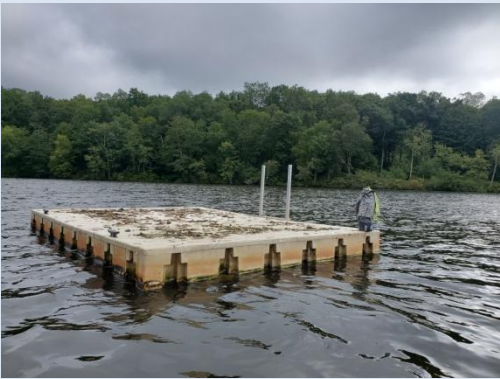
Site Code	Location Description	Observations	Potential Bacteria Sources	Potential BMPs	Other Recommendations and Notes	BMP Potential	BMP Priority	BMP Cost	Photos
HSI-02	Long Meadow Pond Town Beach	Hotspot Site Investigation (HSI-02) - Long Meadow Pond Beach. Lots of duck and goose poop scattered throughout the beach, playground, picnic and boat launch area. Port-o-potty located immediately adjacent to the water at the boat launch; potential bacteria source if leaking or if pushed over / backed into by a car.	Ducks / Geese / Port-o-let / Septic	Highly visible / high traffic area suitable for demonstration projects like native buffer plantings or a rain garden. A Rain garden could capture runoff from the pavilion or the building used for summer camp. Pervious gravel parking lots are already in place along with a stormwater detention pond.	Low risk for septic failure given seasonal use of bathrooms.	Med	Med	Med /High
