Appendix D

Structural BMP Prioritization Matrix Pomperaug River Watershed Based Plan

BMP Prioritization Matrix for Potential Areas of Concern
Pomperaug River Watershed Based Plan

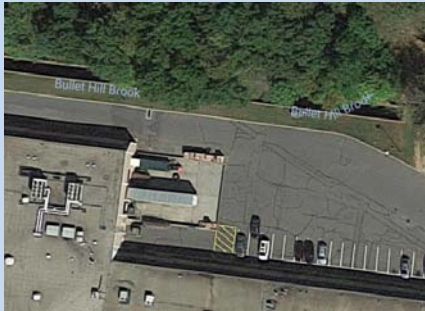
Wastewater Treatment Facility 1 (Pomperaug-03)	Heritage Road, Southbury	Wastewater treatment plant	<ul style="list-style-type: none"> Conduct additional ambient water quality monitoring at new sampling locations to determine extent of impairment and possible source(s) of bacteria 		N/A	Low	N/A	Yes		
Commercial Complex 1 (tributary to Pomperaug-03)	East side of intersection of Route 6 and Main Street South, Southbury (South of Bullet Hill Brook)	Stormwater runoff, waste management, past septic issues	<ul style="list-style-type: none"> Incorporate LID retrofits into site redevelopment Underground infiltration, permeable pavement Inspect septic systems for failure (due to size this falls under DPH or DEEP jurisdiction) 	<ul style="list-style-type: none"> Cover dumpsters with roof Review stormwater control plan, if exists Heavily channelized stream Conduct survey for potential illicit discharges from businesses in plaza 	High	High	High	Yes

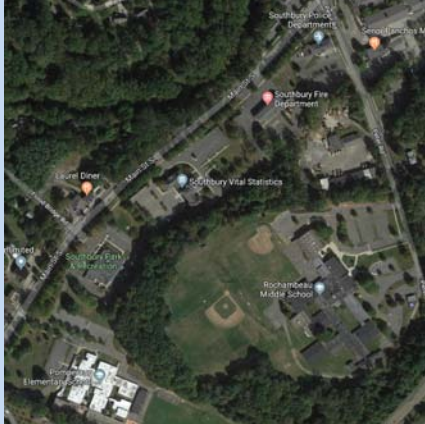
Business District 1 (Pomperaug-03)	Main Street South Corridor, Southbury (particularly concentrated at Municipal Complex west of the intersection with Peter Road)	Stormwater runoff	<ul style="list-style-type: none"> Develop and implement GI/LID "master plan" for Main Street South corridor LID retrofits of municipal and commercial properties and within the municipal ROW between Route 6/Southbury Plaza and South Britain Road (Route 172) Potential municipal sites include: <ul style="list-style-type: none"> Southbury Police, Fire, and DPW Southbury Town Hall Southbury Park and Recreation Rochambeau Middle School Pomperaug Elementary School Southbury Library Municipal ROW Numerous commercial redevelopment sites along the corridor 		High	High	High	Yes

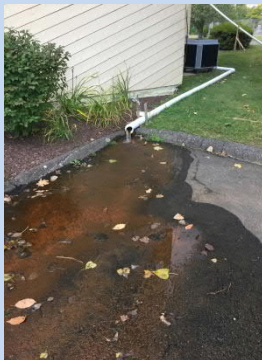
Health Care 2 (tributary to Pomperaug-03)	Intersection of Main Street South and Garage Road	Dry weather discharge (pavement stained)	<ul style="list-style-type: none"> Follow up sampling of dry weather discharge and removal of any illicit connections found 		Medium	Low	Low	Yes

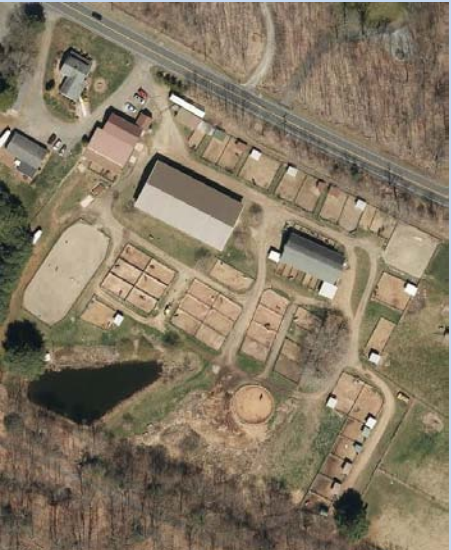
New Site ID (Impaired Segment)	Location Description	Bacteria Sources	Potential Best Management Practices (BMPs)	Other Recommendations and Notes	Relative BMP Pollutant (Bacteria) Removal	Relative Cost	Maintenance Requirements	Field Visit Conducted	BMP Concept Development	Photo
Equestrian 3	Route 67 along South Branch of Bullet Hill Brook	Stream running through paddock	<ul style="list-style-type: none"> Encourage sufficient buffer Animal exclusion fencing 					No

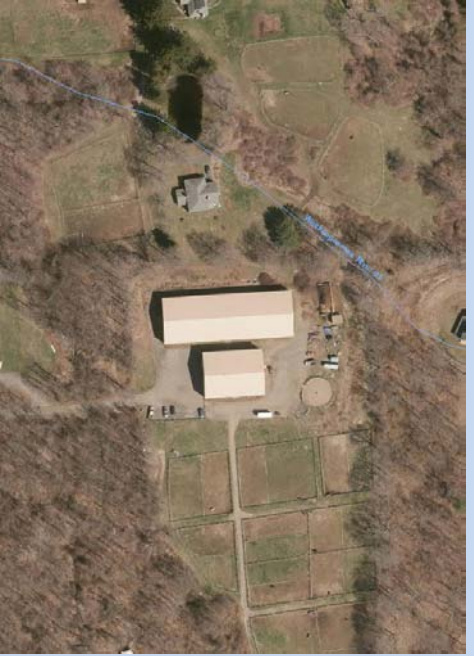
New Site ID (Impaired Segment)	Location Description	Bacteria Sources	Potential Best Management Practices (BMPs)	Other Recommendations and Notes	Relative BMP Pollutant (Bacteria) Removal	Relative Cost	Maintenance Requirements	Field Visit Conducted	BMP Concept Development	Photo
Equestrian 6	east of Todd Hill Road, south of Bergman Hill Road, Bethlehem	Manure storage	<ul style="list-style-type: none"> Encourage effective manure management 	<ul style="list-style-type: none"> Evaluate manure storage Outreach for manure management best practices 				No

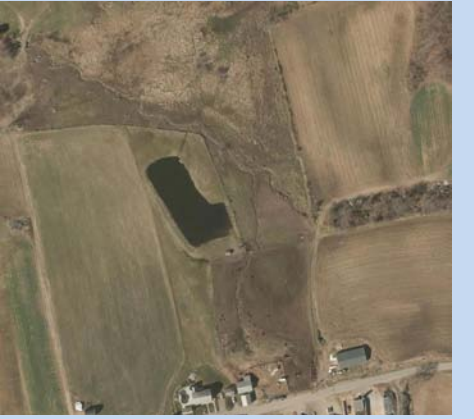
Dairy Farm 2	Artillery Road, Woodbury	Livestock access to tributary. Incomplete coverage of manure storage.	<ul style="list-style-type: none"> Filter berms or fencing and increased buffer around stream to prevent livestock access Reconfigure manure composting to divert runoff away from catch basins Consider covered manure storage or manure composting 		High	Medium	Low	Yes

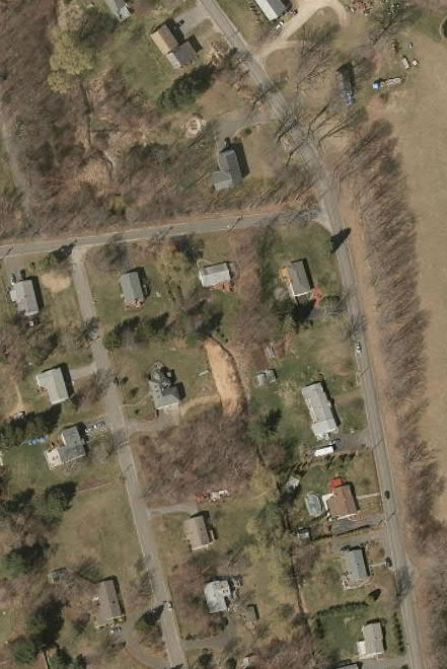
New Site ID (Impaired Segment)	Location Description	Bacteria Sources	Potential Best Management Practices (BMPs)	Other Recommendations and Notes	Relative BMP Pollutant (Bacteria) Removal	Relative Cost	Maintenance Requirements	Field Visit Conducted	BMP Concept Development	Photo
Residential Neighborhood 7	Quassapaug Road at Soucy Road, Woodbury	Impacts to wetland areas Historic (chronic) septic failures	<ul style="list-style-type: none"> • Ensure wetland limits have been respected • Septic inspections 					No

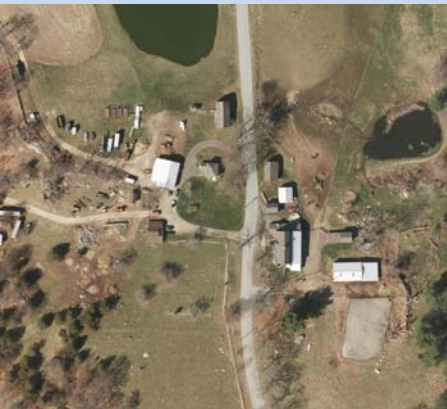
Livestock 4	Hard Hill Road South, approximately 1/4 mile north of intersection with Nonnewaug Road, Bethlehem	Livestock paddock near farm pond Possible junkyard	<ul style="list-style-type: none"> • Encourage adequate buffer to water body • Ensure proper waste storage and disposal 					No

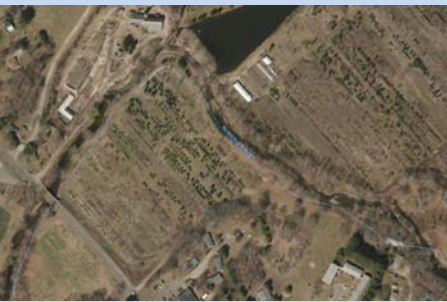
Plant Nursery 1	North of Washington Road (Route 47 Bridge), Woodbury	Fertilizer and pesticide applications	<ul style="list-style-type: none"> • Encourage effective application (and storage) strategies and timing 					No

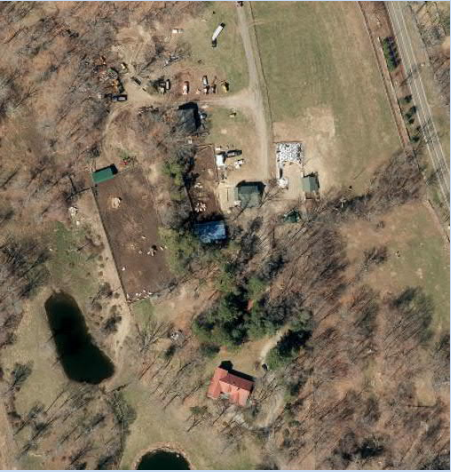
New Site ID (Impaired Segment)	Location Description	Bacteria Sources	Potential Best Management Practices (BMPs)	Other Recommendations and Notes	Relative BMP Pollutant (Bacteria) Removal	Relative Cost	Maintenance Requirements	Field Visit Conducted	BMP Concept Development	Photo
Livestock 7	West side of Flanders Road near intersection with Church Hill Road, Woodbury	Cattle	<ul style="list-style-type: none"> Encourage effective manure management 	<ul style="list-style-type: none"> Outreach for manure management best practices 				No

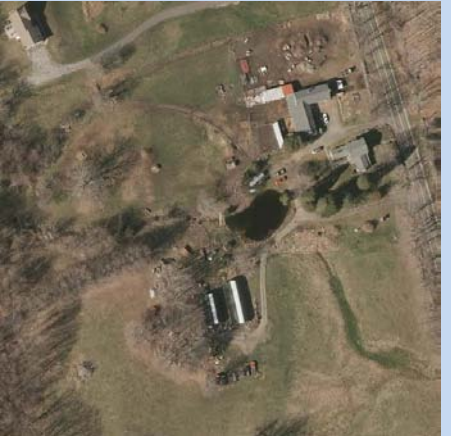
Livestock 6	West side of Flanders Road near intersection with Church Hill Road, Woodbury	Cattle, chickens, pigs, etc	<ul style="list-style-type: none"> Encourage effective manure management 	<ul style="list-style-type: none"> Outreach for manure management best practices 				No

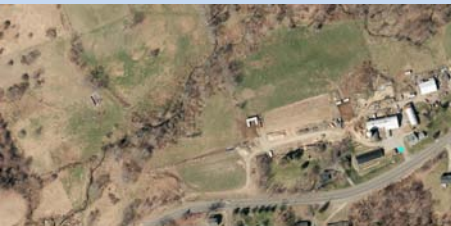
Livestock 5	Route 6 near Guernseytown Road on the Woodbury/Watertown townline	Cattle, chickens, pigs, etc	<ul style="list-style-type: none"> Encourage effective manure management 	<ul style="list-style-type: none"> Outreach for manure management best practices 				No

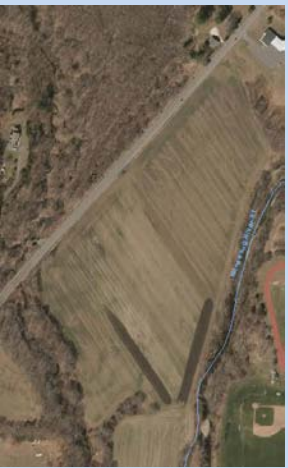
Cropland 3	East of Main Street North (Route 6), north of Scratchville Road along Nonnewaug River	Cornfield – application of manure as fertilizer	<ul style="list-style-type: none"> Encourage effective application strategies and timing Enhance width of riparian buffer 					No

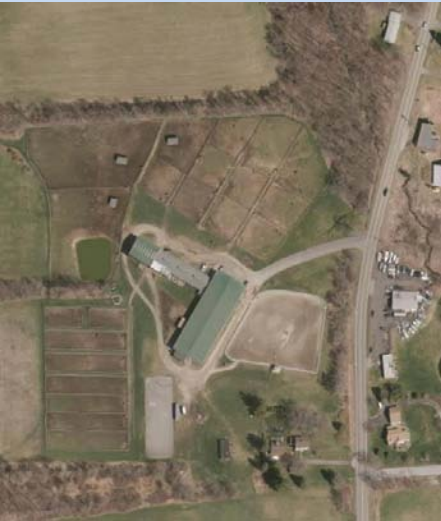
New Site ID (Impaired Segment)	Location Description	Bacteria Sources	Potential Best Management Practices (BMPs)	Other Recommendations and Notes	Relative BMP Pollutant (Bacteria) Removal	Relative Cost	Maintenance Requirements	Field Visit Conducted	BMP Concept Development	Photo
EAST SPRING BROOK SUBWATERSHED										
Equestrian 7	Route 61, Morris north of fairgrounds	Manure storage	<ul style="list-style-type: none"> Increase buffer to stream 	<ul style="list-style-type: none"> Manure management measures appear to be in place Outreach for manure management best practices Connecticut Horse Environmental Awareness Program (HEAP) and Connecticut Horse Farm of Environmental Distinction Program 	High	Low	Low	Yes

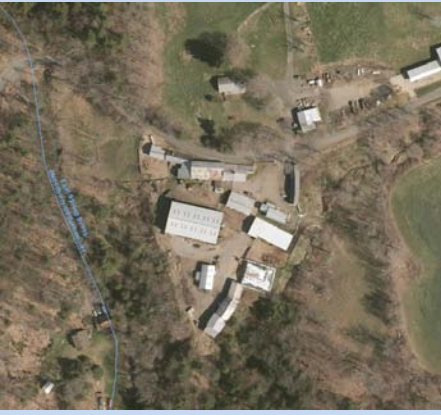
Dairy Farm 3	Magnolia Hill Road and Hard Hill Road South, Bethlehem	Livestock access to tributary. Manure storage	<ul style="list-style-type: none"> Filter berms or fencing and increased buffer around stream to prevent livestock access Evaluate manure storage practices 	<ul style="list-style-type: none"> Outreach for manure management best practices 				No

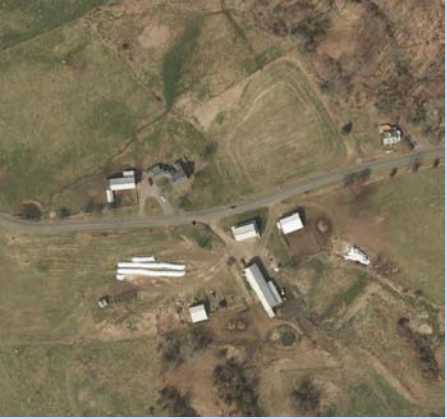
New Site ID (Impaired Segment)	Location Description	Bacteria Sources	Potential Best Management Practices (BMPs)	Other Recommendations and Notes	Relative BMP Pollutant (Bacteria) Removal	Relative Cost	Maintenance Requirements	Field Visit Conducted	BMP Concept Development	Photo
Dairy Farm 4	Spruce Brook Road, Southbury	Manure storage	<ul style="list-style-type: none"> Encourage effective manure management 	<ul style="list-style-type: none"> Outreach for manure management best practices 				No

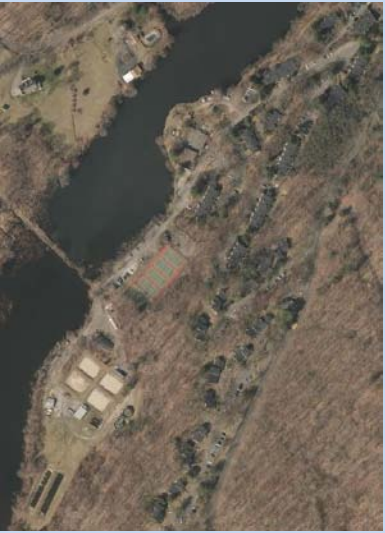
HESSEKEY BROOK SUBWATERSHED										
Residential Complex 4	Transylvania Road & Woodlake Road	Private sewage treatment plant	<ul style="list-style-type: none"> Ensure correct sizing and effective monitoring for failures 					No
