POMPERAUG RIVER WATERSHED BASED PLAN ADDENDUM

*Updated Existing Conditions Report (through 2022)
& Reprioritized Best Management Practices
Implementation Strategy*

Prepared by Pomperaug River Watershed Coalition

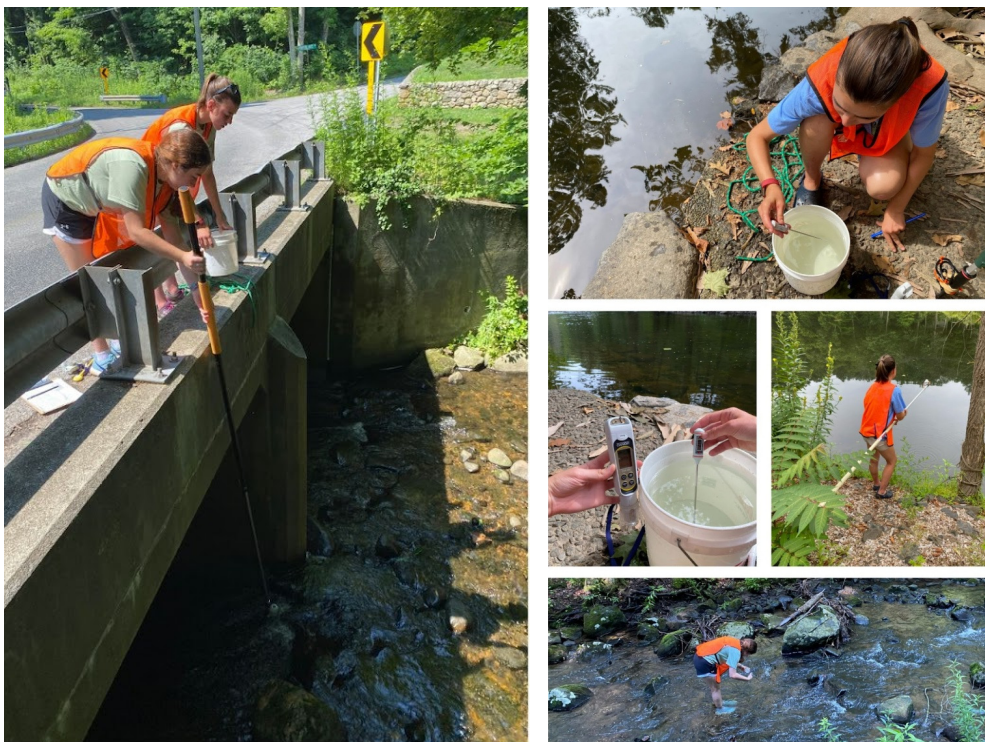
Figure 2-1. PRWC’s field technicians collected ambient water quality monitoring samples at fixed stations located throughout the Pomperaug Watershed between 2019 and 2022.

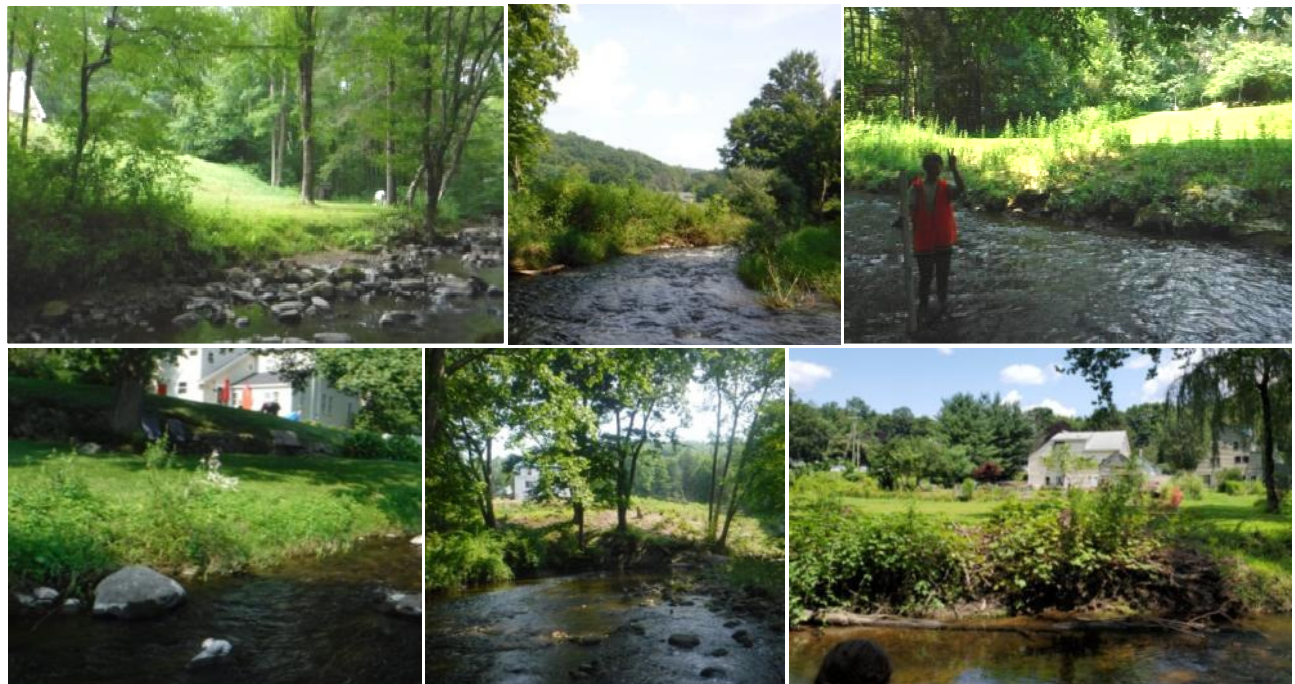
- **Lack of Stream Buffer** – Stream buffer encroachments were prevalent along the Weekeepeemee River and are most often associated with residential and agricultural properties. Residential lawns and some agricultural practices extend down to the banks of the stream in many areas (**Figure 2-10**). The degree of stream buffer encroachment can have a significant impact on the overall stream and habitat conditions. In general, larger natural buffers are associated with better stream health, including channel substrate, flow regime, water quality, and shading as well as better upland and wetland habitat that provide larger areas available to native flora and fauna.

Figure 2-10. Examples of residential and agricultural sites where there are opportunities for riparian buffer restoration. A healthy riparian buffer should consist of vegetation that includes trees, shrubs, and perennial ground cover to provide stream shade, soil stability, stormwater infiltration, and habitat and food for a variety of organisms including dragonflies, frogs, turtles, birds, and mammals.

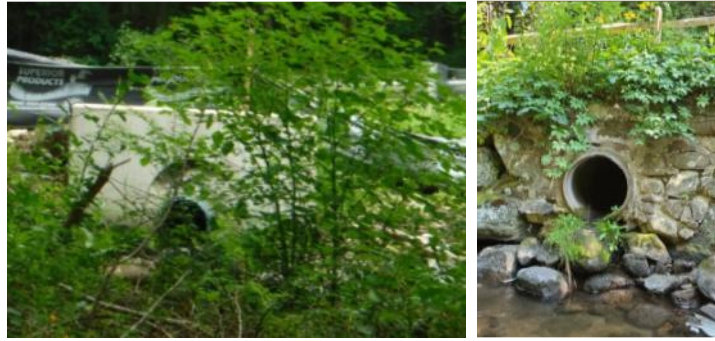
Figure 2-12. Examples of stormwater outfalls that discharge water in catch basins located on roadways and other impervious surfaces; their associated network of drainage pipes discharge stormwater away from the roadway and onto the ground or into a nearby river /stream.

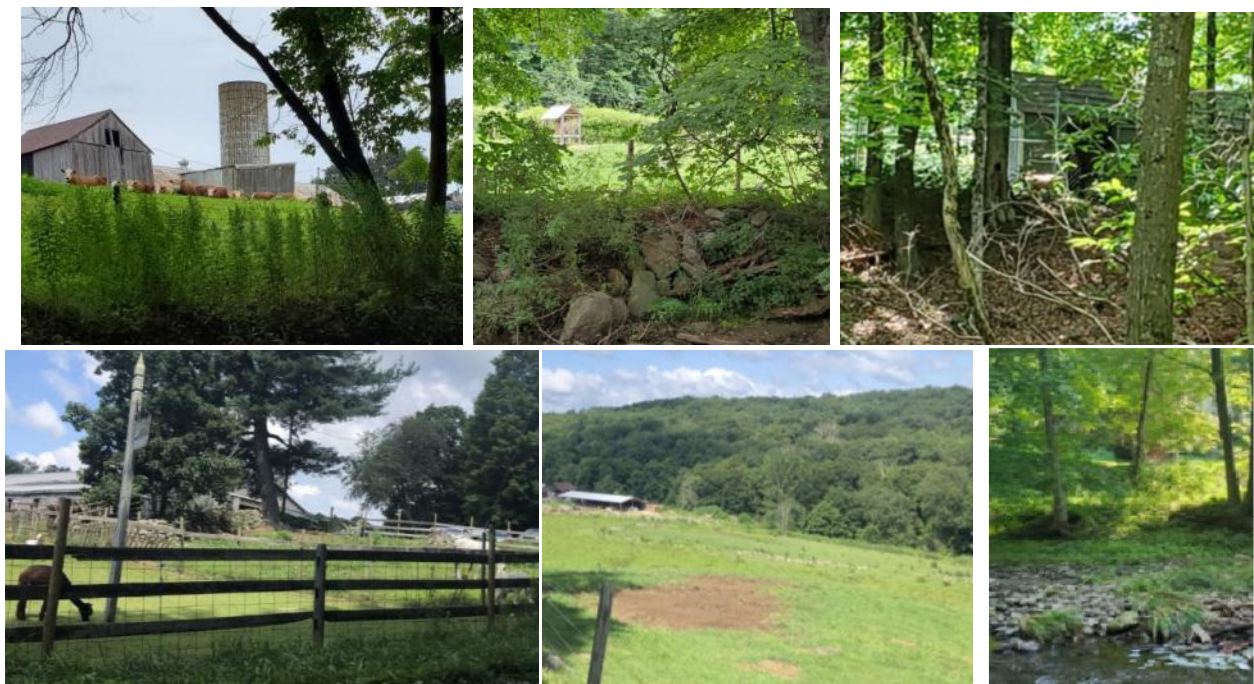
- Agricultural Land Use** – Hobby farms, equestrian centers, and more intensive livestock farming practices were frequently observed in the Weekepeemee watershed. While some farms maintain animal exclusion fencing to separate livestock from streams, other locations have grazing or feeding areas with apparent channelization or full access to streams and discharges to streams. Exclusion fencing, alternative approaches to manure management, such as moving manure piles further away from streams, and other agricultural BMPs can yield water quality improvements (**Figure 2-13**). Crop production is also common in the Weekepeemee watershed; manure-based fertilizers may be used in these areas along with other soil amendments and pest controls. Additional best practices may be suitable in for nutrient and pest management and prevention of soil erosion in these areas including the establishment and maintenance of riparian buffers.

Figure 2-13. Examples of hobby farms and commercial agricultural operations in the Weekepeemee Watershed. Goats, alpaca, cattle, and chickens are common types of livestock present. Crop production is also common in this watershed. Best management practices for these properties include increased livestock fencing setback distances, manure management and storage practices, and riparian buffer restoration and maintenance.

In general, agricultural best practices include implementing and maintaining riparian buffers as one design element for mitigating bacteria pollution. Other elements include installing and maintaining livestock fencing, adopting rotational grazing practices, and storing manure in flat areas away from wetlands and water courses. Among the agricultural operations located along the Weekeepemee River where there are opportunities to implement best management practices, two areas already had BMP recommendations and conceptual designs previously included in the Watershed Based Plan. Conceptual designs for one of the operations are still on point and will continue to be a high priority site for BMP implementation. The other site that had been included in the WBP actually consists of at least two and perhaps three separate operations, which means the BMP recommendations should be broken out as individual sites and updated based on new observations and reflect that some BMPs have already been implemented. The new area for which BMPs are being recommended may consist of two separate agricultural operations based on separate ownership of the parcels; however, it could be one operator leasing both properties. For now, the BMP recommendations will be presented on the assumption that there are two separate operations adjacent to each other. Conceptual plans for each of these agricultural land use areas are included in **Section 3** of this document.

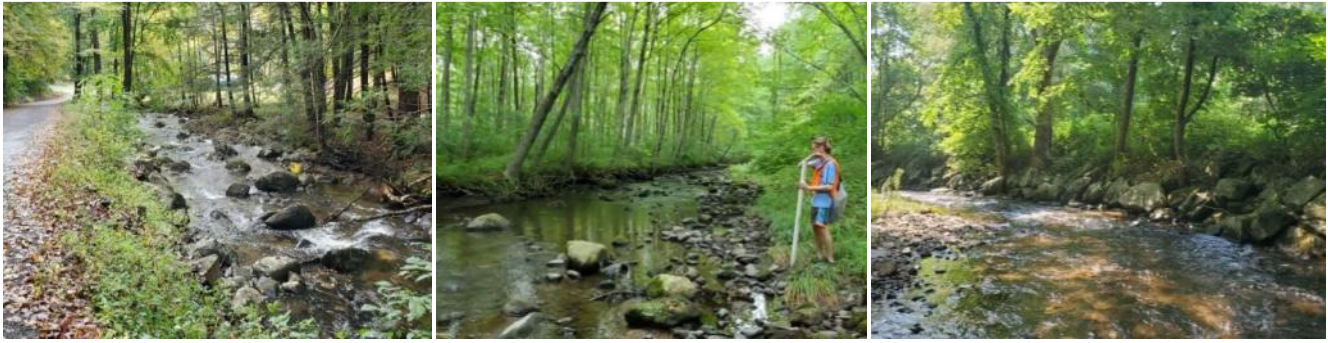
- Channelization** – Historic realignment of stream channels was not uncommon throughout the Pomperaug Watershed (**Figure 2-14**). Many areas were straightened and/or had berms built up along the streambank prior to the adoption of wetlands and watercourses regulations in order to develop transportation routes, commercial areas, neighborhoods, to make agricultural areas easier to cultivate, and to provide faster drainage of water from roads, fields, driveways, and parking lots to help prevent flooding. These practices often result in the river becoming cut off from its floodplain, stream velocity increasing, and river banks/beds eroding which can significantly alter in-stream habitat for aquatic life and exacerbate downstream flooding. Such channelization was observed in several areas along the length of the Weekepeemee River, many of which coincided with observations of streambank erosion. Restoring channelized section to more natural, meandering paths face many challenges including physical infrastructure and obtaining agreements among multiple property owners. While challenging and costly to restore some of these areas, there are opportunities that could support a healthier fishery and enhance recreational opportunities (example: Site Code R01-CM-01). These efforts are low priority restoration actions through the lens of addressing bacteria related impairments.

Figure 2-14. Examples of channel modification where portions of the Weekeepemee River had been straightened at some point in its history; typically in areas adjacent to agricultural fields and transportation routes.

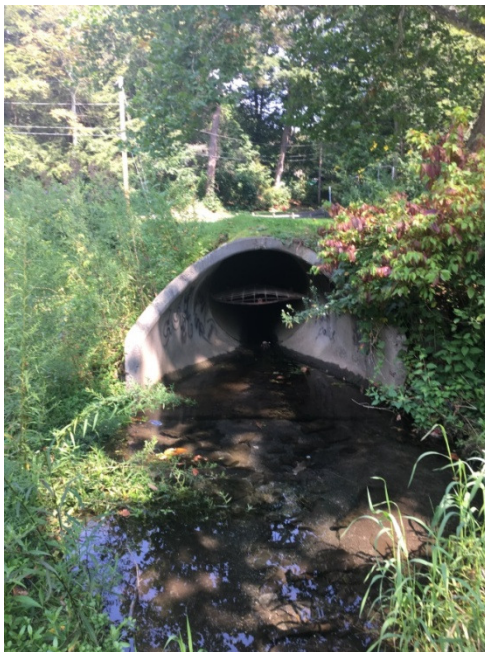
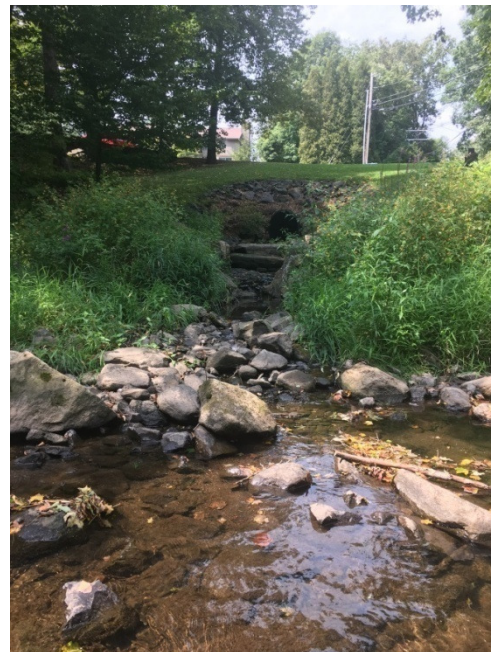
Figure 2-15: Examples of stormwater outfalls that discharge to impaired segments of the Pomperaug River in Southbury, CT. *(Photos by Fuss & O’Neill, Inc.)*

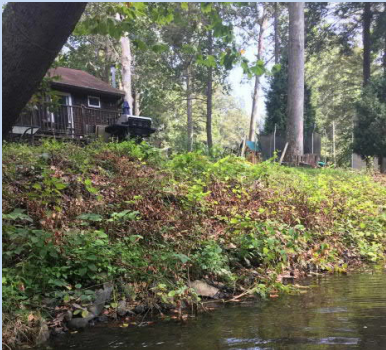
Residential Neighborhood 1 <i>Berkshire Estates</i> (Pomperaug-01)	Western side of Pomperaug River outlet to the Housatonic, North of River Road	Stormwater runoff	<ul style="list-style-type: none"> • Infiltration below roadway, especially cul-de-sac at Pascoe Drive and Pomperaug Trail and at Pascoe Drive and Berkshire Road intersection • Increase buffer along river • More frequent catch basin cleaning 		High	High	High	Yes (WBP)	LOW PRIORITY Great site to achieve DCIA goals in Southbury	See Page 98 Pomperaug Watershed Based Plan

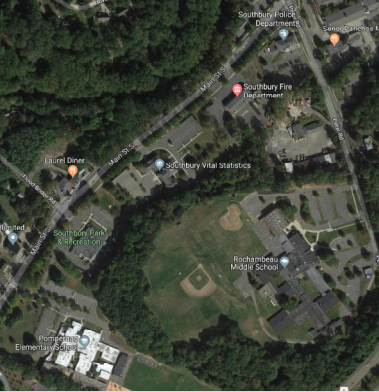
Health Care 2 (tributary to Pomperaug-03)	Intersection of Main Street South and Garage Road	Dry weather discharge (pavement stained)	<ul style="list-style-type: none"> Follow up sampling of dry weather discharge and removal of any illicit connections found 		Medium	Low	Low	Yes (WBP)	<p>LOW PRIORITY</p> <p>Not a big concern based on MS4 data for outfalls in proximity to this site.</p>

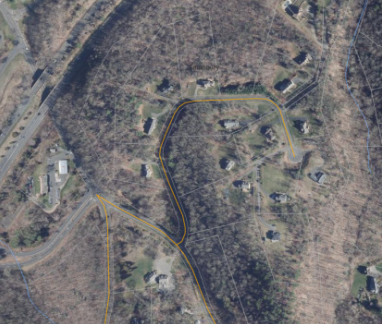
<p>(2019 aerial – NVCOG)</p>

Woodbury School Complex 1 <i>Mitchell Elementary Woodbury</i>	Intersection of School Street and Washington Avenue		<ul style="list-style-type: none"> Biotention and infiltration retrofits to capture runoff from impervious cover areas 	<ul style="list-style-type: none"> Ideal site to achieve DCIA goals in Woodbury 					<p>MID PRIORITY – New project site based on Woodbury DCIA Plan – partially completed with rain garden installation in 2021</p> <p>Conceptual Site Designs Drafted and included in Pomperaug Watershed Based Plan</p>	See Woodbury DCIA Plan
Federal Facility 1 <i>U.S. Post Office, Woodbury</i>	Intersection of Judson Avenue, Washington Avenue, and Main Street South		<ul style="list-style-type: none"> Biotention and infiltration retrofits to capture runoff from impervious cover areas 	<ul style="list-style-type: none"> Ideal site to achieve DCIA goals in Woodbury 					<p>MID PRIORITY – New project site based on Woodbury DCIA Plan</p> <p>Conceptual Site Designs Drafted and included in Pomperaug Watershed Based Plan</p>	See Woodbury DCIA Plan

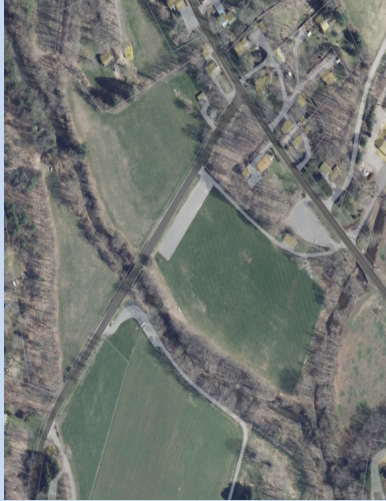
<p>(2019 Aerial – NVCOG)</p>

Residential R1-IB-02 (Weekepeemee-01)	Washington Road near Quassuk Rd	None apparent	<ul style="list-style-type: none"> Recommend planting a shrub layer or establishing a no mow zone. Approximately 200 feet x 15 feet along the river bank available for planting. 	<ul style="list-style-type: none"> Houses are set back from the river approximately 100 feet. Right bank is well vegetated. 	Low	Med	Low	Yes (2021 Streamwalk Weekepeemee)	MEDIUM PRIORITY – new area added based on Streamwalk Assessment One of many sites that illustrates need for community education on attributes and benefits of a healthy riparian buffer is a high priority while site specific implementation is ranked medium priority

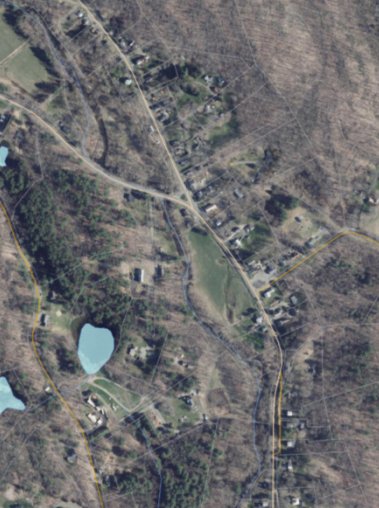
<p>(2019 aerial – NVCOG)</p>

Livestock 1 (Weekepeemee-01) <i>Cattle Farm Upstream of Chohees Trail Bridge</i>	Intersection of Chohees Trail & Weekepeemee Road	Run-off from livestock pasture and feeding paddocks. Livestock access to intermittent stream. Row crops.	<ul style="list-style-type: none"> Filter berms along pasture and Weekepeemee Increased vegetated buffer width Infiltration BMP on north farm next to road Remove stream access through buffer and/or fencing 	<ul style="list-style-type: none"> Fencing in good repair, encourage maintenance Encourage effective manure application (e.g., not before rain storm) Encourage development of Comprehensive Nutrient Management Plan if one does not already exist. 	High	Medium	Low	Yes (WBP & (2021 Streamwalk Weekepeemee)	<p>HIGH PRIORITY</p> <p>Conceptual Site Designs Drafted and included in Pomperaug Watershed Based Plan</p> <p>Update conceptual plan to reflect cropland is a separate operation from livestock production</p>	See Page 123 Pomperaug Watershed Based Plan

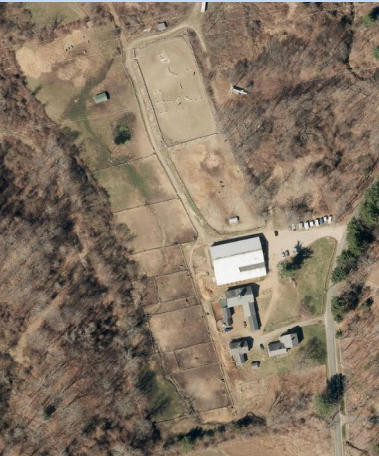
<p>(2016 aerial)</p>

Equestrian 5 (Weekepeemee-01) <i>Another Farm</i>	Weekepeemee Road Woodbury, just south of the Bethlehem town line	Livestock (horses, goats, alpaca) manure	<ul style="list-style-type: none"> Filter berms along intermittent stream Increase buffer width 	<ul style="list-style-type: none"> Fencing in good repair, encourage maintenance Outreach for manure management best practices Operation not immediately adjacent to impaired reach, but tributary to Weekepeemee flows through the along / through the farm property. Encourage development of Comprehensive Nutrient Management Plan if one does not already exist. 	High	Medium	Low	Yes (WBP)	<p>MID PRIORITY</p> <p>Encourage development of Comprehensive Nutrient Management Plan if one does not already exist.</p>

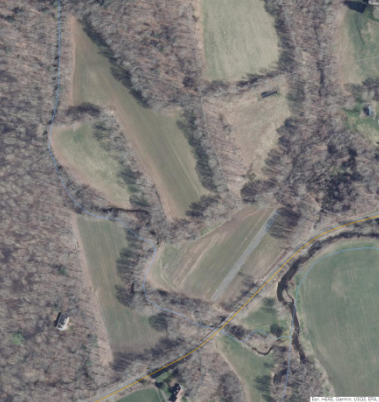
<p>(2019 aerial – NVCOG)</p>

Residential R3-IB-04 (Weekepeemee-01)	Peter Road at Route 132	None apparent	<ul style="list-style-type: none"> Increase buffer width; older house located very close to the river with minimal yard area which is dominated by lawn. Add tree, shrub, or herbaceous layer to reduce direct sun exposure. 	<ul style="list-style-type: none"> Recommend establishing at least 5 feet of a no-mow zone and/or strategically planting native perennials and shrubs along up to 100 feet of river bank. Small area could be kept clear (mowed) for view and or river access if desired. 	Low	Medium	Medium	Yes (2021 Streamwalk Weekepeemee)	<p>MID PRIORITY – <i>New site based on Streamwalk Assessment</i></p> <p>One of many sites that illustrates need for community education on attributes and benefits of a healthy riparian buffer is a high priority while site specific implementation is ranked medium priority.</p>

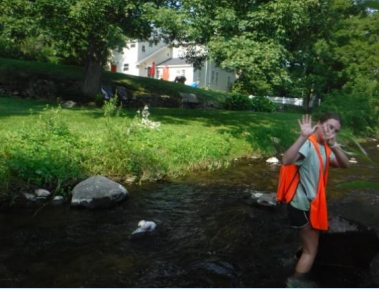
Cropland / Livestock R4-MI-02 (Weekepeemee-01) <i>Weekepeemee River Farm</i>	Weekepeemee Road south of Dowd Brook, north of Brushy Hill Road	Livestock - cattle, sheep, goats, chickens	<ul style="list-style-type: none"> Manure management, livestock fencing, rotational grazing, stream crossings, irrigation, riparian buffer, timing for application of fertilizers / pesticides 	<ul style="list-style-type: none"> At least 2 stream crossings evident from aerial image where vehicles drive through stream Encourage development of Comprehensive Nutrient Management Plan if one does not already exist. 	High	High	Med	No	<p>HIGH PRIORITY – <i>New area assessed based on Streamwalk Assessment</i></p> <p>Develop conceptual BMP design plans for both parcels whether as one operation or two.</p>

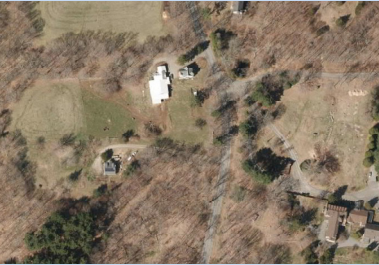
(2016 aerial – NVCOG)

Cropland / Livestock 2 <i>Percy Thomson Meadows</i>	Thomson Road, Bethlehem	Livestock access to tributary	<ul style="list-style-type: none"> Increased buffer and fencing or filter berms 	<ul style="list-style-type: none"> Evaluate manure storage Outreach for manure management best practices Operation is located well away from the main stem of the Weekepeemee River; farm runoff drains to unnamed tributary. 	High	Low	Low	Yes (WBP)	<p>LOW PRIORITY – PARTIALLY COMPLETED</p> <p>Spoke with one of the operators in 2018 and learned livestock fencing had been installed to keep animals away from river and alternate water supply near barn was established with funding through NRCS EQIP grant program.</p>	See Page 124 Pomperaug Watershed Based Plan
Livestock 2 <i>Abbey of Regina Laudis</i>	Robert Leather Road, Bethlehem	<p>Convent with active farm operation. Past grant recipient for cattle management to get cows out of a wetland area.</p> <p>Variety of livestock present – sheep; goats; cattle; chickens</p>	<ul style="list-style-type: none"> Encourage effective manure management 	<ul style="list-style-type: none"> Evaluate manure storage Encourage development of Comprehensive Nutrient Management Plan if one does not already exist for this site. Not located immediately adjacent to Weekepeemee River Operation is located well away from the main stem of the Weekepeemee River; farm runoff drains to unnamed tributary. 				Yes (WBP)	<p>LOW PRIORITY</p> <p>Encourage development of Comprehensive Nutrient Management Plan if one does not already exist for this site.</p>

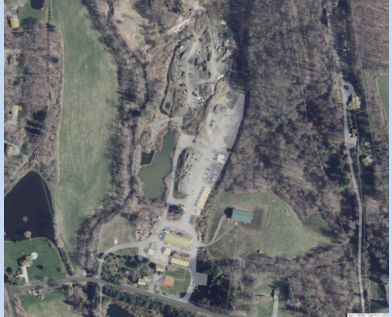
<p>(2019 aerial – NVCOG)</p>

Residential R6-IB-02 (Weekepeemee-01)	Arrowhead Lane	None apparent Possible pet waste and wildlife	<ul style="list-style-type: none"> Increase buffer width Pool chemical storage and discharge best practices 	<ul style="list-style-type: none"> Recommend planting native trees, shrubs, perennials to create at least a 15 foot wide riparian buffer along the 125 feet of streambank. 	Medium	Med	Low	Yes (2021 Streamwalk Weekepeemee)	<p>MID PRIORITY – <i>New site based on Streamwalk Assessment</i></p> <p>One of many sites that illustrates need for community education on attributes and benefits of a healthy riparian buffer</p>

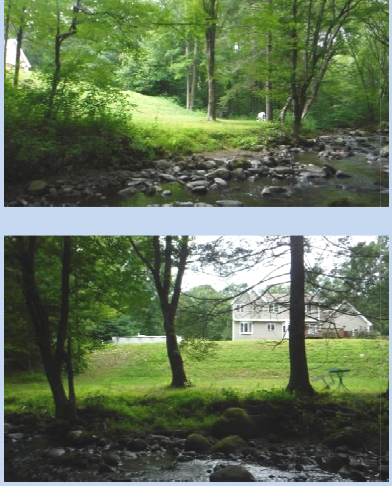
Residential Neighborhood 6	Kasson Grove, Bethlehem	Lake side housing community -- old seasonal camps, many now year round residences	<ul style="list-style-type: none"> Inspect septic system for proper function and sizing 					No	<p>LOW PRIORITY</p> <p>BMP Conceptual Design drafted and included in Pomperaug Watershed Based Plan</p>	See Page ___ Pomperaug Watershed Based Plan

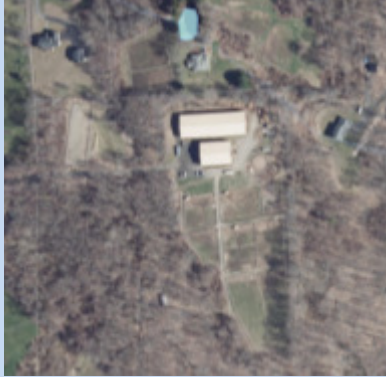
<p>(2019 aerial – NVCOG)</p>

Equestrian 6 (Weekepeemee-01) <i>Windhorse International</i>	East of Todd Hill Road, south of Bergman Hill Road, Bethlehem	Manure storage	<ul style="list-style-type: none"> Encourage effective manure management 	<ul style="list-style-type: none"> Evaluate manure storage Outreach for manure management best practices Ample vegetation along streambank / riparian buffer Encourage development of Comprehensive Nutrient Management Plan if one does not already exist for this site. Ambient water quality monitoring stations had relatively low bacteria counts in the upper watershed area 	High	Medium	Low	No	<p>LOW TO PRIORITY</p> <p>Encourage development of Comprehensive Nutrient Management Plan if one does not already exist for this site.</p>

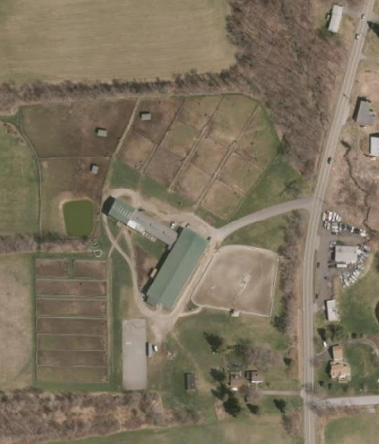
<p>2016 aerial</p>

NONNEWAUG RIVER SUBWATERSHED										
Equestrian 8 <i>Fraizer Farm Equestrian Training Center</i>	Middle Road Turnpike, Woodbury	Horse access to tributary stream	<ul style="list-style-type: none"> Filter berms and/or increased buffer in pasture Reconfigure paddocks to avoid stream 	<ul style="list-style-type: none"> Some buffer exists in parts of pasture land Outreach for manure management best practices Connecticut Horse Environmental Awareness Program (HEAP) and Connecticut Horse Farm of Environmental Distinction Program 	High	Medium	Low	Yes (WBP)	<p>HIGH PRIORITY</p> <p>Conceptual Site Designs Drafted and included in Pomperaug Watershed Based Plan</p>	See Page 129 Pomperaug Watershed Based Plan
Dairy Farm 2 <i>Logue Farm</i>	Artillery Road, Woodbury	Livestock access to tributary. Incomplete coverage of manure storage.	<ul style="list-style-type: none"> Filter berms or fencing and increased buffer around stream to prevent livestock access Reconfigure manure composting to divert runoff away from catch basins Consider covered manure storage or manure composting 	<ul style="list-style-type: none"> Encourage development of Comprehensive Nutrient Management Plan if one does not already exist for this site. Also consider BMPs for properties leased by this operator for corn / feed production. 	High	Medium	Low	Yes (WBP)	<p>HIGH PRIORITY</p> <p>Encourage development of Comprehensive Nutrient Management Plan if one does not already exist for this site. Develop site specific conceptual BMP designs.</p>

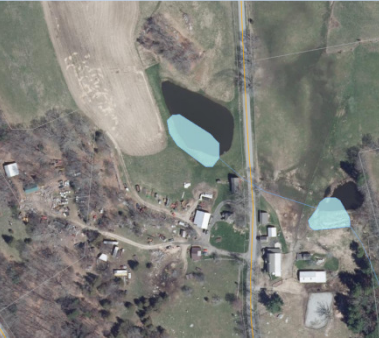
(2019 aerial – NVCOG)
Plant Nursery 1 <i>Young’s Nursery</i>	North of Washington Road (Route 47 Bridge), Woodbury	Fertilizer and pesticide applications	<ul style="list-style-type: none"> Encourage effective application (and storage) strategies and timing Increase riparian buffer width and/or composition 	<ul style="list-style-type: none"> Encourage development of Comprehensive Nutrient Management Plan if one does not already exist for this site. Less potential for bacteria pollution 	Medium			No	MID TO LOW PRIORITY Encourage development of Comprehensive Nutrient Management Plan if one does not already exist for this site.

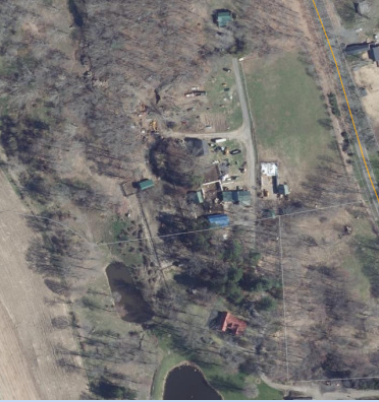
Livestock 6 <i>Geraci Farm</i>	West side of Flanders Road South of Intersection with Brushy Hill Rd, Woodbury	Cattle, chickens, pigs, etc	<ul style="list-style-type: none"> Encourage effective manure management 	<ul style="list-style-type: none"> Outreach for manure management best practices Encourage development of Comprehensive Nutrient Management Plan if one does not already exist for this site. 	High	High	Medium	No	MID TO LOW PRIORITY Need to conduct windshield survey and consider if ranking should shift. Conceptual site designs should be drafted.	  (2019 aerial – NVCOG)
Livestock 5 <i>Young's Longrange Farm</i>	Route 6 near Guernseytown Road on the Woodbury / Watertown townline	Cattle, chickens, pigs, etc	<ul style="list-style-type: none"> Encourage effective manure management Several fields for hay and corn production 	<ul style="list-style-type: none"> Outreach for manure management best practices Encourage development of Comprehensive Nutrient Management Plan if one does not already exist for this site. 	High	High	Medium	No	HIGH PRIORITY Encourage development of Comprehensive Nutrient Management Plan if one does not already exist for this site.

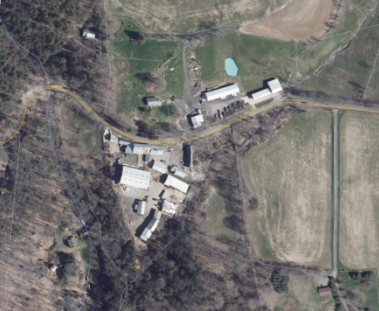
<p>(2019 Aerial NVCOG)</p>

EAST SPRING BROOK SUBWATERSHED										
Fish Hatchery 1	Nonnewaug Road, Bethlehem	Nutrients	<ul style="list-style-type: none"> If still active, encourage effective waste management, possibly through multi-trophic aquaculture 					No	LOW PRIORITY	N/A
Dairy Farm 3 <i>Devil’s Backbone Farm</i>	Magnolia Hill Road and Hard Hill Road South, Bethlehem	Livestock access to tributary. Manure storage	<ul style="list-style-type: none"> Filter berms or fencing and increased buffer around stream to prevent livestock access Increase buffer width Evaluate manure storage and spreading practices 	<ul style="list-style-type: none"> Outreach for manure management best practices Encourage development of Comprehensive Nutrient Management Plans if not already in place 				No	<p>MID PRIORITY</p> <p>Need to conduct windshield survey and consider if ranking should shift. Draft conceptual BMP site designs.</p>

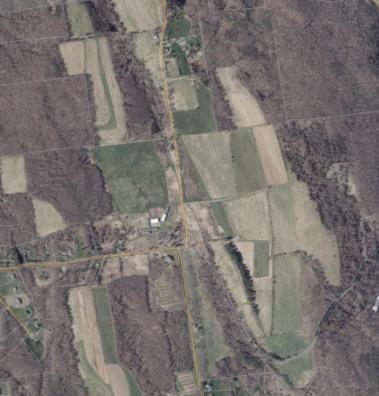
<p>(2019 aerial – NVCOG)</p>

State Facility 2 <i>(Transylvania Brook-01)</i>	Route 172, Southbury north of South Britain Historic District	Waterfowl	<ul style="list-style-type: none"> Establish / increase riparian buffer width to filter runoff from fields where geese graze 	<ul style="list-style-type: none"> Pond infested with water chestnut Dam endured partial breach in 2023. Town working on redevelopment plans for Training School Property – encourage integration of stormwater retrofits for DCIA 				No	<p>LOW PRIORITY – PARTIALLY COMPLETED with native riparian buffer planting installed in 2022.</p> <p>Conceptual Site Designs Drafted and included in Pomperaug Watershed Based Plan.</p> <p>Other recommended BMPs align more with municipal DCIA goals.</p>	See Page 116 Pomperaug Watershed Based Plan
Dairy Farm 4 <i>(Transylvania Brook-01)</i> <i>Platt Dairy Farm</i>	Spruce Brook Road, Southbury	Manure storage	<ul style="list-style-type: none"> Encourage effective manure management Headwaters of Spruce Brook flow through pasture and feeding areas; Spruce Brook is a primary tributary of the impaired section of Transylvania Brook 	<ul style="list-style-type: none"> Outreach for manure management best practices Encourage development of Comprehensive Nutrient Management Plan if one does not already exist for this site. 				No	<p>HIGH TO MID PRIORITY</p> <p>Need to conduct windshield survey and consider if ranking should shift and if conceptual site designs should be drafted. Encourage Comprehensive Nutrient Management Plan if one does not already exist.</p>

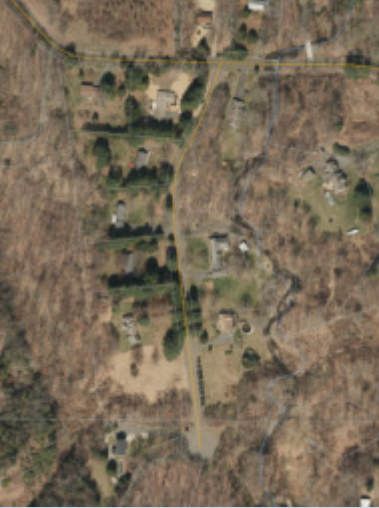
<p>(2016 aerial – NVCOG)</p>

HESSEKEY BROOK SUBWATERSHED										
Residential Complex 4 <i>Wood Lake Tax District</i>	Transylvania Road & Woodlake Road	Private sewage treatment plant Municipal Stormwater Runoff	<ul style="list-style-type: none"> Ensure correct sizing and effective monitoring for failures Illicit Discharge Detection and Elimination Sewage treatment plant upgrades for nitrogen and phosphorus removal 	<ul style="list-style-type: none"> Municipal stormwater outfalls in this neighborhood with high indicator bacteria levels. Increasing algae blooms in the lake/pond and presence of invasive aquatic plants (fanwort, water chestnut confirmed upstream in Transylvania Pond) 	High	Low	Low	No	<p>HIGH PRIORITY – <i>Elevated concern based on MS4 data</i></p> <p>Conduct neighborhood assessment survey to evaluate potential sources of pollution and BMP opportunities and draft conceptual site designs as needed. Explore funding opportunities for upgrading wastewater treatment system. Review wastewater discharge data for permit compliance.</p>

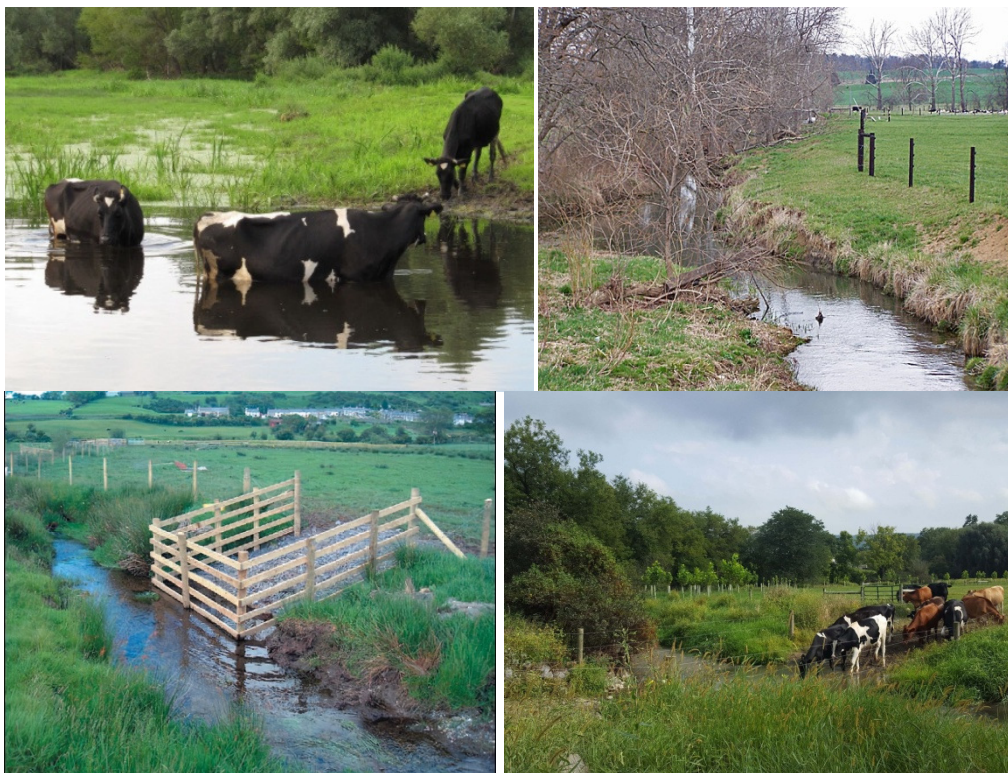
Figure 3-3. Examples of temporary and permanent exclusionary fencing.

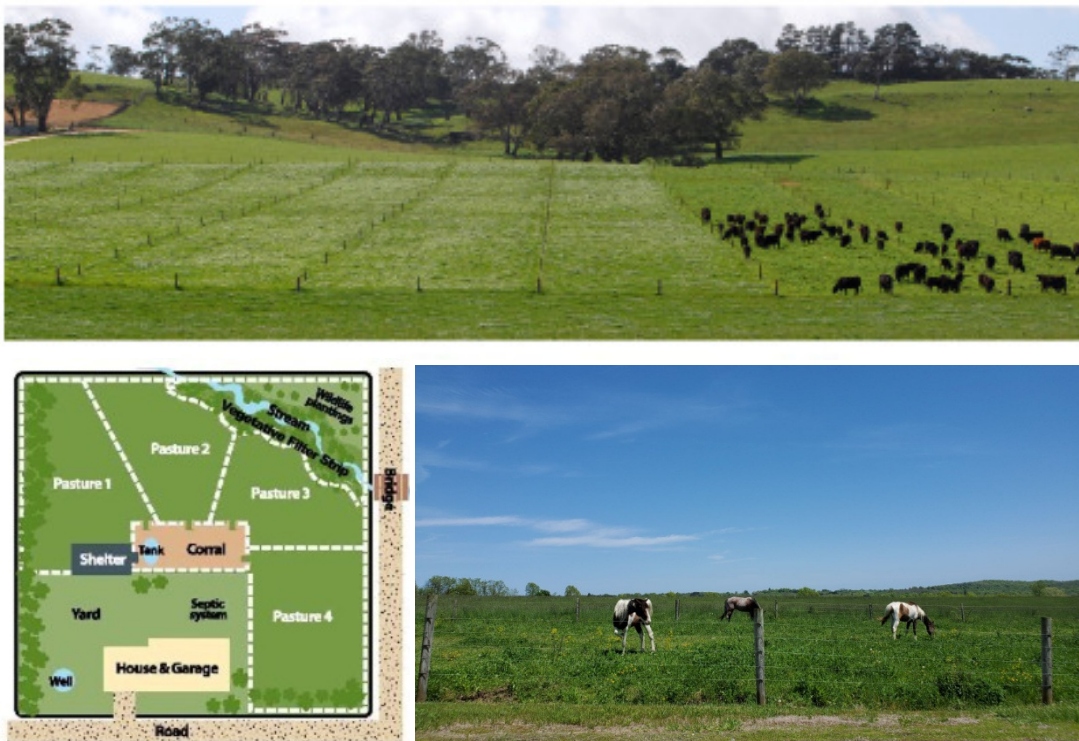
Figure 3-4. Examples of rotational pasturing practices.

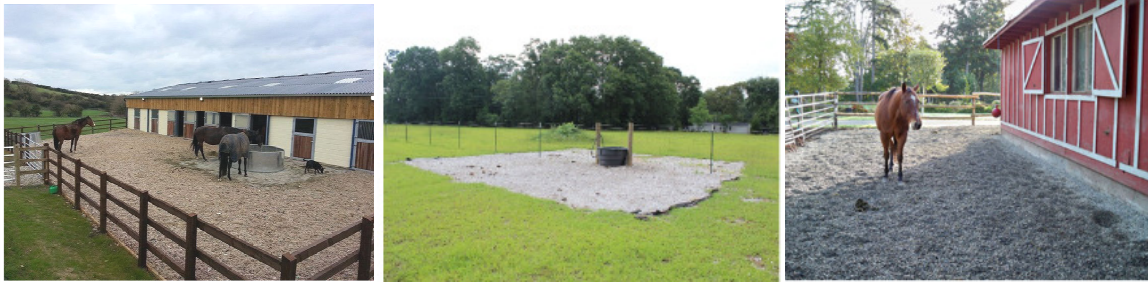
Figure 3-5. Examples of sacrifice and heavy use areas.

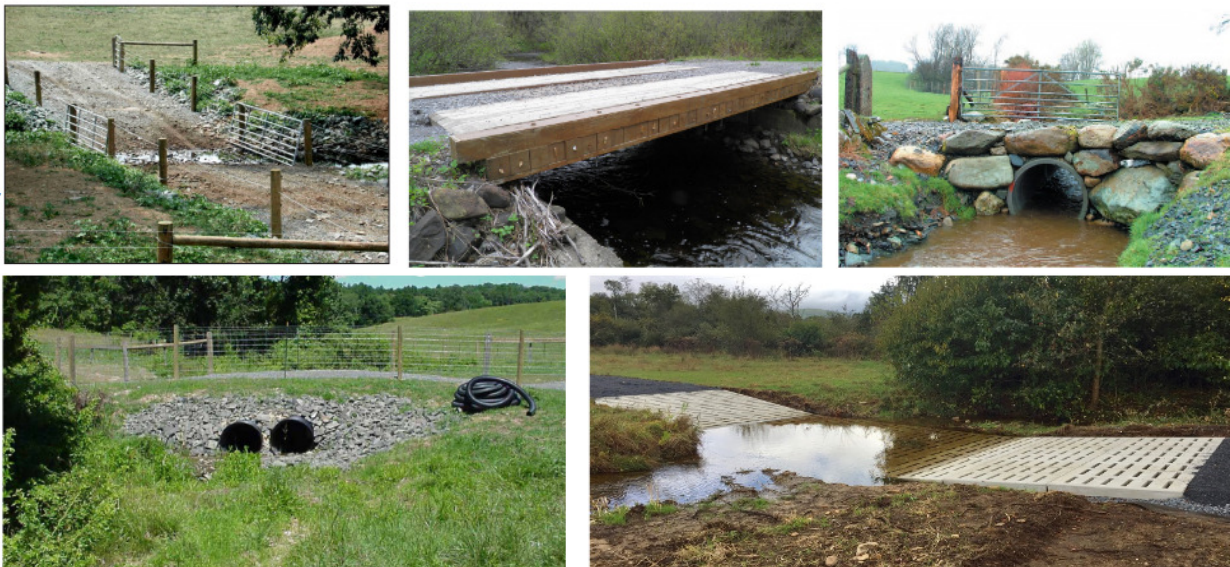
Figure 3-6. Examples of stream crossing structures.

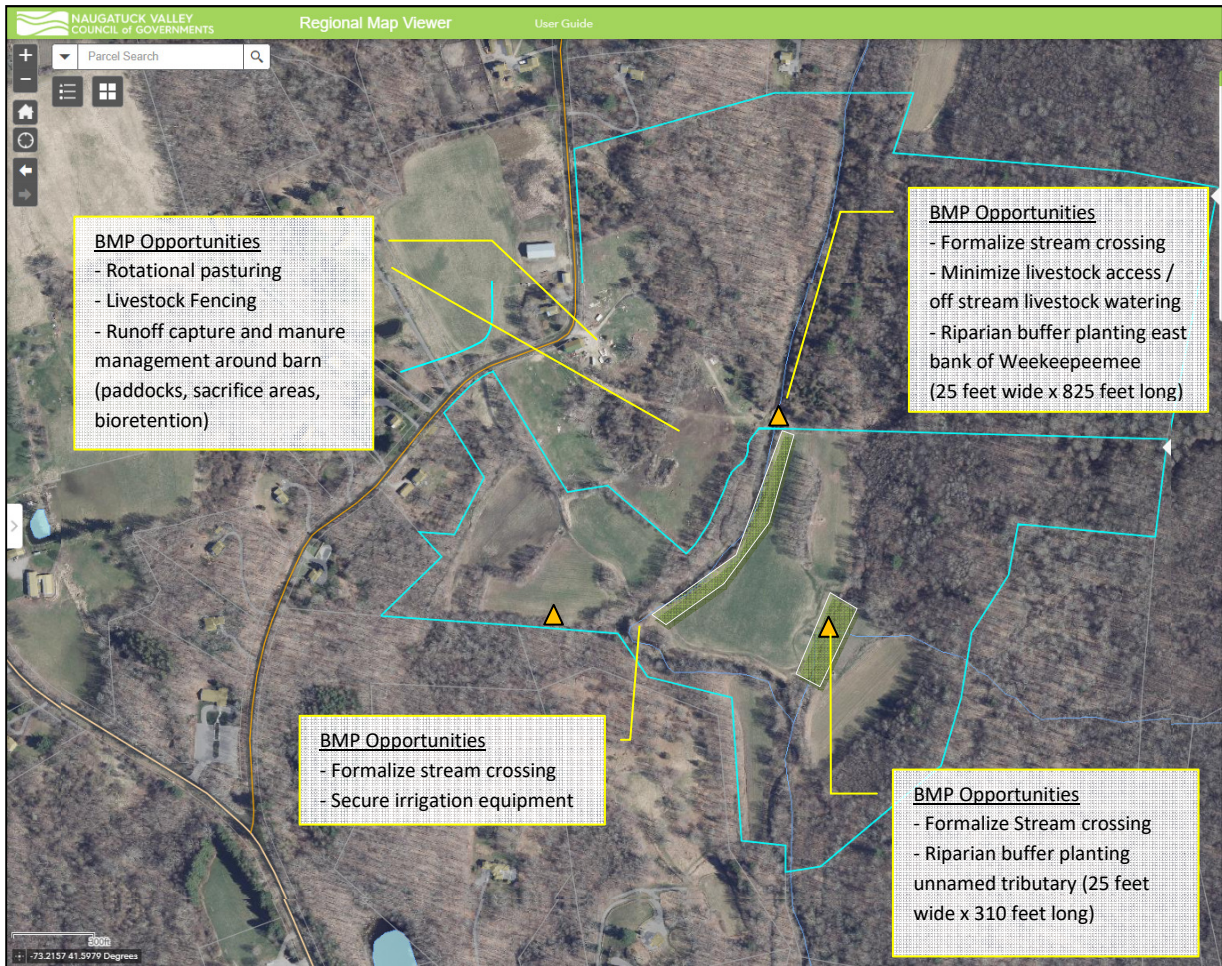
Figure 3-7. BMP Concepts for Agriculture / Livestock (R4-MI-02)

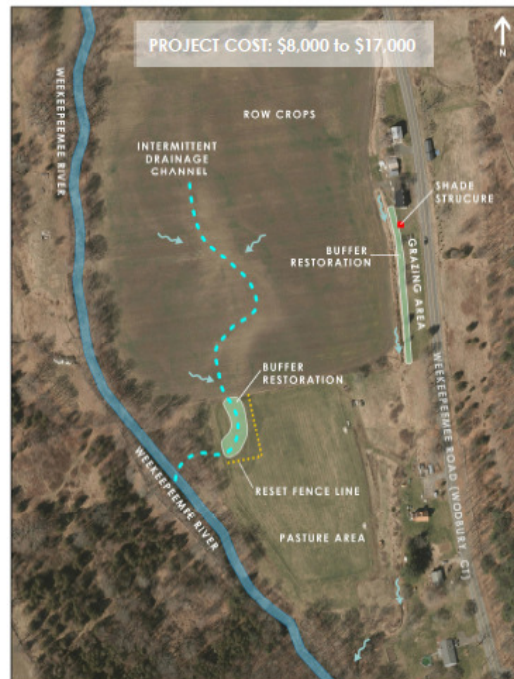
Figure 3-8. BMP Concepts for Livestock 1 as presented in the Pomperaug Watershed Based Plan.
