Town of Bethlehem

Road-Stream Crossing Assessment Inventory

Prepared by:
Pomperaug River Watershed Coalition
2025

August 2025

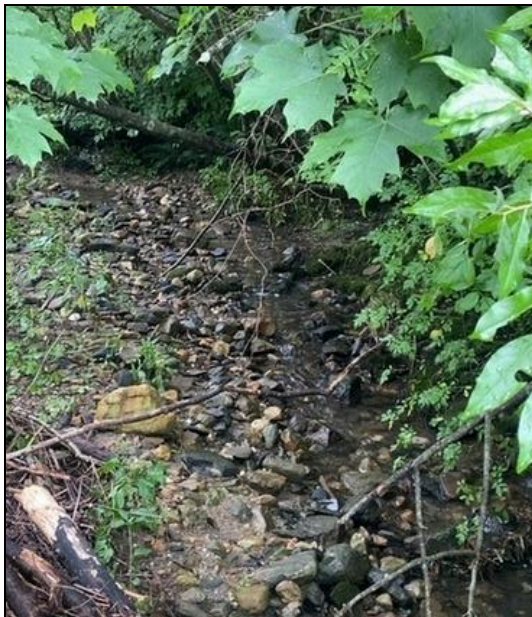
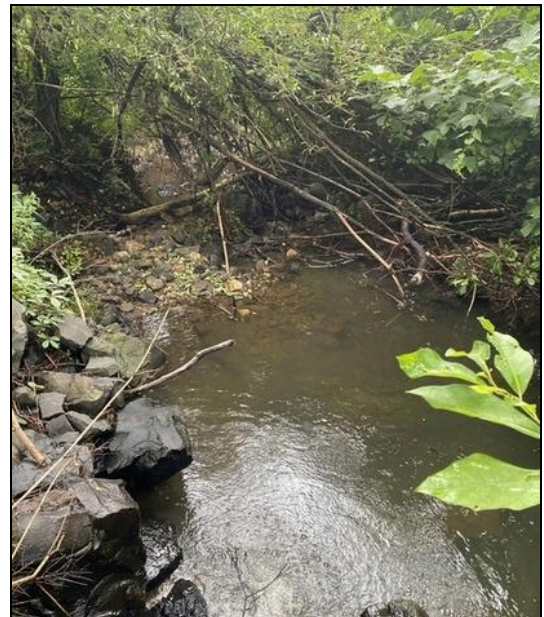
- Moderate debris accumulation at inlet
- Outlet grade (cascade) has caused a 3ft-deep scour pool at outlet
- Culvert is made of thin grey plastic
- No substrate inside the structure
- No dry passage

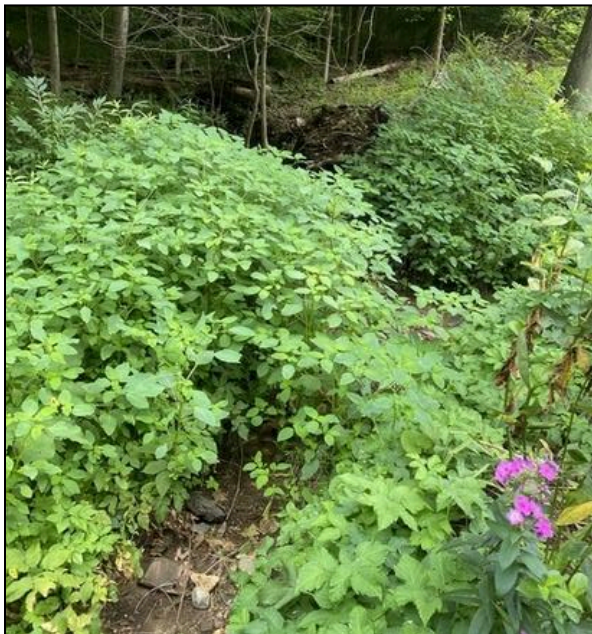
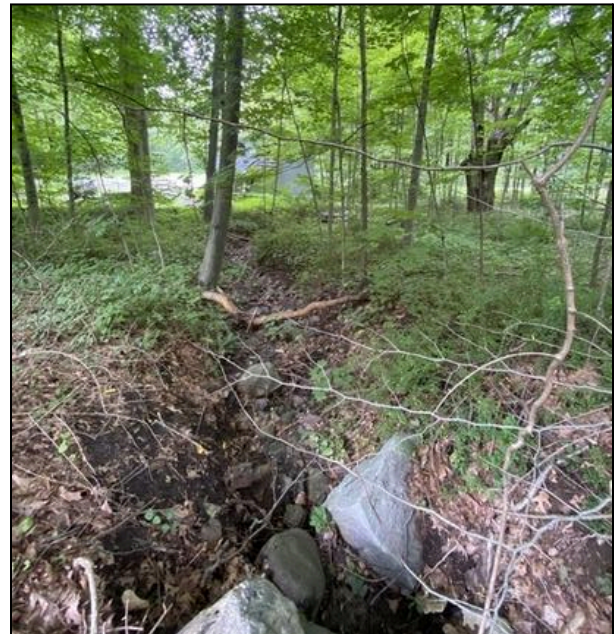
- “Puzzle piece” shaped inlet is much smaller than outlet
- Large inlet drop into culvert
- Appears a new, smaller inlet may have been built in front of existing culvert inlet to accommodate catch basin system
- 5ft drop (cascade) from outlet to water surface
- Stream was dry at the time of assessment
- No dry passage if stream was flowing
- Extensive armoring needed because of cascade outlet grade to prevent scour

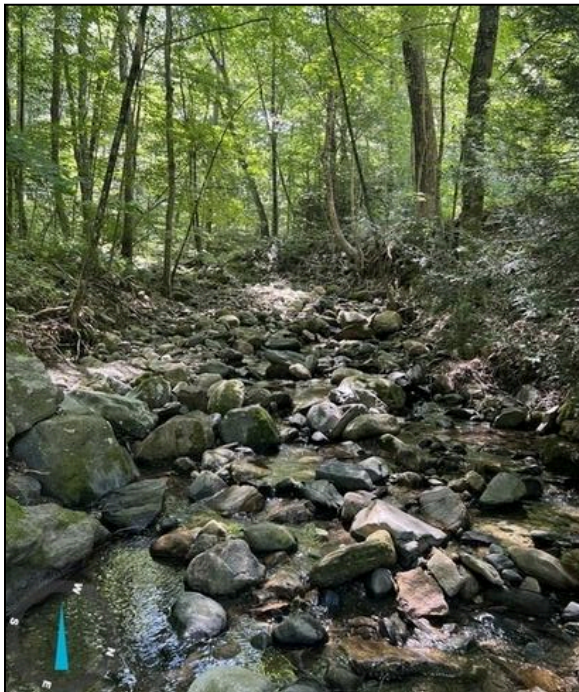
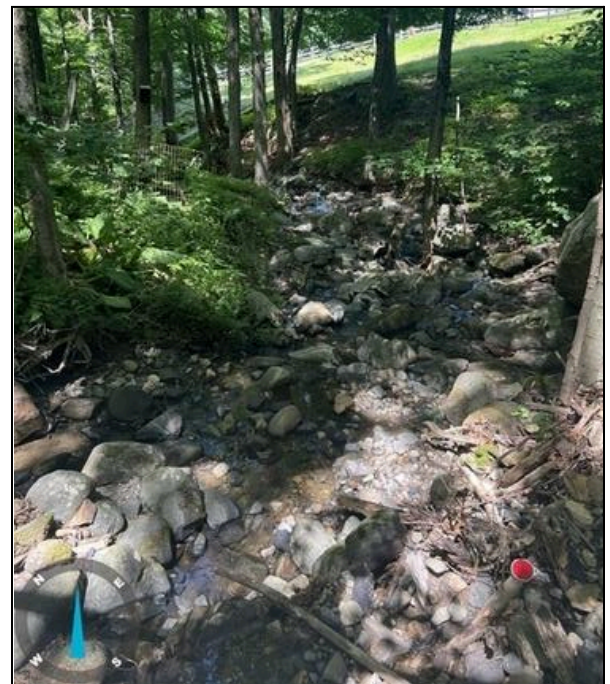
- Cracking of culvert segments inside structure
- 4.8ft drop from outlet to water surface
- Extensive armoring at outlet to mitigate scour
- Inlet is fed by 2 streams, both have skewed alignment relative to inlet
- Erosion of headwall around culvert at inlet
- Overgrown thorny vegetation and minor debris buildup at inlet
- No dry passage through structure

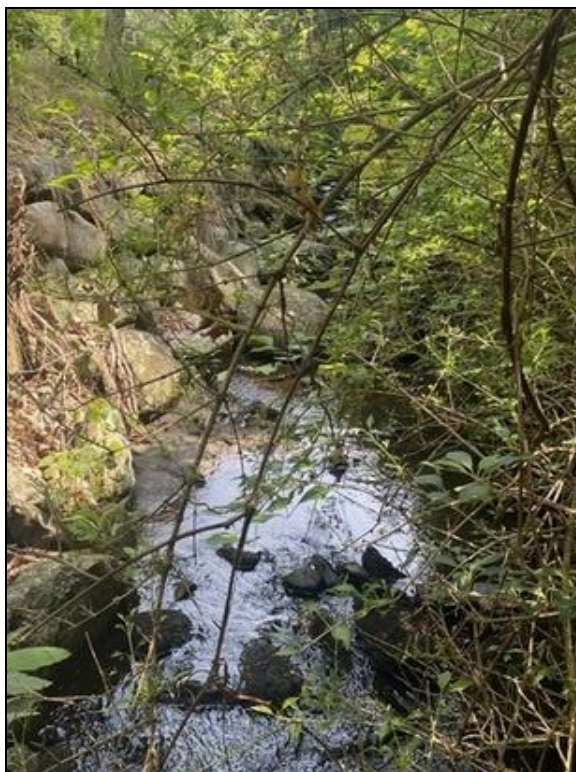
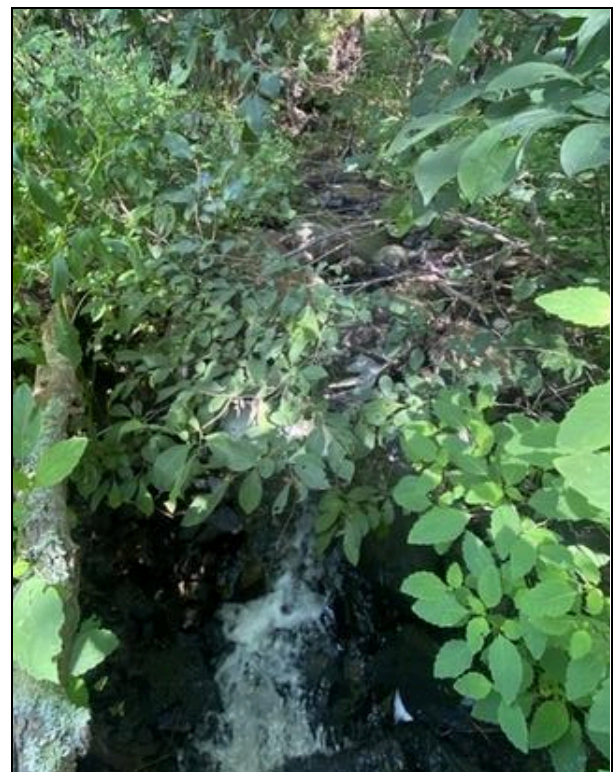
- Severe constriction
- Outlet grade (free fall onto cascade) has contributed to the formation of a small scour pool at outlet
- No dry passage through structure
- Rubber-lined metal culvert is rusted and eroded
- Outlet is very overgrown
- Skewed alignment

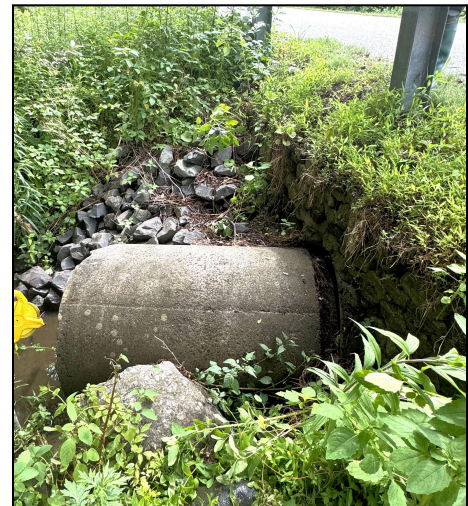
Inlet

- Moderate constriction
- 2.5 ft drop from outlet to water surface
- Large, 1.5ft-deep scour pool at outlet caused by outlet grade (free fall onto cascade)
- No dry passage through structure
- Extensive overgrowth and rip rap at outlet
- Headwall present at inlet but culvert projects
- Culvert segments separating at inlet
- Erosion of culvert inlet, rebar exposed

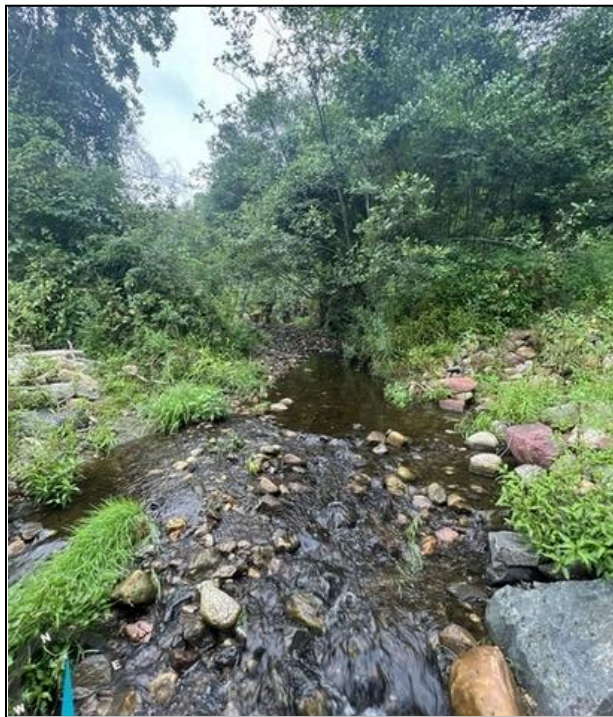
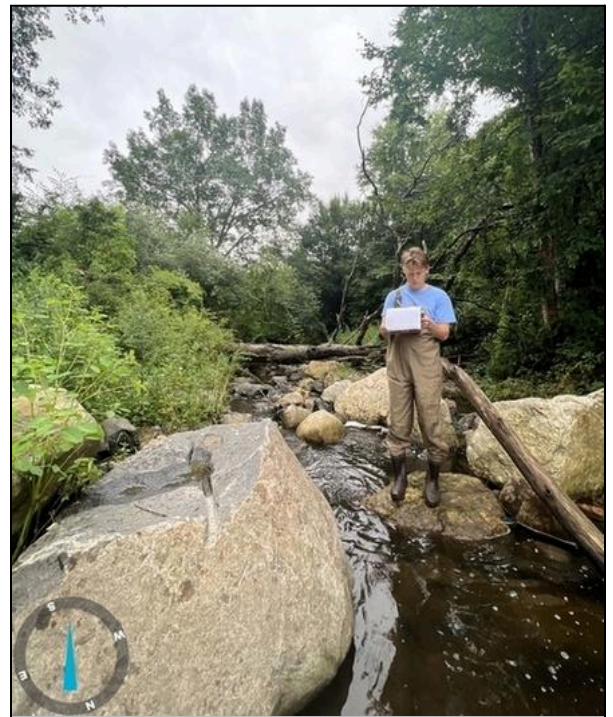
- Moderate constriction
- 2.0 ft drop from outlet to water surface
- Large, 2.5 ft-deep scour pool at outlet caused by outlet grade (free fall onto cascade)
- No dry passage through structure
- Heavy rip rap at both the inlet and outlet and extensive armoring at outlet
