TECHNICAL MEMO

Weekeepeemee River Streamwalk Assessment Survey Woodbury and Bethlehem, CT

Field Assessments Completed July and August 2021
by Pomperaug River Watershed Coalition

Project Led and Memo Prepared by
Carol Haskins, PRWC Executive Director

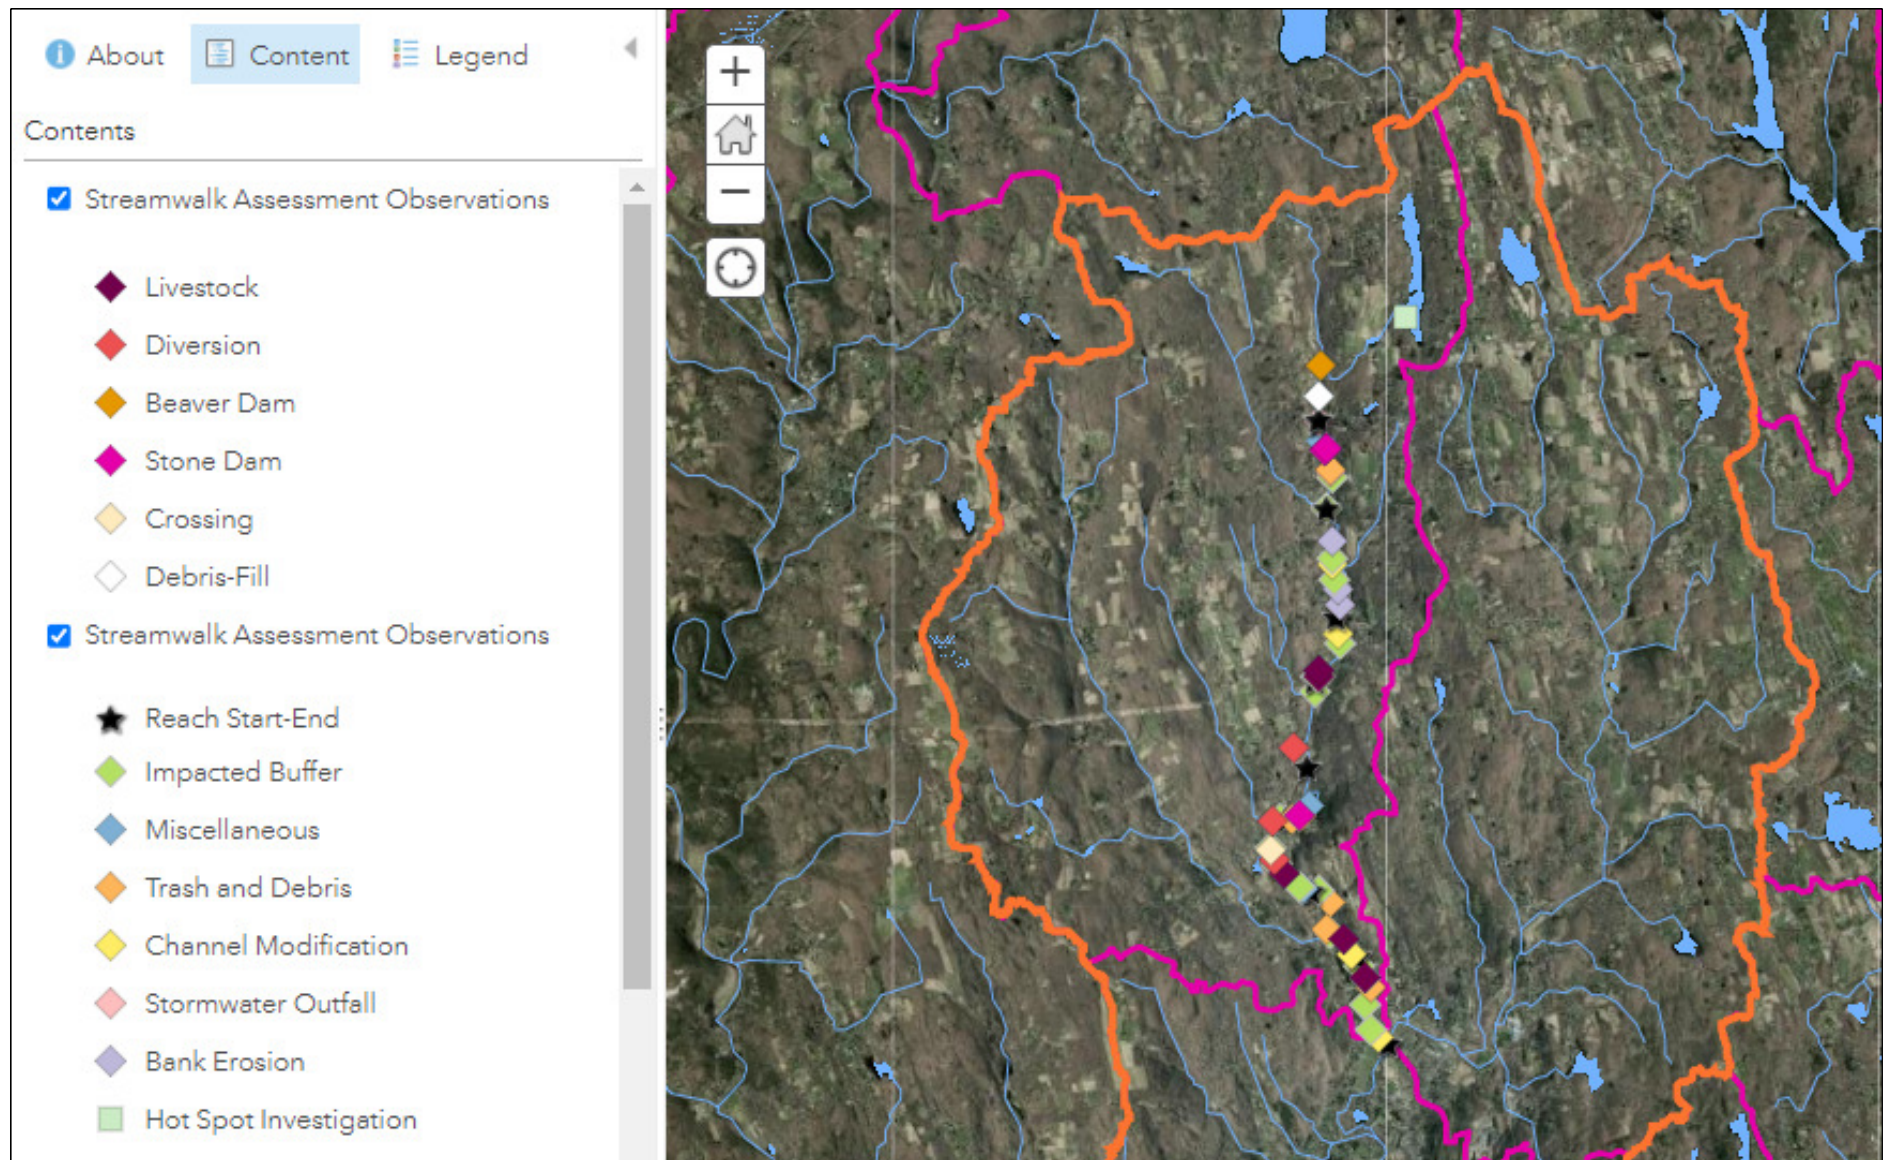
Figure 5. Weekepeemee River Streamwalk Survey Observations – July and August 2021.

- **Lack of Stream Buffer** – Stream buffer encroachments were prevalent along the Weekepeemee River and are most often associated with residential and agricultural properties. Residential lawns and some agricultural practices extend down to the banks of the stream in many areas (**Figure 5**). The degree of stream buffer encroachment can have a significant impact on the overall stream and habitat conditions. In general, larger natural buffers are associated with better stream health, including channel substrate, flow regime, water quality, and shading as well as better upland and wetland habitat that provide larger areas available to native flora and fauna.

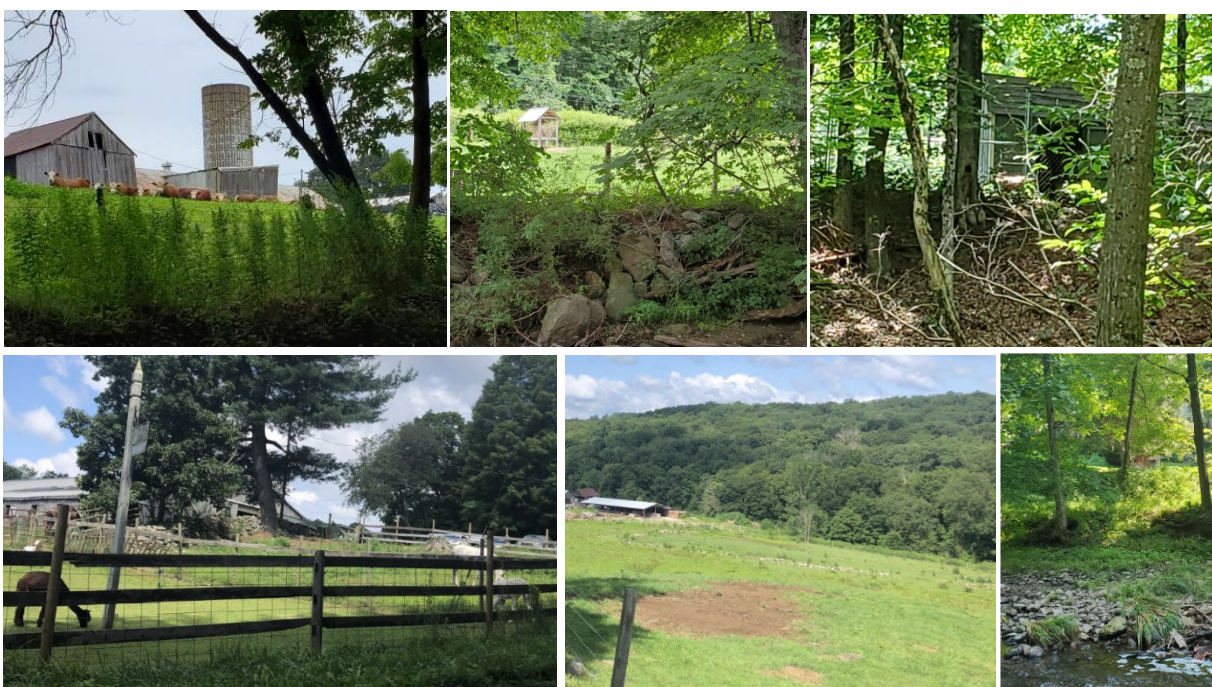
Figure 8. Examples of hobby and commercial agricultural activities in the Weekeepeemee Watershed.

- **Agricultural Land Use** – Hobby farms, equestrian centers, and more intensive livestock farming practices were frequently observed in the Weekepeemee watershed. While some farms maintain animal exclusion fencing to separate livestock from streams, other locations have grazing or feeding areas with apparent channelization or full access to streams and discharges to streams. Exclusion fencing, alternative approaches to manure management, such as moving manure piles further away from streams, and other agricultural BMPs can yield water quality improvements (**Figure 8**). Crop production is also common in the Weekepeemee watershed; manure based fertilizers may be used in these areas along with other soil amendments and pest controls. Additional best practices may be suitable in for nutrient and pest management and prevention of soil erosion in these areas including the establishment and maintenance of riparian buffers.

Goats, alpaca, cattle, and chickens are common types of livestock present. Crop production is also common in this watershed. Best management practices for these properties include increased livestock fencing setback distances, manure management and storage practices, and riparian buffer restoration and maintenance.

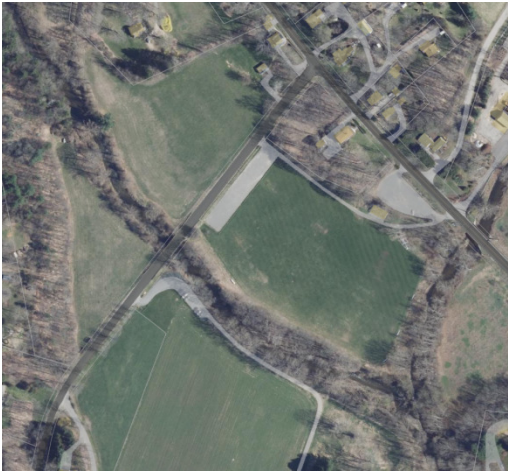
Site Code	Location Description	Observations	Potential Bacteria Sources	Potential BMPs	Other Recommendations and Notes	BMP Potential	BMP Priority	BMP Cost	Photos
R1-CM-01	Three Rivers Park Route 47 at Jack's Bridge Rd	Channel Modification (CM-01) - 50 feet of heavy armoring on the right bank; Exposed tree roots on right bank; berm between the cornfield and the river; river channelized from Jack's Bridge to the Confluence	Popular dog walk area Manure spreading on cornfield	Root wads, large woody debris, strategically placed boulders, lower or strategically breach the berm to help reconnect the river to the floodplain, native tree and shrub plantings, invasive plant removal	Town owned property on both sides. Pet waste bags and trash receptacles are well managed. Pomperaug WBP previously identified an opportunity to relocate the parking area away from the river.	Med	Med	High

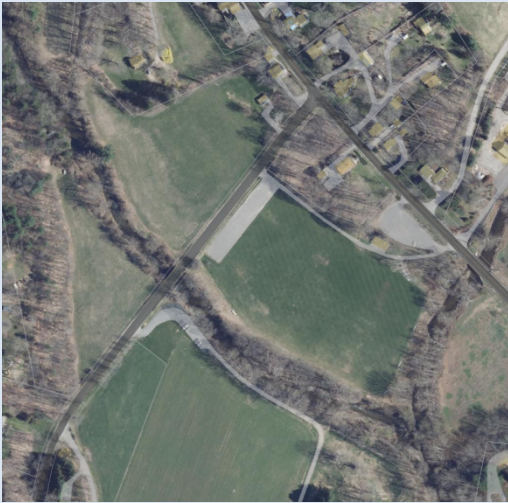
R1-IB-01	Meadow Farm Route 47 at Jack's Bridge Rd	Impacted Buffer (IB-01a) - Less than 25% shading of the river channel for a length of approximately 600 feet; ample vegetation dominated by shrub and tall grasses along both sides of the river providing buffer between the hayfields and the river, yet little canopy to provide shade. A few younger sycamores are established on both sides. Minimally shaded area spans from Jack's Bridge to Rock Outcrop located on the right bank approximately 600 feet upstream from the bridge.	No livestock present but possibly manure if spread on fields as fertilizer	Add shade trees along the river bank	Landowner has been working to clear invasive species from the riparian buffer	High	Med	Med

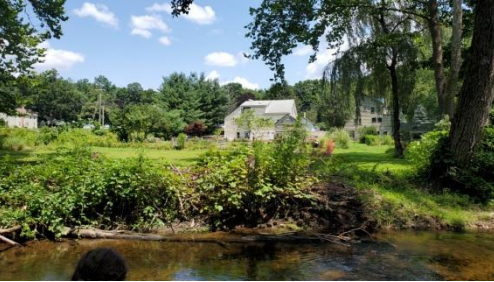
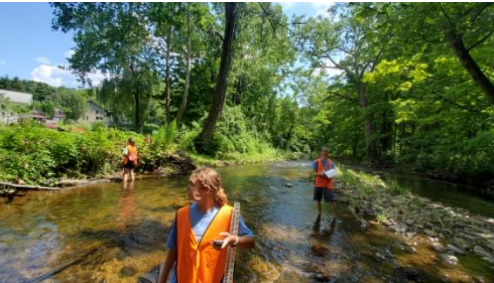
R1-IB-02	Washington Road near Quassuk Rd	Impacted Buffer (IB-02) - Three houses on the left bank with large, open, level lawns mowed to the edge of the river bank; some large shade trees (sycamores) interspersed;	None apparent	Recommend planting a shrub layer or establishing a no mow zone. Approximately 200 feet x 15 feet along the river bank available for planting.	Houses are set back from the river approximately 100 feet. Right bank is well vegetated.	Med	Med	Med

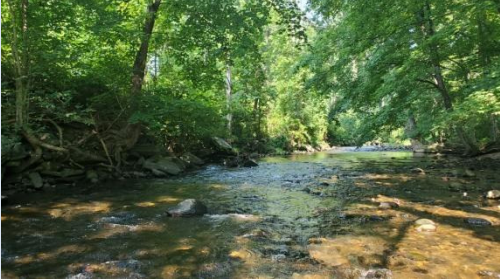
Site Code	Location Description	Observations	Potential Bacteria Sources	Potential BMPs	Other Recommendations and Notes	BMP Potential	BMP Priority	BMP Cost	Photos
R2-CM-01	Route 47 at Route 132	Channel Modification (CM-01) - River is straightened for approximately 1000 feet on the right bank where it flows along the edge of Route 47 upstream of the bridge. The area between the river and the road is only about 10 to 15 feet wide and is heavily armored. There is a large scour at the upstream end of the channelized area where the river is forced to make a sharp turn as it flows towards the armored bank. The river is also forced to make a sharp turn to flow under the bridge.	Wildlife	Update / replace / realign Hotchkissville Bridge at Route 47 so that it spans beyond the banks and is better aligned to the river channel. Root wads, woody debris, strategically placed boulders for in-stream habitat diversity, dissipating energy in the river channel, and better connecting the river to its floodplain.	Note restoration challenge presented by Route 47 as well as the power lines located along the river-side of the road. There is room on the left bank for the river to spill into the floodplain. In heavy storms, the river will also spill over Route 47.	Low	Med	High	<div>

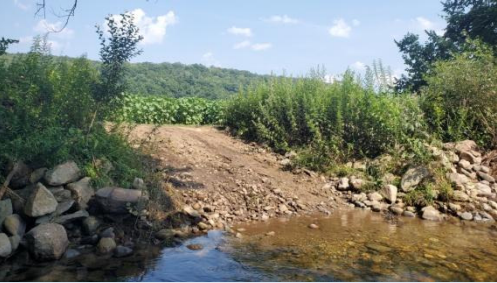
Site Code	Location Description	Observations	Potential Bacteria Sources	Potential BMPs	Other Recommendations and Notes	BMP Potential	BMP Priority	BMP Cost	Photos
R3-MI-04	Route 132, The Farm	Miscellaneous (MI-04) - Ford-style tractor crossing between crop fields on opposite sides of the river. Water downstream of the crossing was noticeably turbid.	None apparent	May be an opportunity to formalize the crossing as a ford wherein the riverbed is stabilized to prevent bed erosion or to establish a bridge crossing.	“Hog panel” or “GeoWeb” style crossing materials may be appropriate for this site. See NRCS bulletin: https://www.nrcs.usda.gov/Internet/FSE_DOCUMENTS/stelprdb1167481.pdf	Med	Med	Med /High

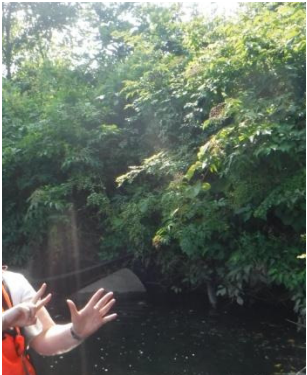
Site Code	Location Description	Observations	Potential Bacteria Sources	Potential BMPs	Other Recommendations and Notes	BMP Potential	BMP Priority	BMP Cost	Photos
R3-OT-01	Peter Road	Stormwater Outfall (OT-01). Concrete stormwater pipe / old stormwater outfall on the right bank along the edge of Peter Road.	None apparent	Regularly inspect and clear sediment trap.	Should already be accounted for in town's MS4 inventory. Continue outfall monitoring as required by MS4 permit.	High	Low	Low	N/A
R3-MI-05	Peter Road	Miscellaneous (MI-05) - Irrigation pipe - likely inactive; possibly deposited by flooding.	n/a	Remove pipe if not in active use.	Located next to concrete stormwater pipe / old stormwater outfall on the right bank along the edge of Peter Road that should be accounted for in town's MS4 inventory.	High	Low	Low

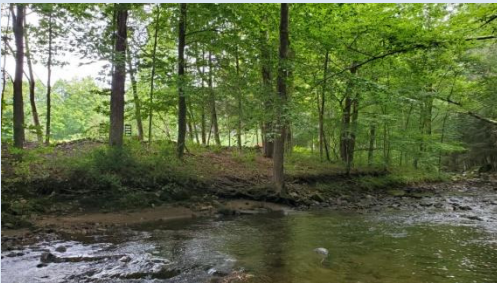
Site Code	Location Description	Observations	Potential Bacteria Sources	Potential BMPs	Other Recommendations and Notes	BMP Potential	BMP Priority	BMP Cost	Photos
R4-IB-01	Brushy Hill Road	Impacted Buffer (IB-01) - Private residence where there are a number of brush piles located in the floodplain which appear to be associated with active clearing along the right bank. A good number of large trees are present which provide 75% shading over the stream. Construction equipment is present.	Wildlife	Recommendation adding more understory vegetation along 200 feet of the bank to enhance the riparian buffer. Area approximately 25 feet wide is available for planting.	Stonewall and terracing down to the river. Stones somewhat piled in the river to enhance / deepen an existing pool. Disassemble this “dam” and redistribute rocks throughout the immediate area.	Medium	Low	Medium

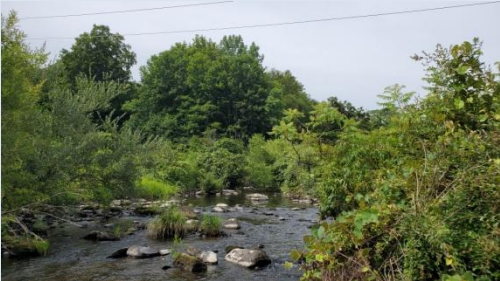
Site Code	Location Description	Observations	Potential Bacteria Sources	Potential BMPs	Other Recommendations and Notes	BMP Potential	BMP Priority	BMP Cost	Photos
R4-IB-02	Chohees Trail, The Farm	Impacted Buffer (IB-02) - Area under the power transmission lines has been cleared leaving the stream 95% unshaded for a length of 300 to 350 feet. There is ample understory vegetation providing stability, but the area is dominated by multiflora rose, Russian olive, mugwort, and other invasives.	None apparent	Recommend establishing shrub height vegetation so not to compete with maintenance of the power lines and in effort to provide some shading. More room on the right bank for natural revegetation or planting - 50 feet available. About 10 feet is available on the left bank where there is active crop production and where greenhouses are present.	Livestock presence was noted in the Pomperaug Watershed Based Plan (2018); they are no longer a component of the operations at this site. Adding vegetation under the power lines might not be feasible based on line maintenance practices and access needs of the power copy. Water conservation practices and other BMPs including drip irrigation; infiltration of stormwater runoff; rainfall capture (i.e. cistern); limited application of fertilizers and pesticides may be appropriate. Farm is already known to be using Integrated Pest Management strategies.	Low/ Med	Med	High

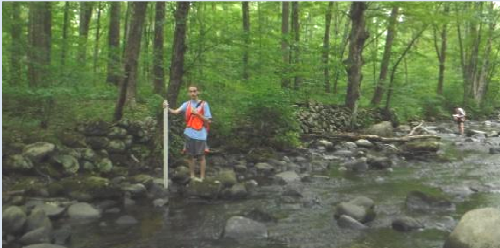
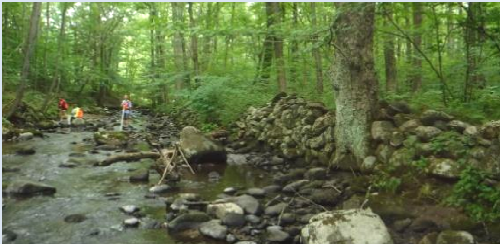
R6-CM-01	Arrowhead Lane	Channel Modification (CM-01) - Old stone wall armors the stream along the left bank. The wall is approximately 200 feet long and 3 to 4 feet high. It appears that water can flow over (and probably through the wall) into the floodplain in high flow events. The wall doesn't appear to alter the flow pattern in the river; no evidence of sediment deposition or vegetation growth in the channel.	None apparent / wildlife	None	Ample room for the river to move and let nature take its course. The stonewall is the only infrastructure at risk for failure and there are no major consequences evident if it collapses.	Low	Low	Low

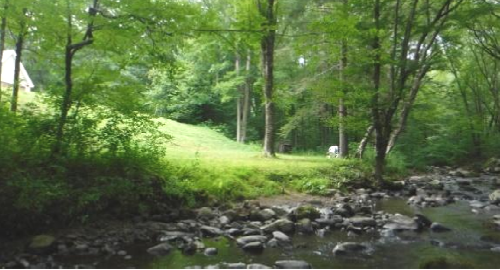
Site Code	Location Description	Observations	Potential Bacteria Sources	Potential BMPs	Other Recommendations and Notes	BMP Potential	BMP Priority	BMP Cost	Photos
R6-IB-02	Arrowhead Lane	Impacted Buffer (IB-02) - Approximately 125 feet of open lawn up to the water's edge on the right bank. No trees or shrubs and no shade cover. There is an above ground pool situated about 100 feet upslope of the stream, while the house is about 150 feet from the stream.	None apparent	Recommend planting native trees, shrubs, perennials to create at least a 15 foot wide riparian buffer along the 125 feet of streambank.		Med	Med	Med

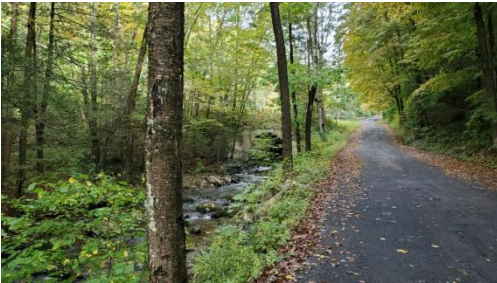
Site Code	Location Description	Observations	Potential Bacteria Sources	Potential BMPs	Other Recommendations and Notes	BMP Potential	BMP Priority	BMP Cost	Photos
R7-IB-01	Mill Pond Road	Impacted Buffer (IB-01) - Approximately 300 foot stretch along Mill Pond Road, downstream of Route 132 appears to have been straightened; both banks are armored with cobble to boulder sized riprap. The bank between the road and the river is slightly steeper than a 1:1 slope and the width to the road is only about 10 feet (this is on the left bank of the river). Sparse vegetation grows between the rocks and is dominated by poison ivy and jewelweed. The right bank is a little lower and opens into a narrow floodplain. There is some minor undercutting along the right bank.	None apparent		There is room for some plantings on the right bank, but not possible on the left given the intensive riprap. Stream is more than 50% shaded. Stability of the banks and potential for road washing out is the greater concern here.	Low	Med	High

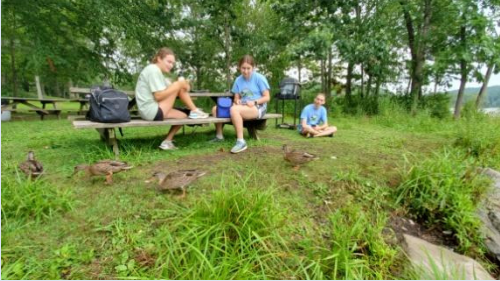
Site Code	Location Description	Observations	Potential Bacteria Sources	Potential BMPs	Other Recommendations and Notes	BMP Potential	BMP Priority	BMP Cost	Photos
HSI-02	Long Meadow Pond Town Beach	Hotspot Site Investigation (HSI-02) - Long Meadow Pond Beach. Lots of duck and goose poop scattered throughout the beach, playground, picnic and boat launch area. Port-o-potty located immediately adjacent to the water at the boat launch; potential bacteria source if leaking or if pushed over / backed into by a car.	Ducks / Geese / Port-o-let / Septic	Highly visible / high traffic area suitable for demonstration projects like native buffer plantings or a rain garden. A Rain garden could capture runoff from the pavilion or the building used for summer camp. Pervious gravel parking lots are already in place along with a stormwater detention pond.	Low risk for septic failure given seasonal use of bathrooms.	Med	Med	Med /High
