TECHNICAL MEMO

Weekeepeemee River Streamwalk Assessment Survey Woodbury and Bethlehem, CT

Field Assessments Completed July and August 2021
by Pomperaug River Watershed Coalition

Project Led and Memo Prepared by
Carol Haskins, PRWC Executive Director

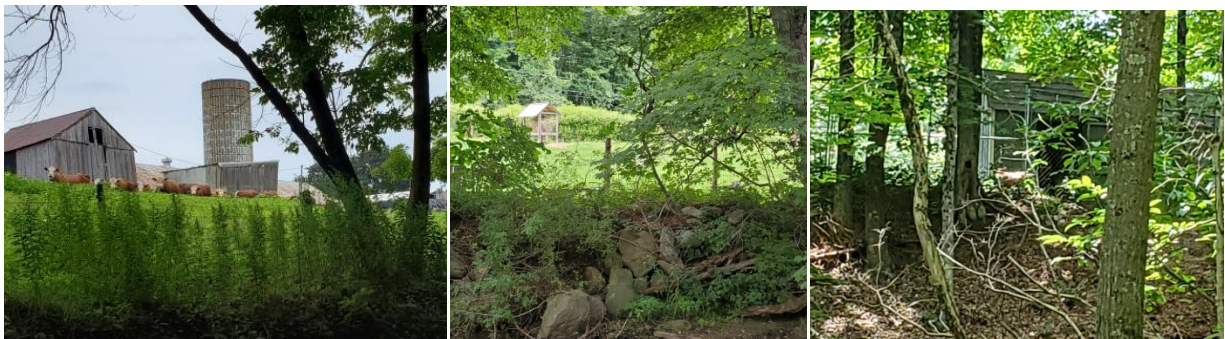
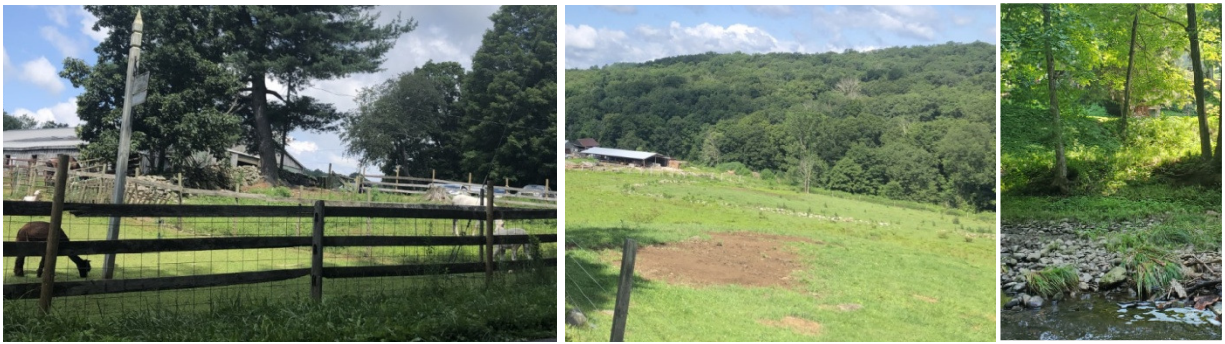
Figure 8. Examples of hobby and commercial agricultural activities in the Weekeepemee Watershed.

- **Agricultural Land Use** – Hobby farms, equestrian centers, and more intensive livestock farming practices were frequently observed in the Weekepeemee watershed. While some farms maintain animal exclusion fencing to separate livestock from streams, other locations have grazing or feeding areas with apparent channelization or full access to streams and discharges to streams. Exclusion fencing, alternative approaches to manure management, such as moving manure piles further away from streams, and other agricultural BMPs can yield water quality improvements (**Figure 8**). Crop production is also common in the Weekepeemee watershed; manure based fertilizers may be used in these areas along with other soil amendments and pest controls. Additional best practices may be suitable in these areas for nutrient and pest management and prevention of soil erosion in these areas including the establishment and maintenance of riparian buffers.

Goats, alpaca, cattle, and chickens are common types of livestock present. Crop production is also common in this watershed. Best management practices for these properties include increased livestock fencing setback distances, manure management and storage practices, and riparian buffer restoration and maintenance.

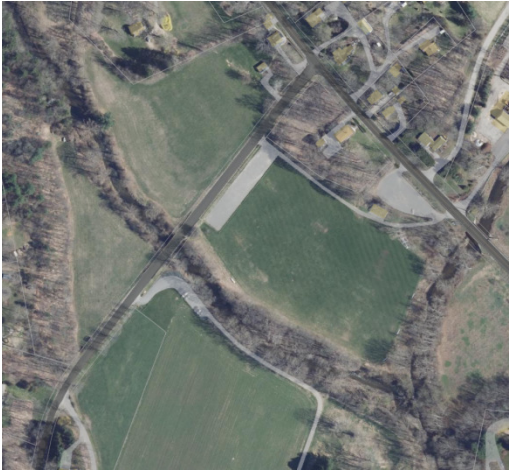
Site Code	Location Description	Observations	Potential Bacteria Sources	Potential BMPs	Other Recommendations and Notes	BMP Potential	BMP Priority	BMP Cost	Photos
R1-CM-01	Three Rivers Park Route 47 at Jack's Bridge Rd	Channel Modification (CM-01) - 50 feet of heavy armoring on the right bank; Exposed tree roots on right bank; berm between the cornfield and the river; river channelized from Jack's Bridge to the Confluence	Popular dog walk area Manure spreading on cornfield	Root wads, large woody debris, strategically placed boulders, lower or strategically breach the berm to help reconnect the river to the floodplain, native tree and shrub plantings, invasive plant removal	Town owned property on both sides. Pet waste bags and trash receptacles are well managed. Pomperaug WBP previously identified an opportunity to relocate the parking area away from the river.	Med	Med	High

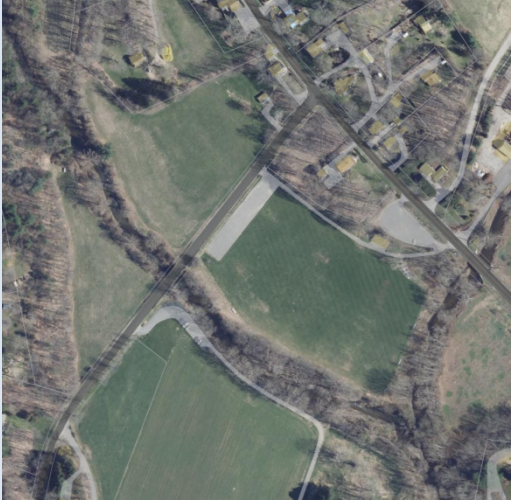
R1-IB-01	Meadow Farm Route 47 at Jack's Bridge Rd	Impacted Buffer (IB-01a) - Less than 25% shading of the river channel for a length of approximately 600 feet; ample vegetation dominated by shrub and tall grasses along both sides of the river providing buffer between the hayfields and the river, yet little canopy to provide shade. A few younger sycamores are established on both sides. Minimally shaded area spans from Jack's Bridge to Rock Outcrop located on the right bank approximately 600 feet upstream from the bridge.	No livestock present but possibly manure if spread on fields as fertilizer	Add shade trees along the river bank	Landowner has been working to clear invasive species from the riparian buffer	High	Med	Med

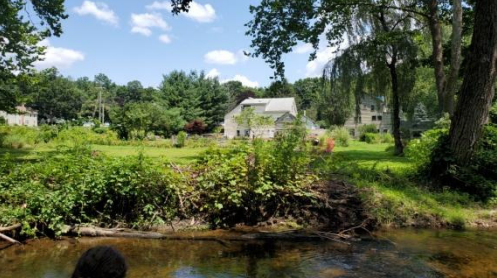
R1-IB-02	Washington Road near Quassuk Rd	Impacted Buffer (IB-02) - Three houses on the left bank with large, open, level lawns mowed to the edge of the river bank; some large shade trees (sycamores) interspersed;	None apparent	Recommend planting a shrub layer or establishing a no mow zone. Approximately 200 feet x 15 feet along the river bank available for planting.	Houses are set back from the river approximately 100 feet. Right bank is well vegetated.	Med	Med	Med

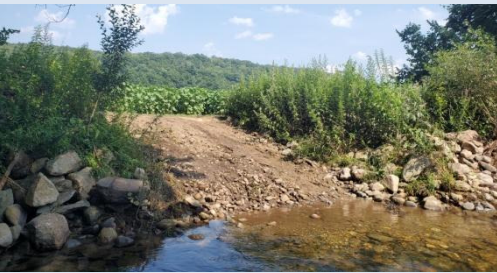
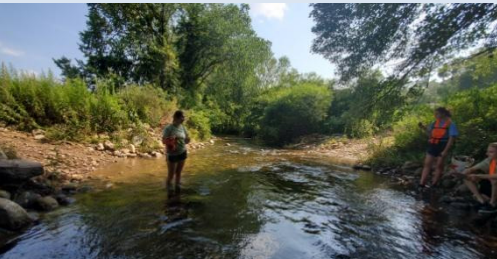
Site Code	Location Description	Observations	Potential Bacteria Sources	Potential BMPs	Other Recommendations and Notes	BMP Potential	BMP Priority	BMP Cost	Photos
R3-MI-04	Route 132, The Farm	Miscellaneous (MI-04) - Ford-style tractor crossing between crop fields on opposite sides of the river. Water downstream of the crossing was noticeably turbid.	None apparent	May be an opportunity to formalize the crossing as a ford wherein the riverbed is stabilized to prevent bed erosion or to establish a bridge crossing.	“Hog panel” or “GeoWeb” style crossing materials may be appropriate for this site. See NRCS bulletin: https://www.nrcs.usda.gov/Internet/FSE_DOCUMENTS/stelprdb1167481.pdf	Med	Med	Med /High

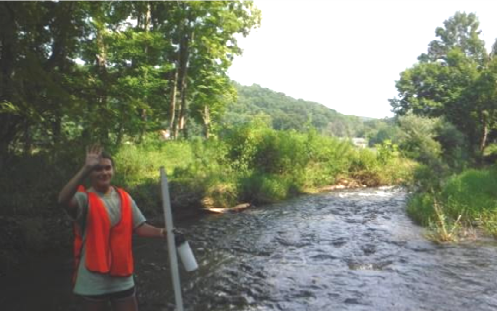
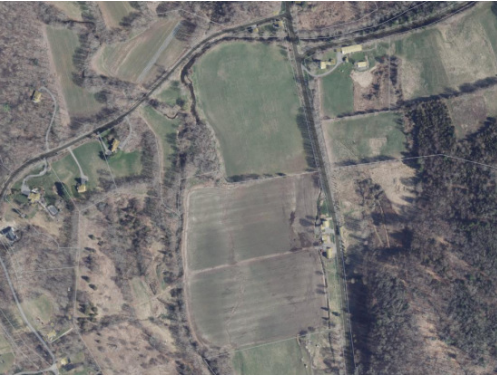
R3-IB-03	Route 132, The Farm	Impacted Buffer (IB-03) - On the left bank, farm/crop field has a narrow row of established trees along the river with minimal understory.	None apparent; possibly manure if spread as fertilizer on the crop fields.	Could use an additional row of shrubs, trees, and/or perennials between the river and the crop field. Area available for planting spans approximately 300 feet by 10 feet. Opposite bank also has room for similar planting or letting it naturally regenerate.	Aim to balance crop production area with river protections.	Med	High	High

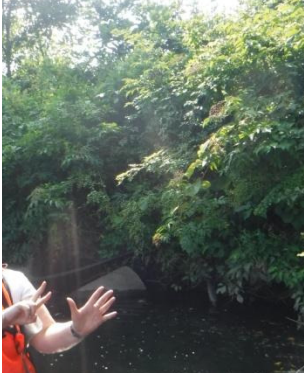
Site Code	Location Description	Observations	Potential Bacteria Sources	Potential BMPs	Other Recommendations and Notes	BMP Potential	BMP Priority	BMP Cost	Photos
R3-OT-01	Peter Road	Stormwater Outfall (OT-01). Concrete stormwater pipe / old stormwater outfall on the right bank along the edge of Peter Road.	None apparent	Regularly inspect and clear sediment trap.	Should already be accounted for in town's MS4 inventory. Continue outfall monitoring as required by MS4 permit.	High	Low	Low	N/A
R3-MI-05	Peter Road	Miscellaneous (MI-05) - Irrigation pipe - likely inactive; possibly deposited by flooding.	n/a	Remove pipe if not in active use.	Located next to concrete stormwater pipe / old stormwater outfall on the right bank along the edge of Peter Road that should be accounted for in town's MS4 inventory.	High	Low	Low

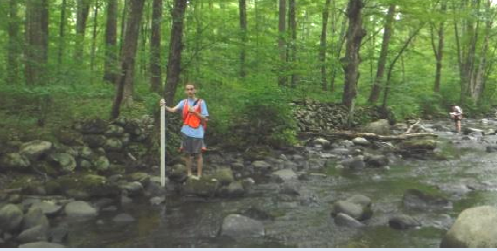
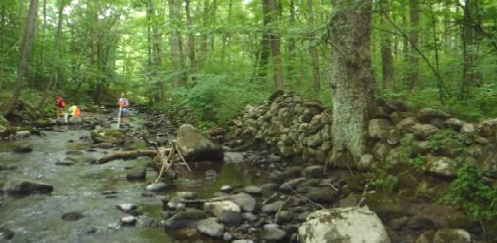
R6-CM-01	Arrowhead Lane	Channel Modification (CM-01) - Old stone wall armors the stream along the left bank. The wall is approximately 200 feet long and 3 to 4 feet high. It appears that water can flow over (and probably through the wall) into the floodplain in high flow events. The wall doesn't appear to alter the flow pattern in the river; no evidence of sediment deposition or vegetation growth in the channel.	None apparent / wildlife	None	Ample room for the river to move and let nature take its course. The stonewall is the only infrastructure at risk for failure and there are no major consequences evident if it collapses.	Low	Low	Low

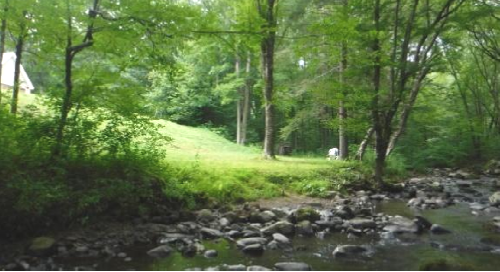
Site Code	Location Description	Observations	Potential Bacteria Sources	Potential BMPs	Other Recommendations and Notes	BMP Potential	BMP Priority	BMP Cost	Photos
R6-IB-02	Arrowhead Lane	Impacted Buffer (IB-02) - Approximately 125 feet of open lawn up to the water's edge on the right bank. No trees or shrubs and no shade cover. There is an above ground pool situated about 100 feet upslope of the stream, while the house is about 150 feet from the stream.	None apparent	Recommend planting native trees, shrubs, perennials to create at least a 15 foot wide riparian buffer along the 125 feet of streambank.		Med	Med	Med

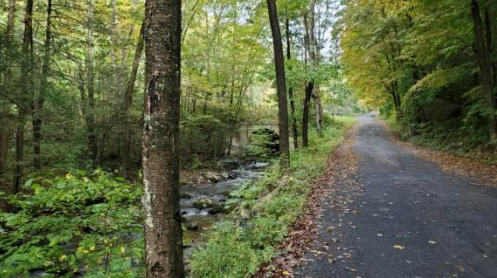
Site Code	Location Description	Observations	Potential Bacteria Sources	Potential BMPs	Other Recommendations and Notes	BMP Potential	BMP Priority	BMP Cost	Photos
R7-IB-01	Mill Pond Road	Impacted Buffer (IB-01) - Approximately 300 foot stretch along Mill Pond Road, downstream of Route 132 appears to have been straightened; both banks are armored with cobble to boulder sized riprap. The bank between the road and the river is slightly steeper than a 1:1 slope and the width to the road is only about 10 feet (this is on the left bank of the river). Sparse vegetation grows between the rocks and is dominated by poison ivy and jewelweed. The right bank is a little lower and opens into a narrow floodplain. There is some minor undercutting along the right bank.	None apparent		There is room for some plantings on the right bank, but not possible on the left given the intensive riprap. Stream is more than 50% shaded. Stability of the banks and potential for road washing out is the greater concern here.	Low	Med	High

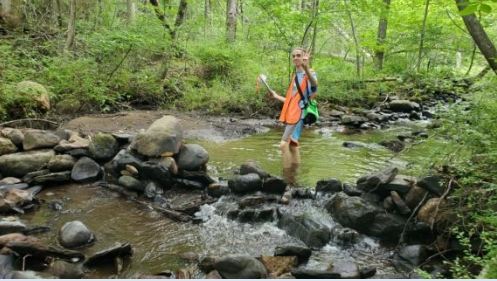
Site Code	Location Description	Observations	Potential Bacteria Sources	Potential BMPs	Other Recommendations and Notes	BMP Potential	BMP Priority	BMP Cost	Photos
R7-TR-01	Upstream Route 132	Trash and Debris (TR-01) - Lots of roadside litter including bottles, cans, plastic, cups, wrappers, etc.	None apparent	Establish "Adopt-a-Spot" for town clean up days.	Less than a pick-up truck load was picked up, but may need more attention for town clean-up days. Most litter seems to be tossed from cars on Route 132; add "No Littering" sign along roadway.	Med	Low	Low	N/A
R7-MI-01	Between Judge Lane and Route 132	Miscellaneous (MI-01) - Small rock dam/stonewall 2 to 3 feet high across the river; easily removed. Also noted is understory clearing on the right bank, mostly brush removal in an area out 100 feet wide in effort to provide a view towards the river; appears to be an invasive plant removal effort; the house is about 500 feet away from the river up a gently sloping hill.	None apparent	Recommend removing "dam" and strategically planting a couple trees in cleared swath to prevent long-term erosion.		Med	Low	Low
